## Technical product information

| <b>Topic</b> | Infotainment screen turns red sporadically |
| <b>Brand</b> | Bentley |
| <b>Transaction No.</b> | 2055846/4 |

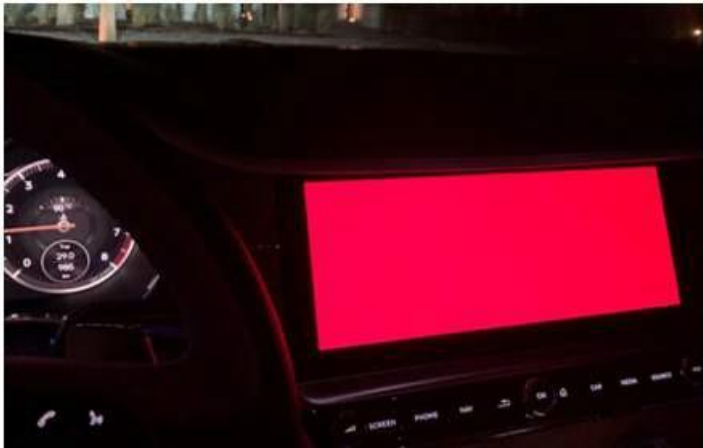
Figure 1

Infotainment screen turns red sporadically (Figure 1)

Reset the Infotainment system as follows:

- Press and hold the volume rotary switch (Figure 2) for 10 seconds
