# Technical Service Bulletin

GROUP <b>CAMPAIGN</b>	NUMBER <b>21-01-056H</b>
DATE <b>JULY, 2021</b>	MODEL(S) <b>ELANTRA (CN7)</b>

**SUBJECT:** ICU(INTEGRATED CENTRAL CONTROL UNIT) SOFTWARE UPDATE  
(SERVICE CAMPAIGN T6V)

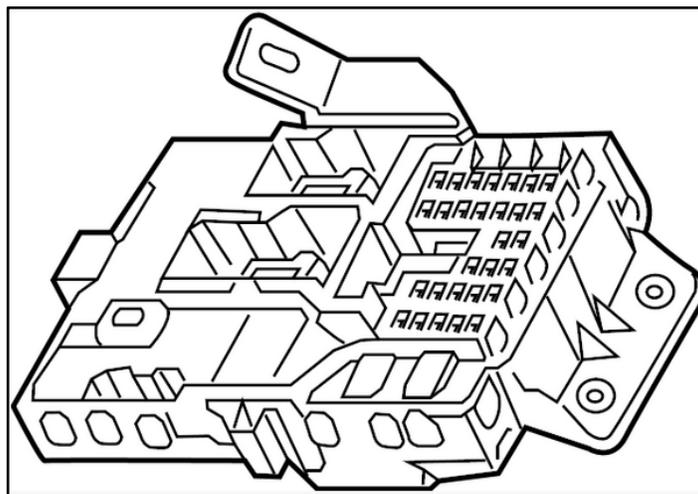
**Description:** Some 2021 Elantra (CN7) vehicles may exhibit a condition with multiple warning lights displayed on the instrument cluster and various symptoms; multiple DTCs (Diagnostic Trouble Code), reduction in power steering assist, and not able to shift out of Park. Possible DTCs set are:

- C181287 – CAN Time-out Gateway
- C181208 – CAN Time-out Gateway
- C180581 – LKAS CAN Signal Error
- C181887 – CAN Time-out BCA
- B109052 – TCU Missing Error

This bulletin provides the service procedure to update the ICU (Integrated Central Control Unit) software to resolve the conditions stated above.
