HYUNDAI Technical Service Bulletin	GROUP AUTOMATIC TRANSMISSION	NUMBER 21-AT-009H
	DATE JULY, 2021	MODEL PALISADE (LX2) SANTA FE (TMA) SANTA FE HYBRID (TM HEV) SONATA (DN8/DN8A) SONATA HYBRID (DN8 HEV) TUCSON (NX4/NX4A) TUCSON HYBRID (NX4 HEV)
SUBJECT: AUTOMATIC TRANSAXLE PUSH-BUTTON SHIFTER DIAGNOSIS

DESCRIPTION: This TSB provides a procedure to diagnose the push button shifter operation.

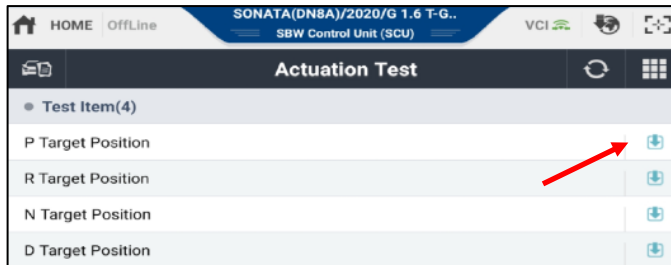
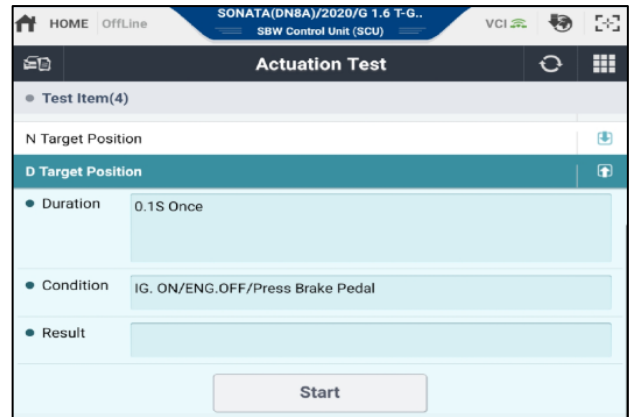
5. Turn the engine off and push the SSB 2 times to turn the ignition **ON**. Press the brake pedal. From the GDS home screen, select **Actuation Test** and **SCU** menu. Test the Target position for P, R, N and D. Press the arrow to change the selection. If the GDS and cluster show:
 - Correct **Target Position** for P, R, N and D: The SCU sent 12v to the SBW actuator, the SCU and SBW actuator are currently operating correctly and the related harness currently does not have an open/short circuit. Go to Step 6.
 - Does not show the correct **Target Position** for P, R, N and D: The SCU, SBW actuator or related harness may have a fault.
