Technical Service Bulletin

GROUP Fuel System	NUMBER 21-FL-003HG
DATE July, 2021	MODEL(S) G80 (DH)

SUBJECT: DTC U0109/U010900 FUEL PUMP CONTROL MODULE

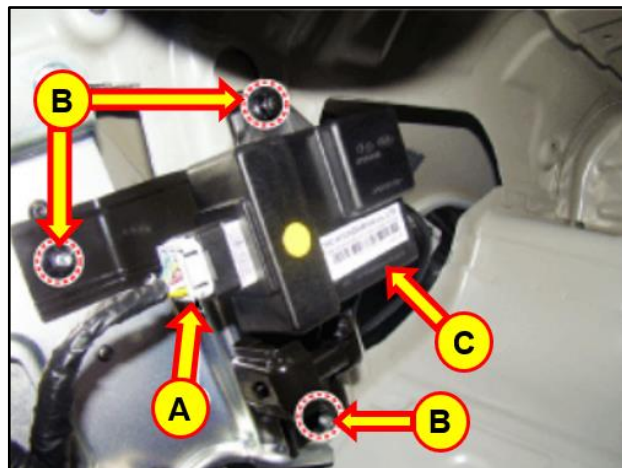
U0109 LOST COMMUNICATION WITH FUEL PUMP CONTROL MODULE

4. To remove FPCM assembly from vehicle:

- Disconnect FPCM connector (A)
- Remove the mounting nuts (B)
- Remove FPCM (C)
