Service Bulletin

Bulletin No.: 12-08-51-002M

Subject: Spray-in Bed Liner General Information and Repair Procedures

Models: 2013-2014 Chevrolet Silverado HD 2500/3500 Series
2014 Chevrolet Silverado 1500
2015-2021 Chevrolet Colorado, Silverado
2013-2014 GMC Sierra HD 2500/3500 Series
2014 GMC Sierra 1500
2015-2021 GMC Canyon, Sierra
2020 Holden Colorado
Equipped with Spray-in Bed Liner (RPO CGN, PDL)

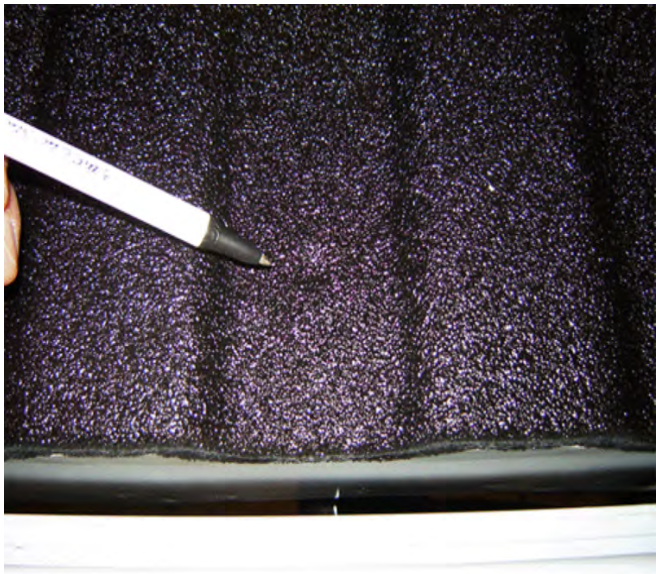
2968675

Because the bed liner material is sprayed on evenly, any variation in the bed such as seam sealer or spot welds in the sheet metal will show underneath the spray on coating. This is an expected condition. The coating does not completely fill in these variations.

Spot weld under bed liner example
