Service Bulletin

Bulletin No.: 21-NA-129

Subject: Rear Seat (60 Percent) and/or (40 Percent) Chucking Movement, and Noise is Present at Rear Latch to Striker

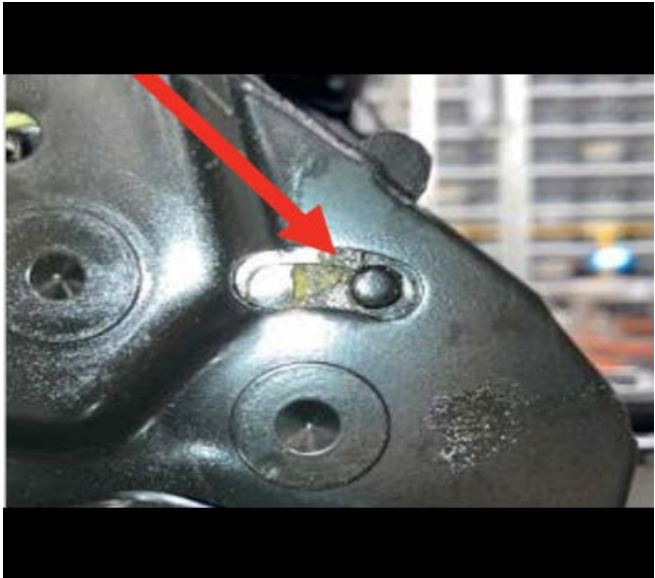
5844081

Involved Region or Country	North America, Middle East, Russia, Chile, Colombia, Peru, Thailand, Japan, Ecuador and S. Korea.
Additional Options (RPOs)	
Condition	Some customers may comment on feeling a chucking movement and hearing a noise present at the rear latch to striker of the rear seat (60 Percent) and/or (40 Percent).
Cause

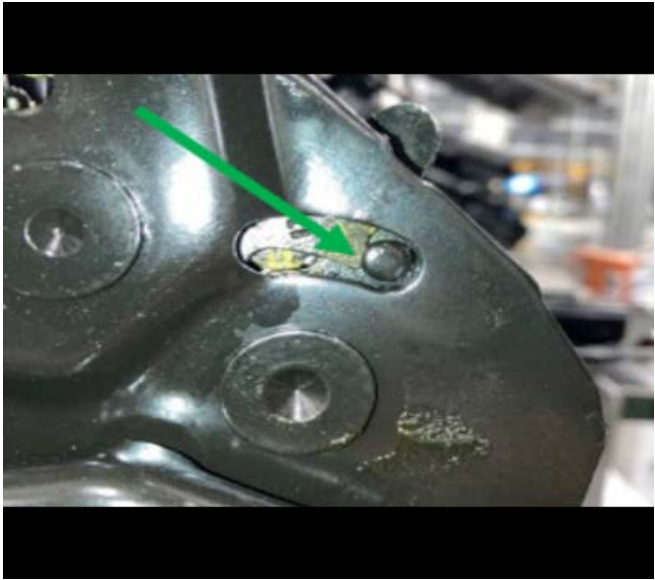
<p data-bbox="1419 739 1484 758">5844082</p> <p data-bbox="539 768 1370 823">Note: Improper engagement is shown by the red arrow example above. Proper engagement is shown by the green arrow example.</p> <p data-bbox="539 833 1471 888">The cause of the condition may be cinch cam on the rear latches are not engaged with the hook semi pierce. This allows movement of the seat, creating the chucking and noise.</p>
<p data-bbox="131 909 253 932">Correction</p>	<p data-bbox="539 896 1438 951">Verify the condition using the <i>Latch Chucking Movement Check Procedure</i> below and follow the Service Procedure as necessary.</p>

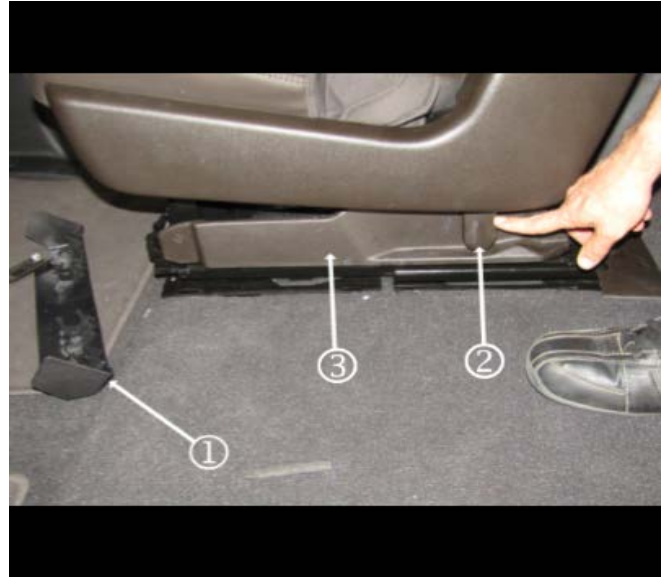
5844087

Note: Verify which latch location (inboard, outboard or both) has the chocking movement, between the floor latch and striker.

1. Remove the front (1), rear seat riser finish covers (2), inboard (3) and outboard, on the affected seat. Refer to the appropriate *Rear Seat Riser Finish Cover Replacement*, in SI.

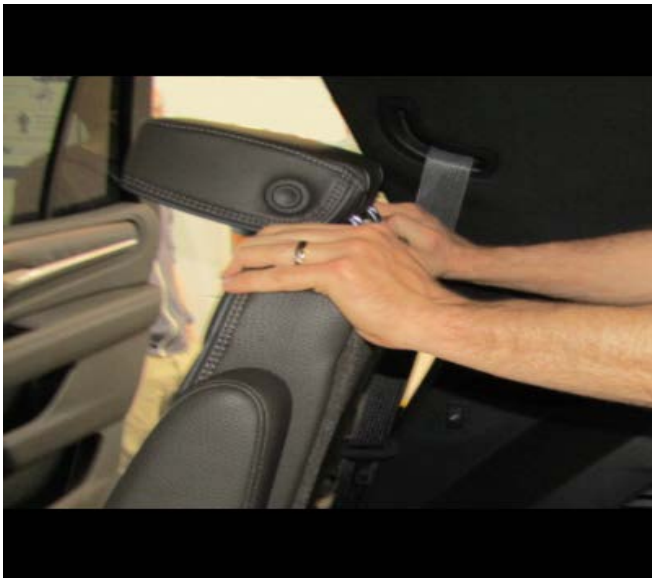
5844086

Note: Perform the chuck test again with plastics off to confirm location of the latch to striker movement (inboard, outboard or both).

3. Again, using 2 hands, apply a fore-aft load to top of the upper seatback corners, using a high force. Repeat 3 times.

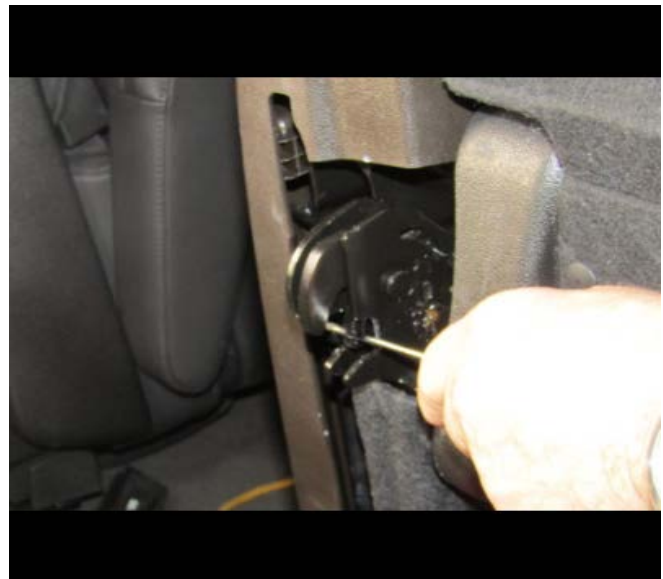
5844091

Caution: Material removal at the latch plates should be by hand tool operation only; NO power tools. If too much material is removed, the chocking movement could become permanent, and the entire seat structure would need to be replaced.

Note: Material removal should be accomplished in several repeated steps, not all at one time. And use care to ensure NO material is removed from the latch hook.

- 4.6. Insert a 4 inch, FLAT fine grade file, or equivalent, and evenly remove a minimal amount of material from both sides of the latch plates; **only until the wax pencil marking has been removed.** Use short strokes keeping the file perpendicular to the latch plates, so an even amount of material is removed from each plate.
