Service Bulletin

Bulletin No.: 21-NA-134

Subject: Squeak Noise from Exhaust System

Brand:	Model:	Model Year:		VIN:		Engino	Transmission:
		from	to	from	to	Engine:	mansinission.
Chevrolet	Camaro	2016	2021	_	_	3.6L (LGX)	_

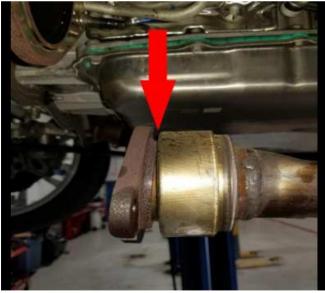
585/883

Involved Region or Country	North America, Europe, Russia, Middle East, Israel, Argentina, Brazil, Bolivia, Chile, Colombia, Ecuador, Paraguay, Peru, Uruguay, Japan, GM Korea Company, China, Taiwan, Philippines		
Additional Options (RPOs)	EXHAUST SYSTEM-DUAL (RPO N10)		
Condition	Some customers may comment that a squeak noise can be heard from the exhaust system while driving over bumps.		
Cause	This condition may be caused by a mis-aligned intermediate exhaust pipe flange rubbing the cup on the flex joint.		
Correction	Inspect the exhaust system and re-align the flange. ⇒ If you encounter a vehicle with the above concern, refer to the Service Procedure below.
