# Service Bulletin

Bulletin No.: 21-NA-136

**Subject: Crooked Rear View Camera Guideline Image on Radio Display**

Brand:	Model:	Model Year:		VIN:		Engine:	Transmission:
		from	to	from	to		
Chevrolet	Silverado 1500	2020	2020				
GMC	Sierra 1500

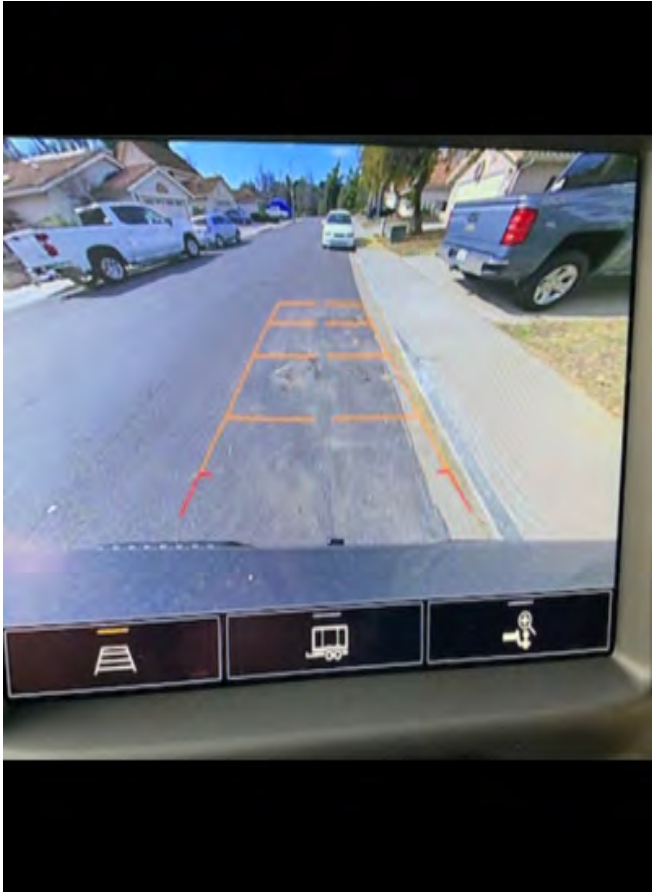
<b>Involved Region or Country</b>	United States, Canada, Mexico, Middle East, Chile, Paraguay, Uruguay, Thailand, Australia/New Zealand
<b>Additional Options (RPOs)</b>	Equipped with RPOs QK1 and UVB
<b>Condition</b>	<p>Some customers may comment on the Rearview Camera (RVC) guidelines appearing crooked on the radio display.</p>

<p style="text-align: right;">5867790</p>
<b>Cause</b>	The cause of the condition may be a software anomaly with the tow hitch guideline update.
<b>Correction</b>	Dealers should reprogram the radio with the latest calibrations.

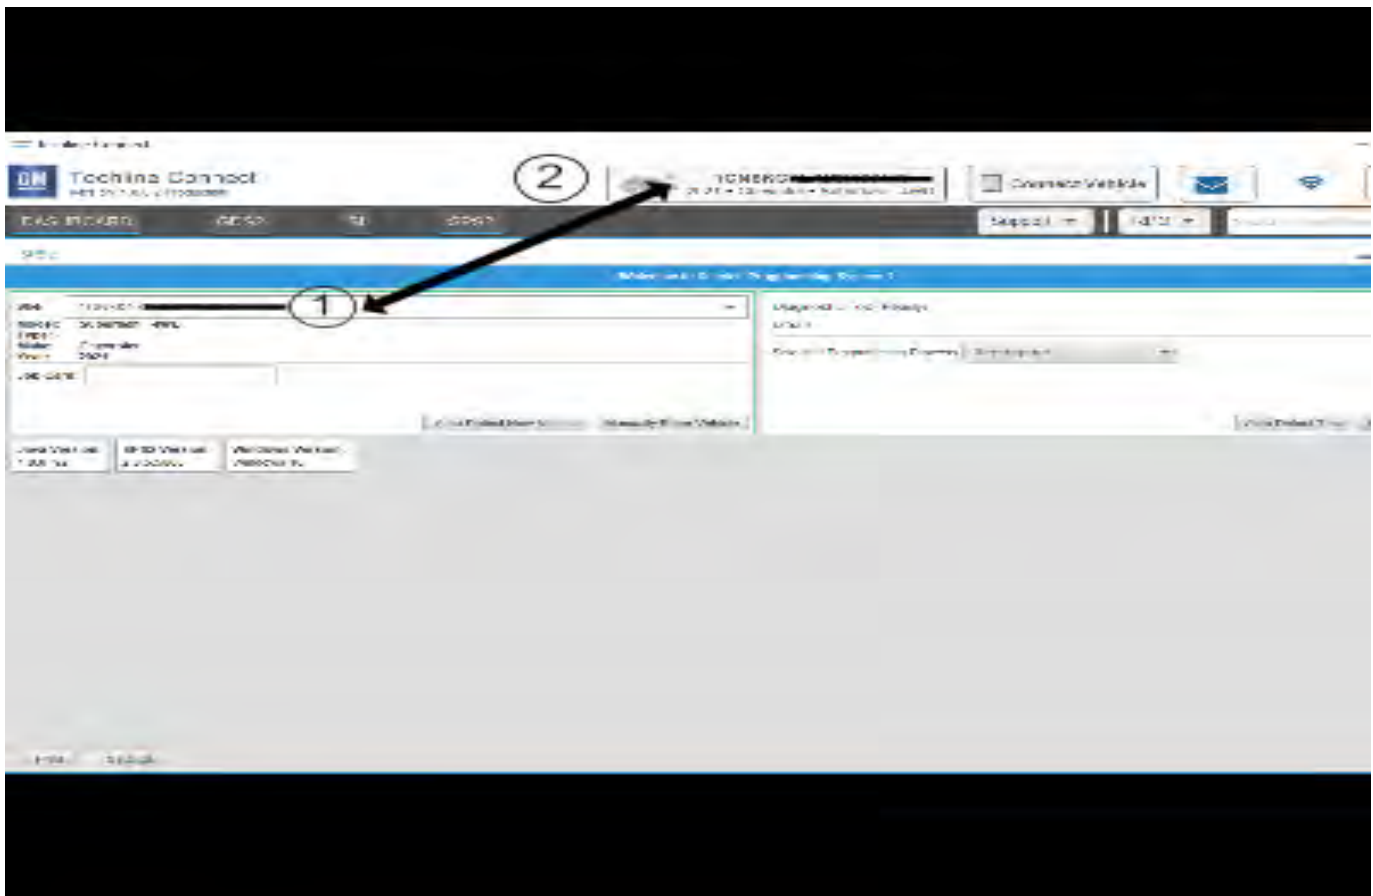
5743643

**Caution:** Be sure the VIN selected in the drop down menu (1) is the same as the vehicle connected (2) before beginning programming.

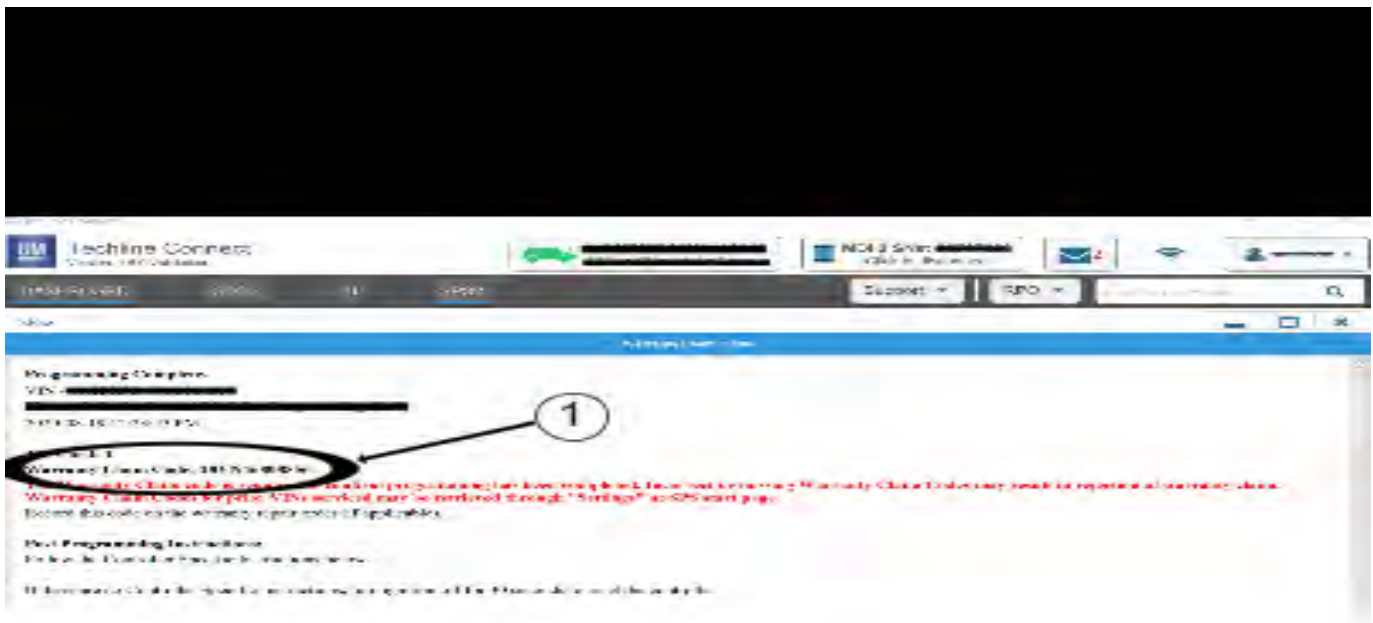
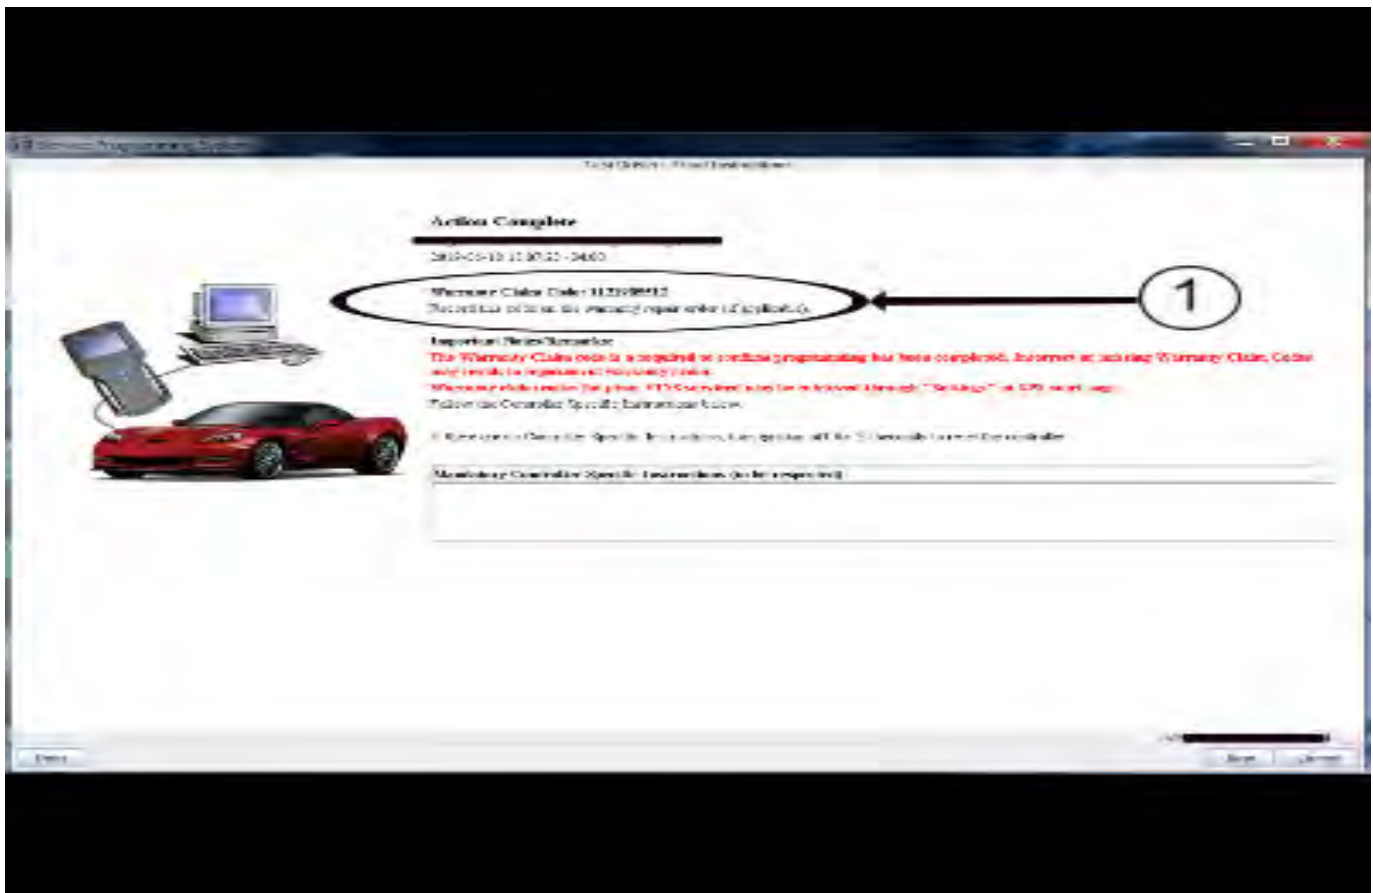
**Important:** To avoid warranty transaction rejections, you **MUST** record the warranty claim code provided on the SPS Warranty Claim Code (WCC) screen shown above on the job card. Refer to callout 1 above for the location of the WCC on the SPS screen

- Record SPS Warranty Claim Code on job card for warranty transaction submission.
