## **Service Bulletin**

Bulletin No.: 21-NA-137

Subject: Information on Headlamp Beam Shadow Appearance and/or Driver Side to Passenger Side Beam Appears Unlevel

Brand:	Model:	Model Year:		VIN:		Engine:	Transmission:
		from	to	from	to	Eligille.	iransinission.
Cadillac	CT4	2020	2021	_	_	All	All

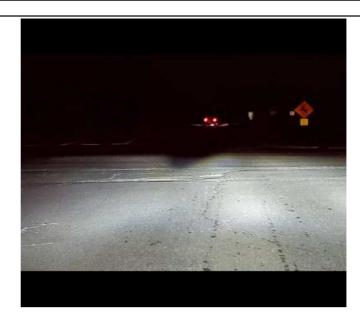
5844384

Involved Region or Country	North America, Europe, Middle East, Cadillac Korea (South Korea), China
Condition	Some customers may comment on seeing a headlamp beam shadow appearance and/or the driver side beam may appear lower than the passenger side beam.

The cause of the condition may be that the shadow is the result of a design notch, which is NOT a defect, but a design intent to reduce distraction of oncoming traffic.

**Note:** If the customer concern appears the same as shown in the graphic examples above, this condition does NOT require adjustment or replacement of the lamp.

Please communicate to the customer that the headlamp system is functioning as designed and this is a normal condition of their vehicle. Please share this information with the customer, including a copy of this bulletin.
