# Service Bulletin

Bulletin No.: 21-NA-145

Date: June, 2021

**Subject:** Radio Software Version U157 Update

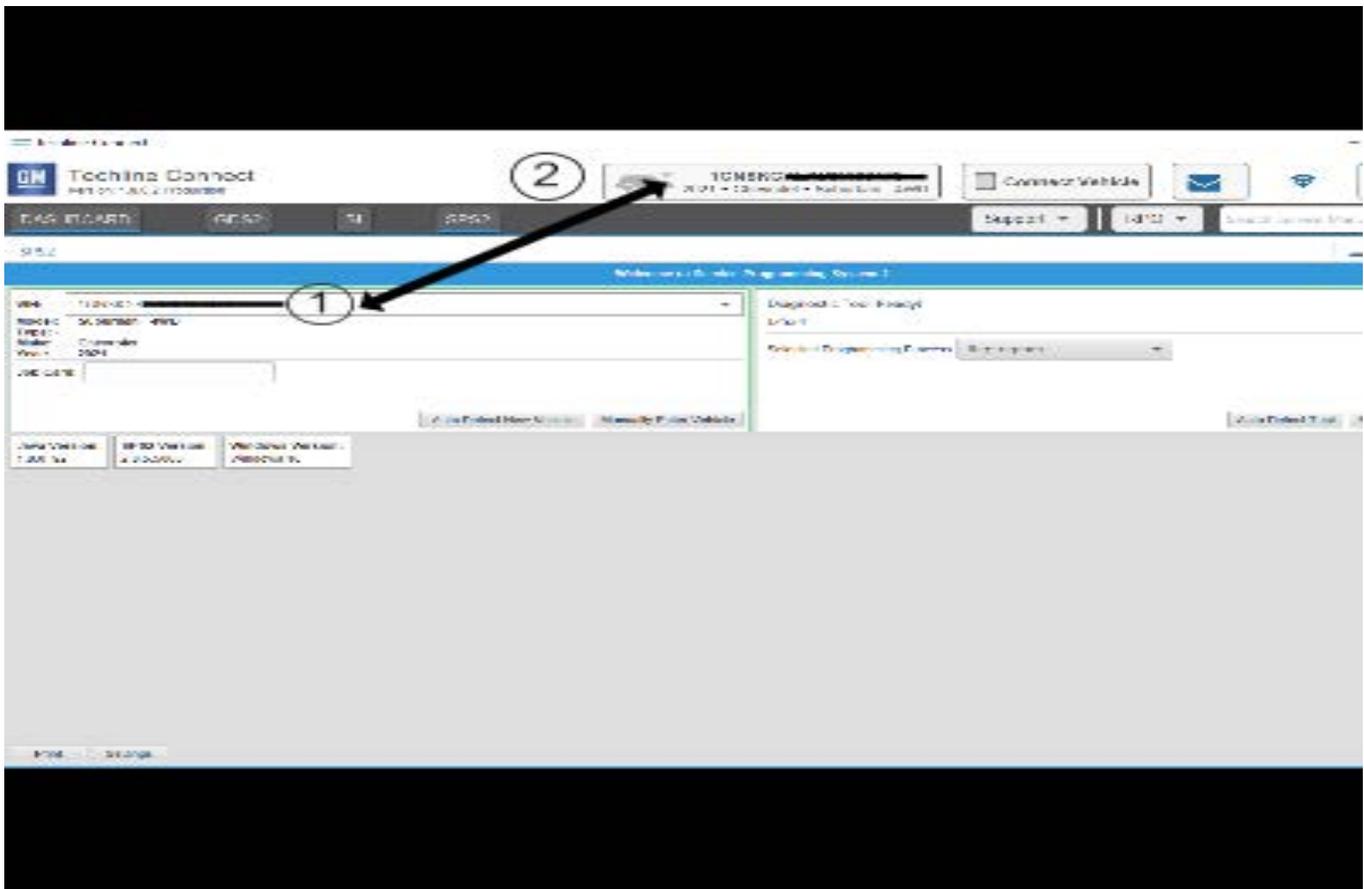
5743643

**Caution:** Be sure the VIN selected in the drop down menu (1) is the same as the vehicle connected (2) before beginning programming.

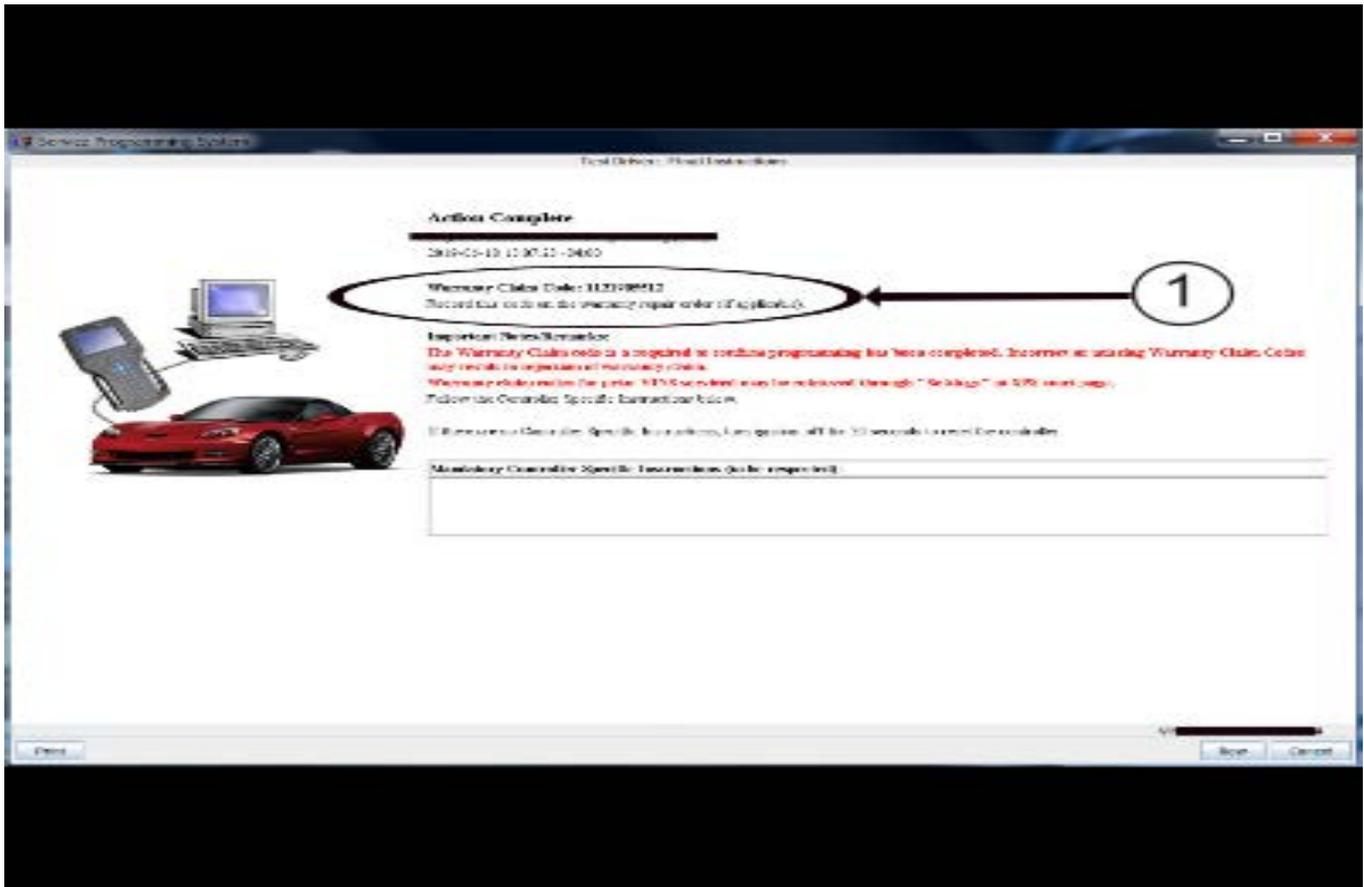
5431209

**Important:** To avoid warranty transaction rejections, you **MUST** record the warranty claim code provided on the SPS Warranty Claim Code (WCC) screen shown above on the job card. Refer to callout 1 above for the location of the WCC on the SPS screen.

- Record the SPS Warranty Claim Code on the job card for warranty transaction submission.
