Service Bulletin

Bulletin No.: 21-NA-146

Subject: Malfunction Indicator Lamp (MIL) Illuminated - DTC P0011 and/or P0014 Set

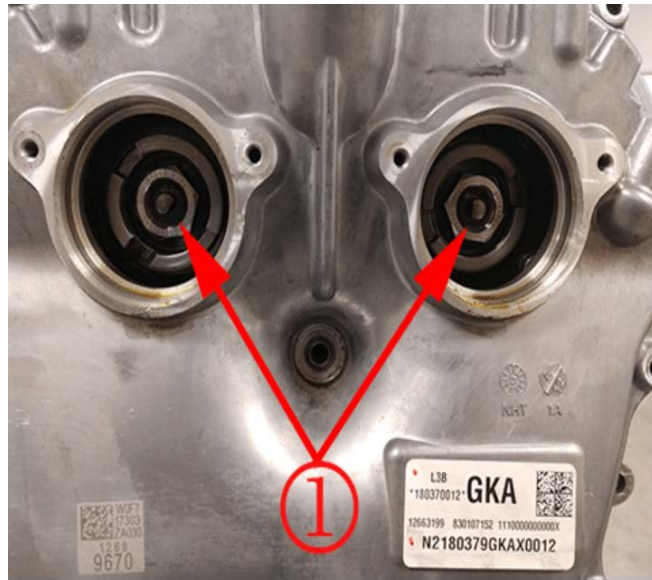
5334856

The Intake and Exhaust Camshaft Position Actuator Valve Solenoid bolt plungers (1) are located in the center of the bolt assemblies and protrude slightly from the head of the bolt at rest.

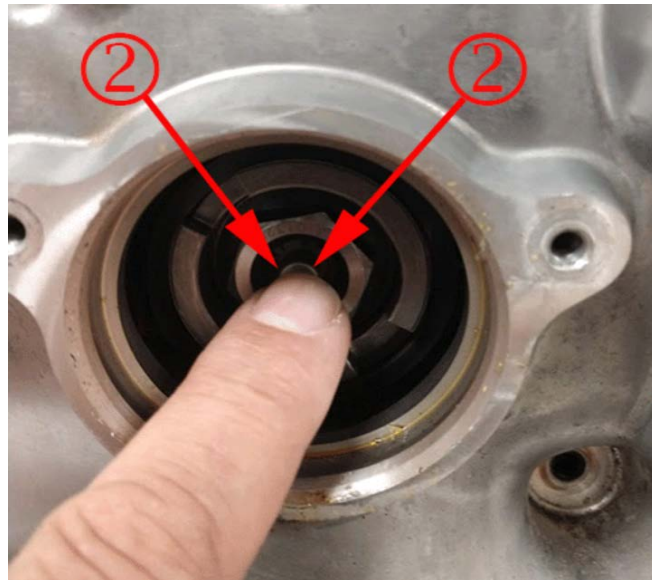
5334859

Using your finger, compare the travel and feel of the Camshaft Position Actuator Valve Bolt Plungers (2) to each other:

- If the spring is broken, the plunger travel may be decreased, it may not fully return to the proud position, and may have poor spring tension as compared to a new assembly.
- If a concern with either plunger is isolated, replace both the intake and exhaust Camshaft Position Actuator Valve Solenoid bolts on vehicles built before March 20, 2019.

Note: On vehicles built after March 20, 2019, replace only the affected Camshaft Position Actuator Valve Solenoid bolt.
