Subject: Engine Wire Harness Chafing

Brand:	Model:	Model Year:		VIN:		Engine:	Transmission:
		from	to	from	to		
Chevrolet	Silverado 1500 (New Model)	2019	2019			Equipped with L82, L84, L87, LV3, L3B, or LM2	
	Silverado 1500	2020	2021				
GMC	Sierra 1500 (New Model)	2019	2019				
	Sierra 1500	2020	2021

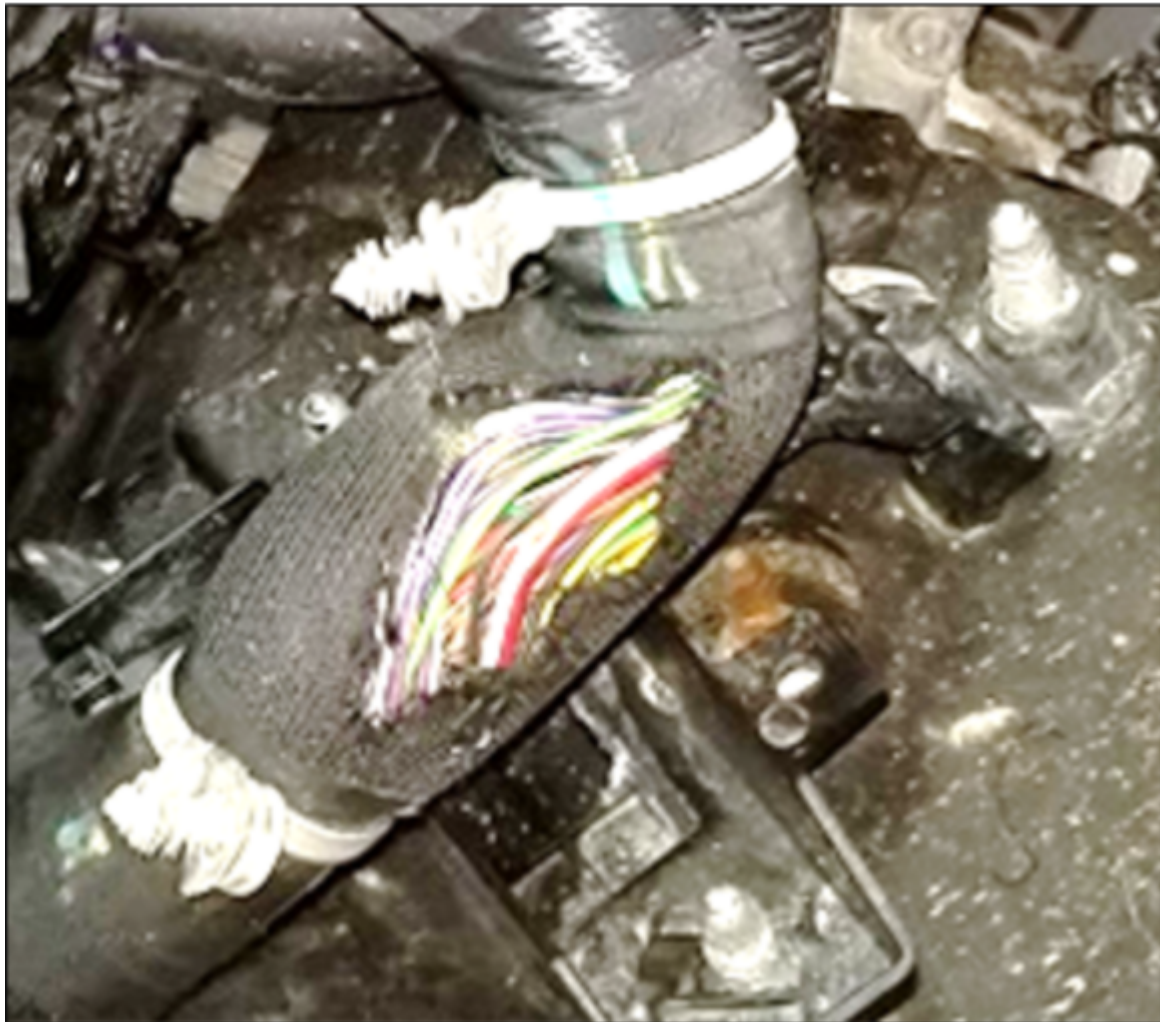
5868347

Example of extreme wire chaffing

The cause of the condition may be an engine wire harness clip was removed during production due to ergonomic issues (hand clearance and branch stiffness). This led to an uncontrolled branch that came into contact with the ECM/TCM bracket, driver side upper control arm, and/or shock tower and caused chaffing during engine vibration and roll.

Utilizing Engine Harness sleeves, anti-abrasion tape, and zip-ties to secure the harness away from one or more of the chaffing points. Follow the Service Procedure steps below.

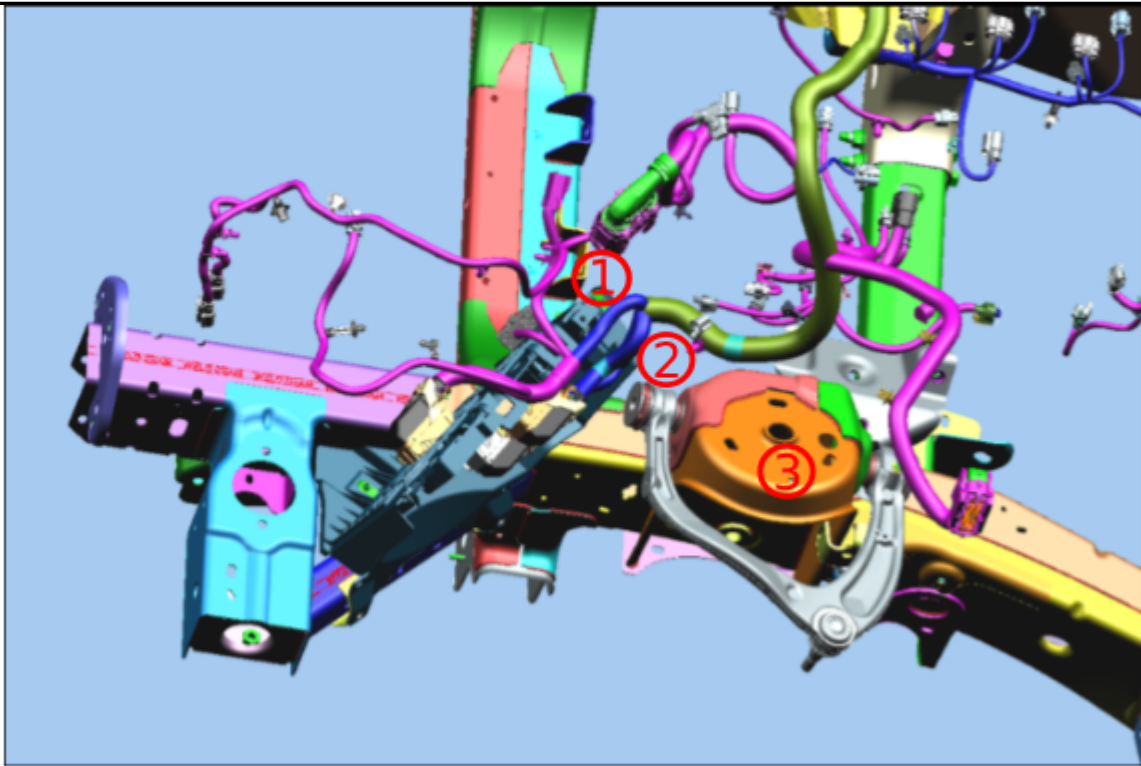
5868341

3. Locate the three contact points where the wire harness is chaffing, the ECM/TCM black bracket (1), the upper control arm (2), and the shock tower bolt (3).

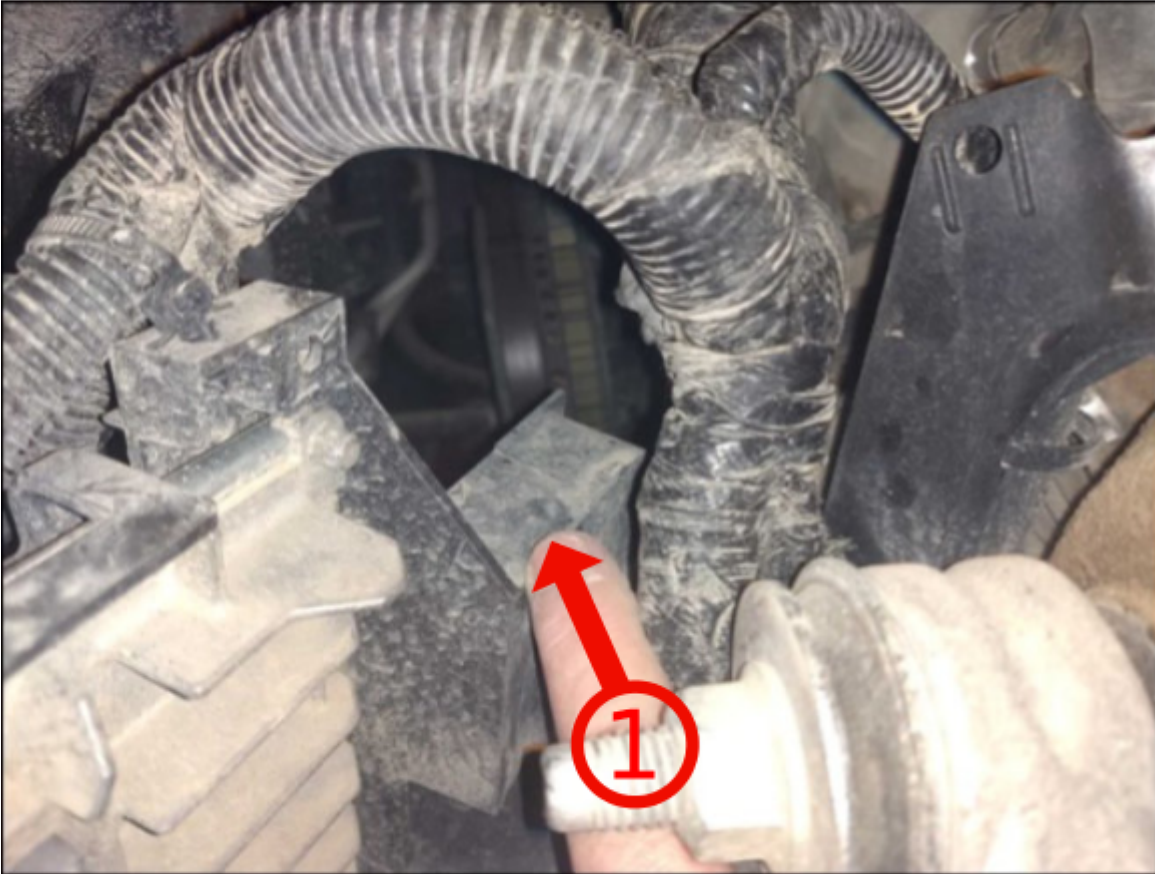
5868349

4. At the ECM/TCM bracket, locate the wire harness laying against the ledge (1).

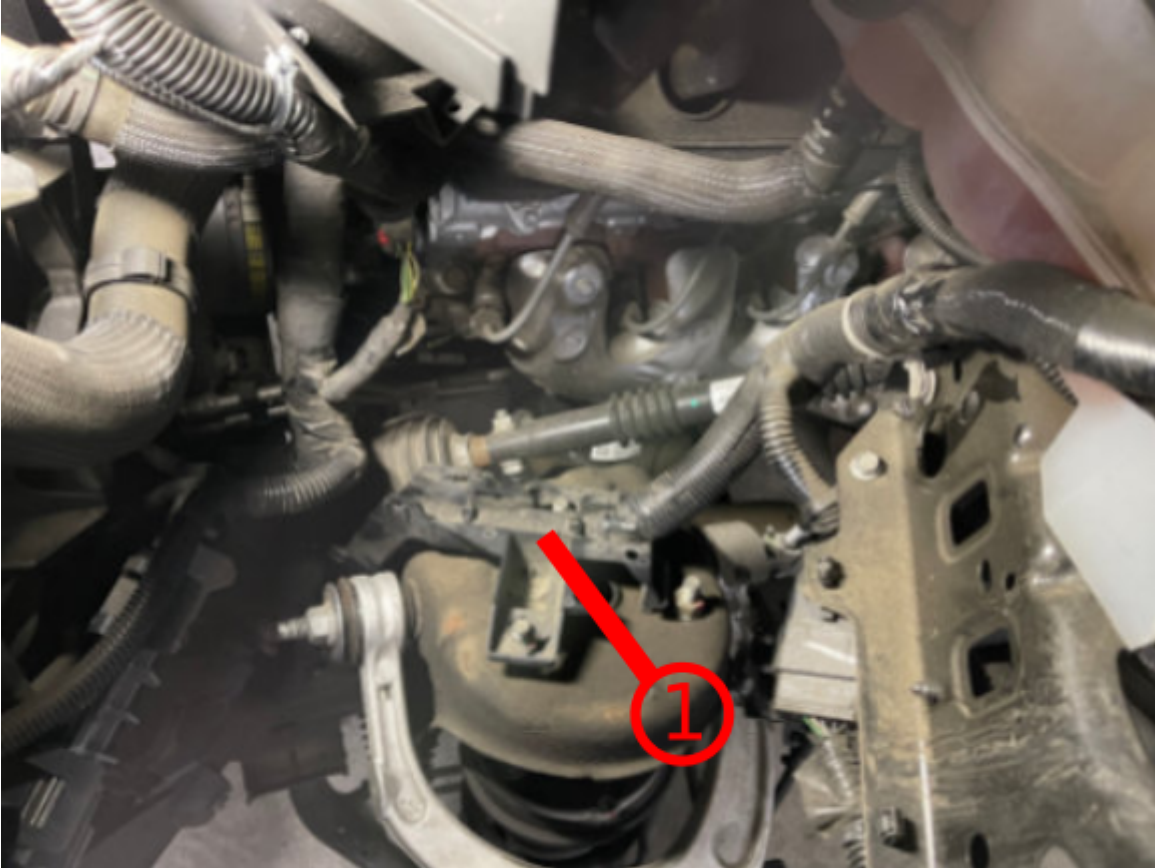
5868359

6. At the shock tower point there is a wire harness canal (1).
