Service Bulletin

Bulletin No.: 01-08-42-001N

Subject: Exterior Lamp Condensation and Water Leak Information and Replacement Guidelines

Models: 2022 and Prior GM Passenger Cars and Trucks (including Medium Duty Trucks)
(Excluding LCF Medium Duty Trucks)

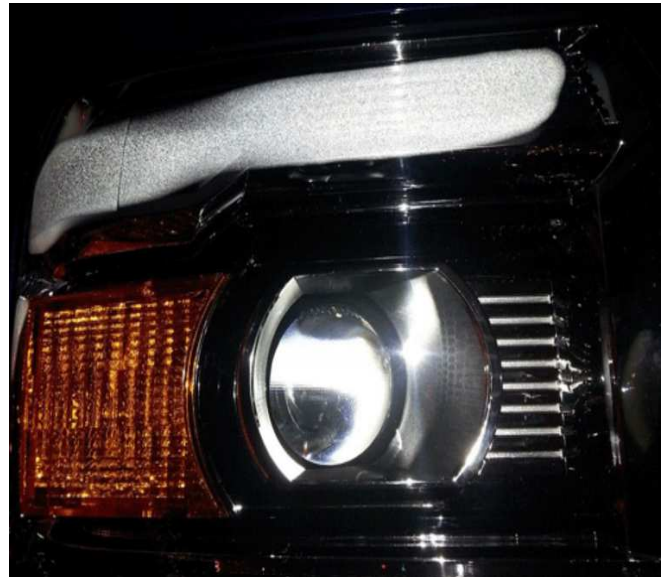
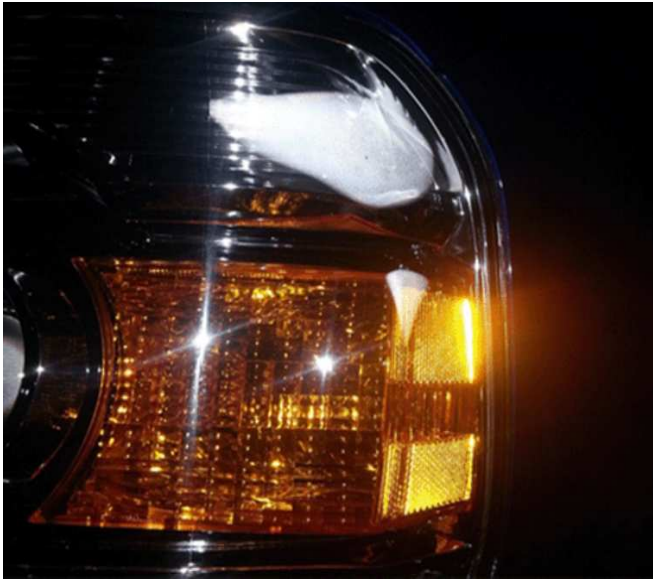
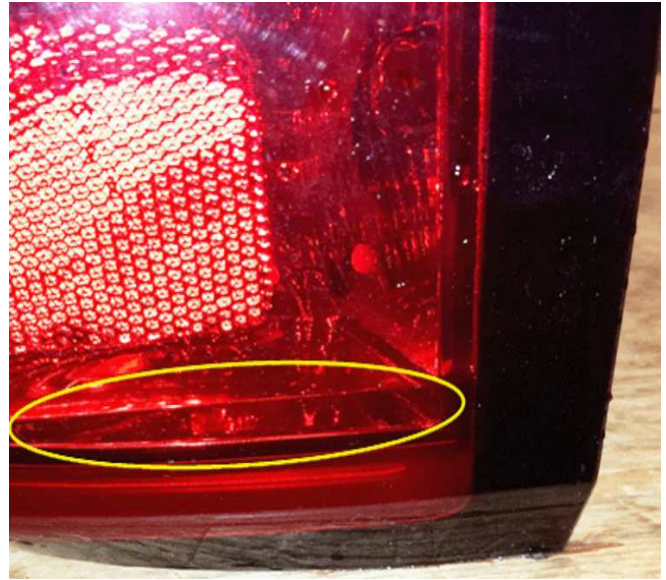
A Fine Mist or White Fog on the Inside Surface of the Lamp Lens Occurring After a Period of High Humidity

- May be located primarily in the lens corners (near the vents) and SHOULD NOT cover more than half the lens surface.
- The condition should clear of moisture when the vehicle is parked in a dry environment, or when the vehicle is driven with the lights ON.
- A comparison of the equivalent lamp on the opposing side of the vehicle indicates a SIMILAR performance.

If the above conditions are noted, the customer should be advised that replacement of a lamp assembly may not correct this condition.

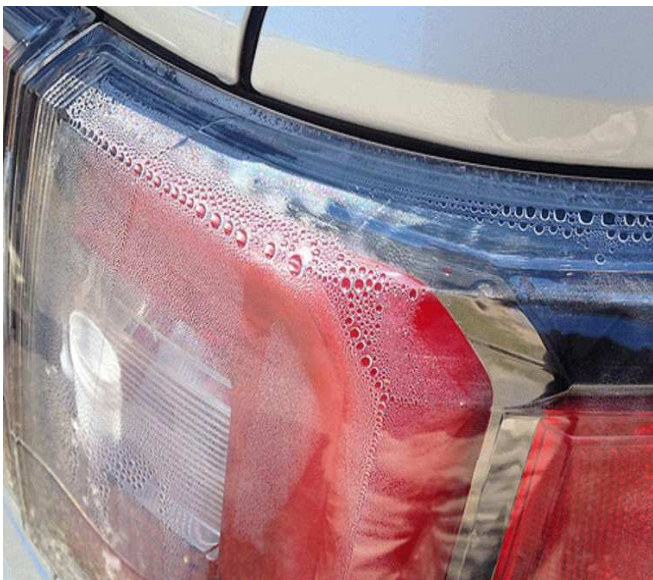
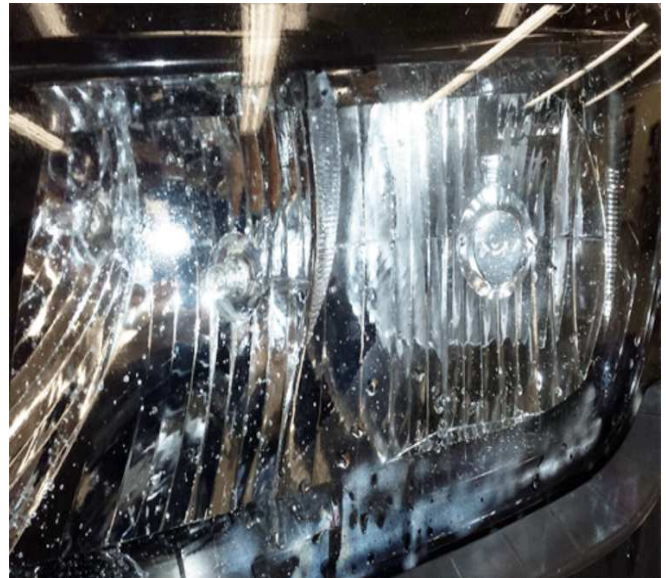
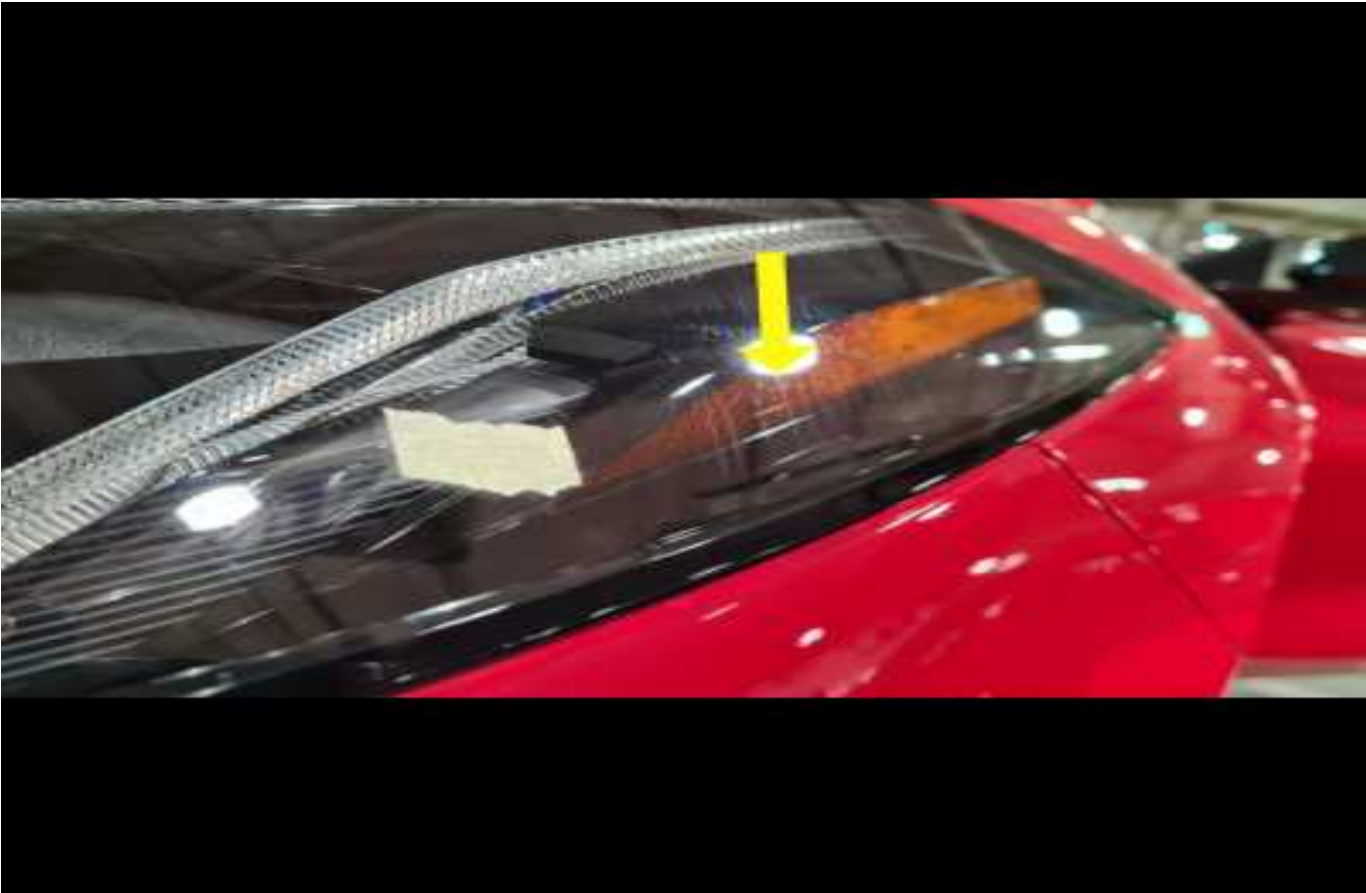
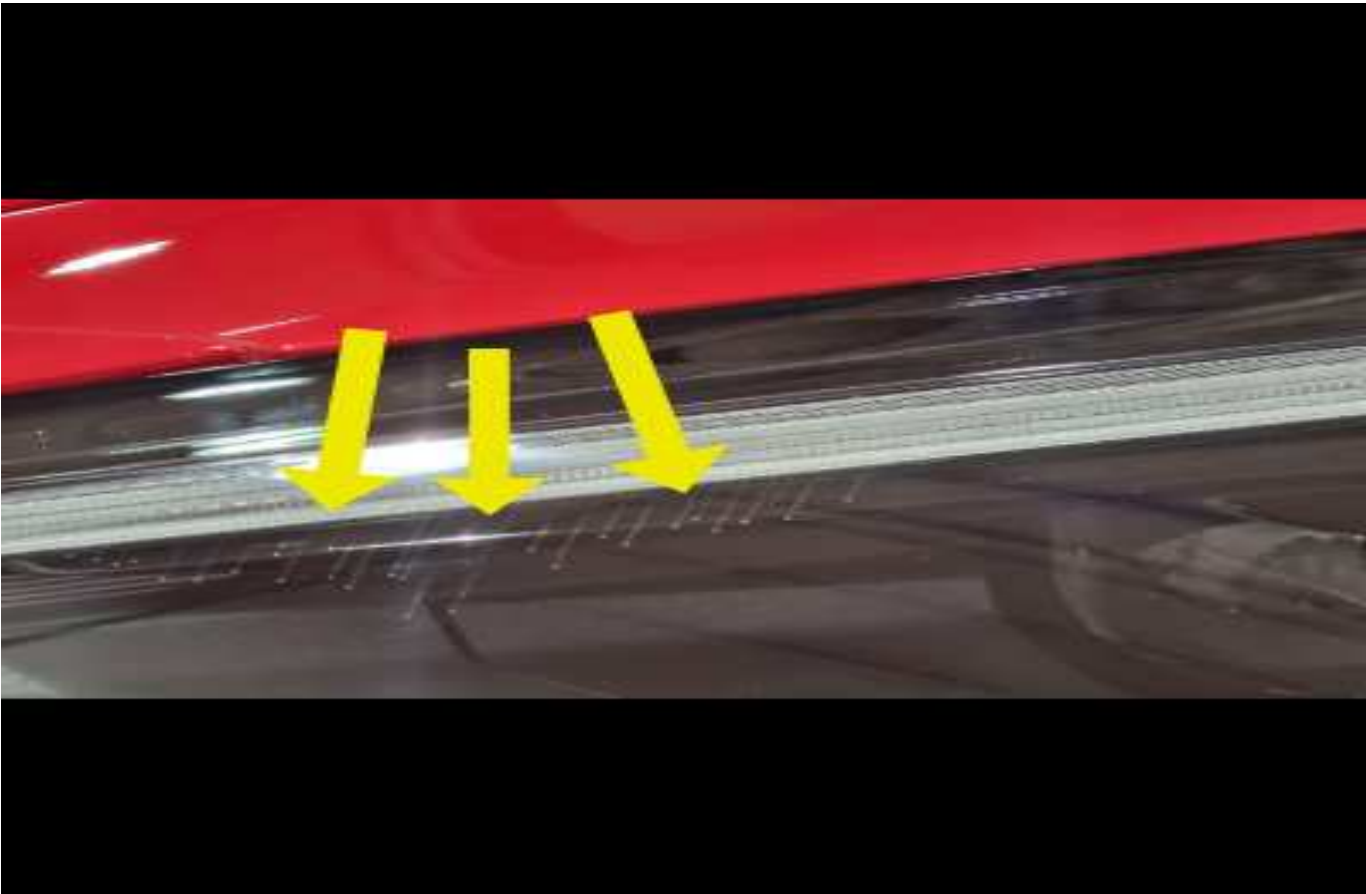
Numerous & Various Size Drops of Water Collecting on the Inside Surface of the Lamp Lens After the Vehicle Has Been Exposed to Rain or a Car Washing Environment

- A condition that covers more than half the surface of the lamp lens.
- An accumulation of water in the bottom of the lamp assembly.
- A condition that WON'T clear when the vehicle is parked in a dry environment, or when the vehicle is driven with the lights ON.
- A comparison of the equivalent lamp on the opposing side of the vehicle indicates a different performance.

Note: Any of the conditions listed below would indicate the need to service the lens or lamp assembly.

If a lamp is found to be exhibiting a leak, review the most recent version of Service Bulletin 02-08-42-001 for information regarding impact damage and modification inspection.
