Subject: N202316020 - Service Update
Radio Software Update (OTA)

Models: 2021 Buick Encore GX, Cadillac XT4, XT5, XT6, Chevrolet Blazer,
Camaro, Malibu, Silverado, Trailblazer, GMC Acadia, Sierra
Equipped with Infotainment (RPO IOS, IOT, IOU)

Service Update

N202316020 Radio Software Update (OTA)

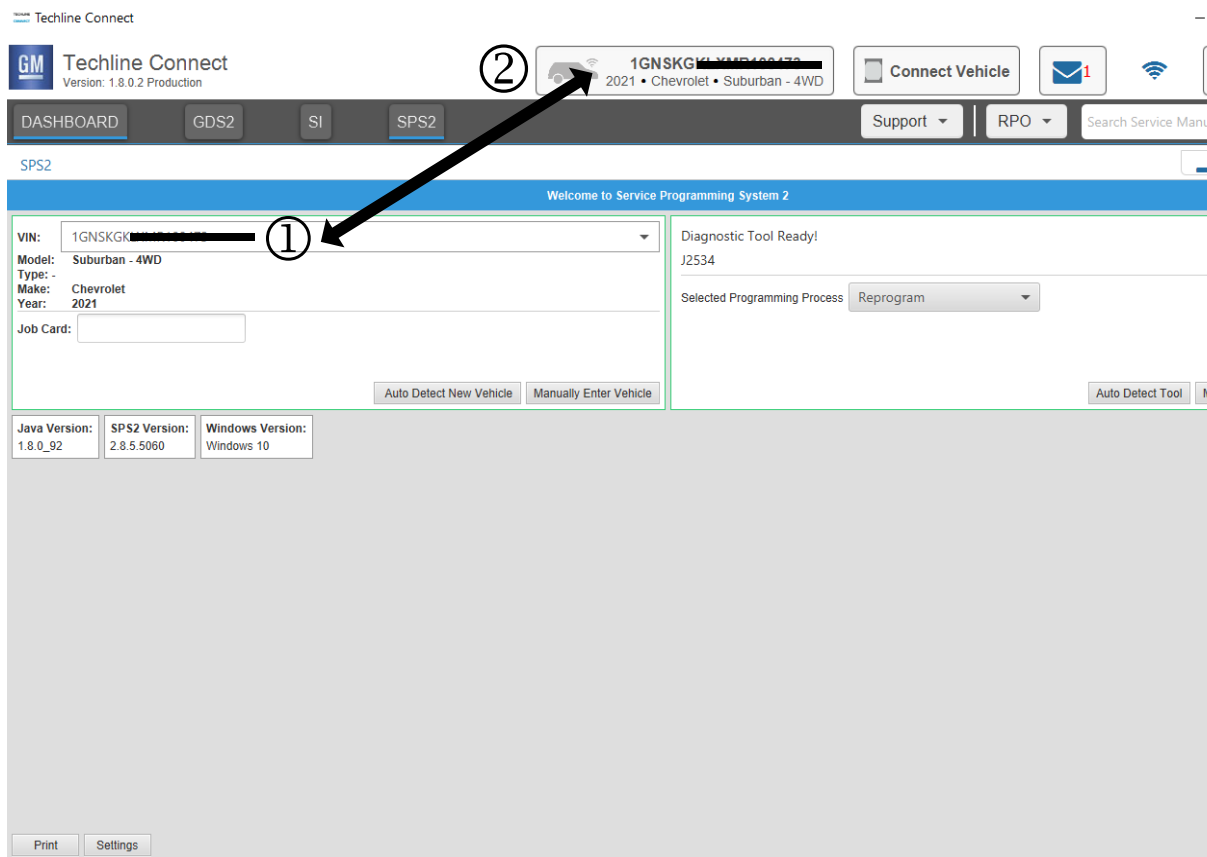
5743643

Caution: Be sure the VIN selected in the drop down menu (1) is the same as the vehicle connected (2) before beginning programming.

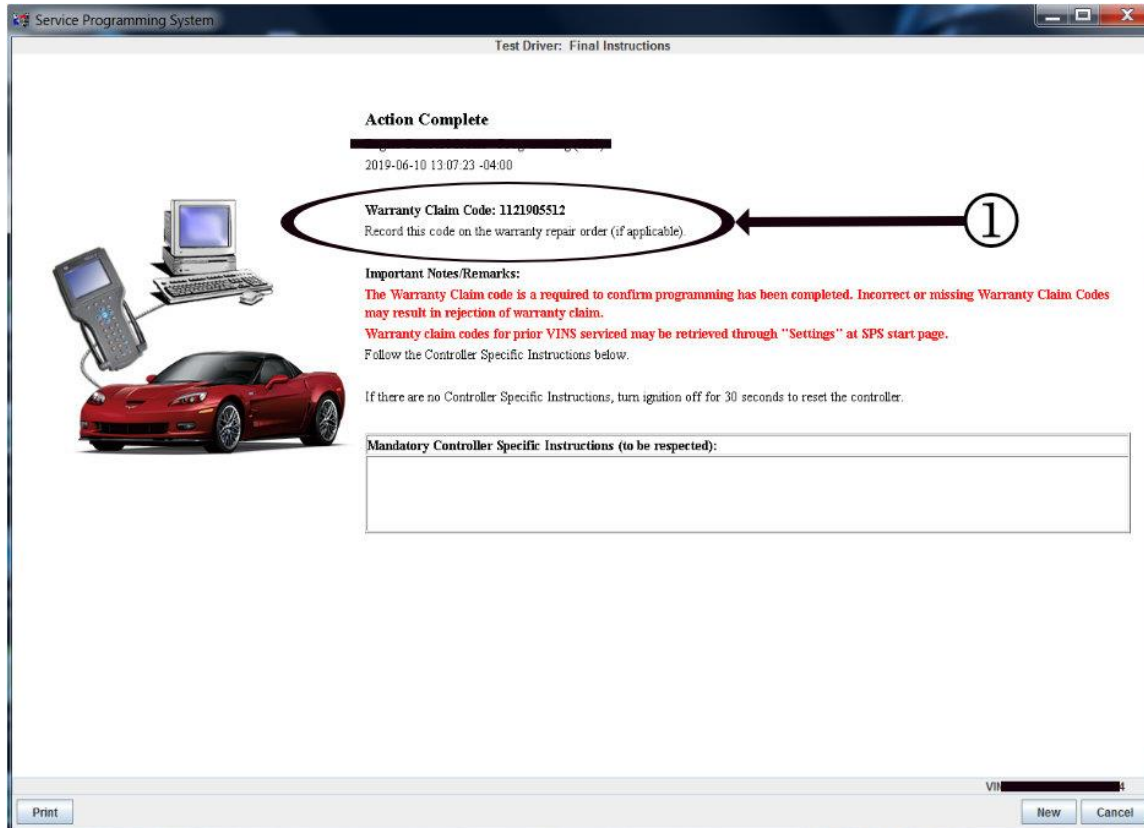
5431209

Important: To avoid warranty transaction rejections, you **MUST** record the warranty claim code provided on the Warranty Claim Code (WCC) screen shown above **after USB reprogramming** on the job card. Refer to callout 1 above for the location of the WCC on the screen.

- Record SPS Warranty Claim Code on job card for warranty transaction submission.
