- Subject: A212334670 Service Update Cylinder Heat Outer Bolts Loose
- Models: 2021 Buick Encore GX 2021 Chevrolet Trailblazer Equipped with 1.3L Gasoline Engine (RPO L3T)
- To: All General Motors Dealers

# Service Update A212334670 Cylinder Head Outer Bolts Loose

### Release Date: June 2021

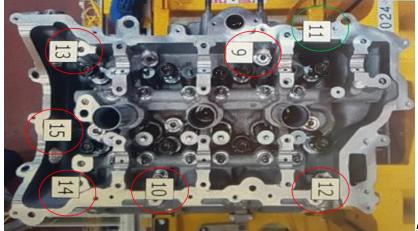
5870365

Condition	Certain 2021 model year Buick Encore GX and Chevrolet Trailblazer vehicles, equipped with a 1.3L			
	gasoline engine (RPO L3T), have cylinder head outer bolts which were not tightened.			
Correction	Dealers are to retighten the cylinder head outer bolts.

**IMPORTANT**: If there is oil in the bolt hole, it can cause hydraulic lock and crack or damage the head. Before tightening each bolt, remove it and blow out the bolt hole with compressed air to clean and dry it. Then, clean the threads of the bolt and bolt seating surface with a shop rag before reinstalling it and proceeding to tighten the bolt.

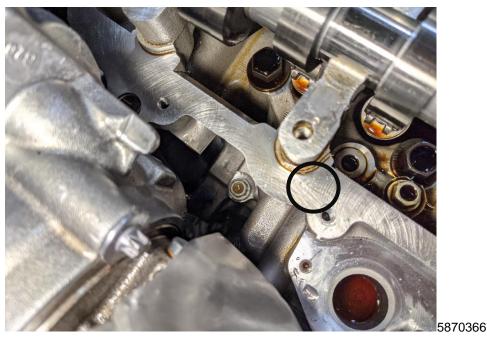
- Bolt #11 is outside of the camshaft cover underneath the Exhaust Manifold Outlet Pipe, which will be removed during Camshaft Position Actuator removal. Bolt shown above for reference.
- 3. Reinstall the camshafts. Refer to Camshaft Replacement in SI.

2. Torque the indicated bolts to 11 Ft-Lb (15N-m) in numerical order, starting with bolt 9 and continuing until bolt 15 is torqued.
