GLOBAL SAFETY FIELD INVESTIGATIONS
DCS5874
URGENT - DISTRIBUTE IMMEDIATELY

Subject: N212339040 - Customer Satisfaction Program
Radio Calibration Incorrect for Steering Wheel Switches

Models: 2021 Chevrolet Tahoe
Equipped with Special Service Sales Package (RPO 5W4) and Radio
Infotainment System (RPO IOR)

N212339040 Radio Calibration Incorrect for Steering Wheel Switches

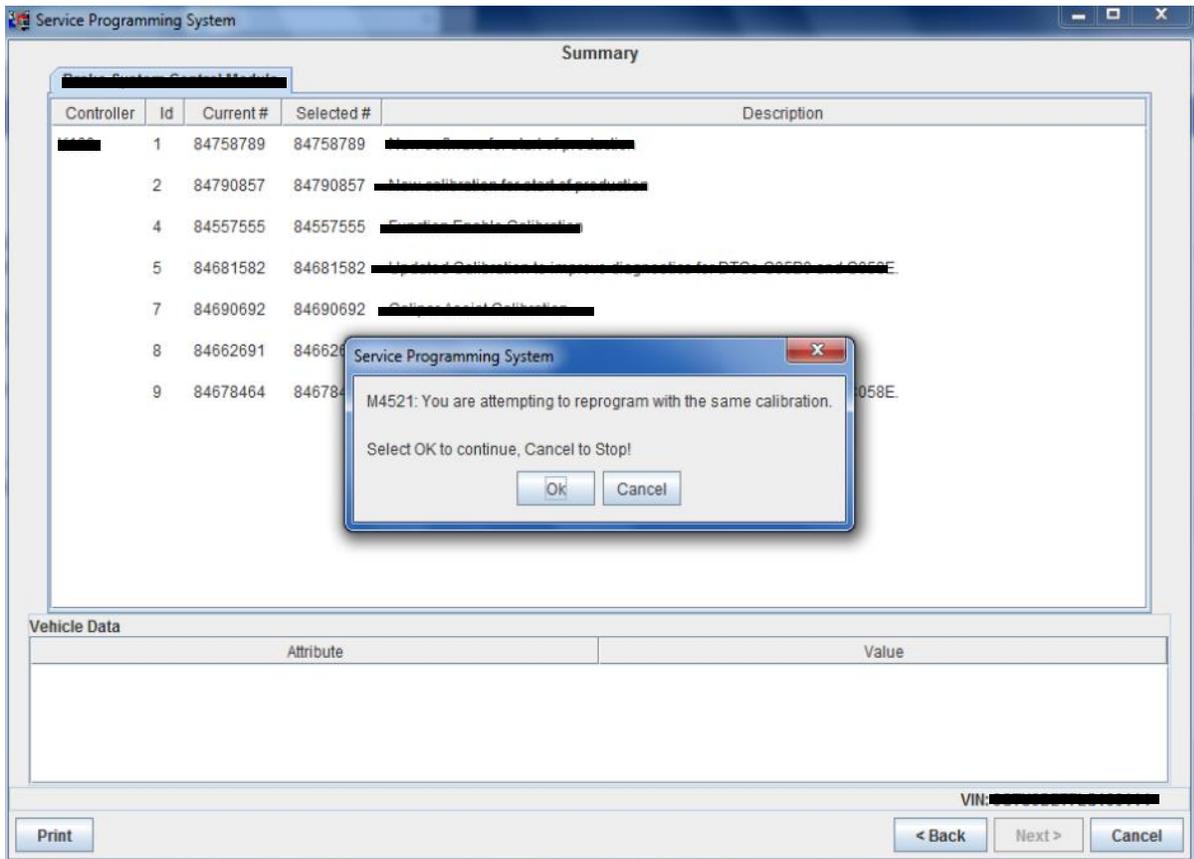
5431207

Important: Techline Connect and TIS2WEB screens shown above.

Important: If the same calibration/software warning is noted on the TLC or SPS Summary screen, select OK and follow screen instructions. After a successful programming event, the WCC is located in the Service Programming System dialogue box of the SPS Summary screen. No further action is required. Refer to the Warranty section of the bulletin.

1. Reprogram the radio. Refer to *A11 Radio: Programming and Setup* in SI. USB reprogramming is not required.

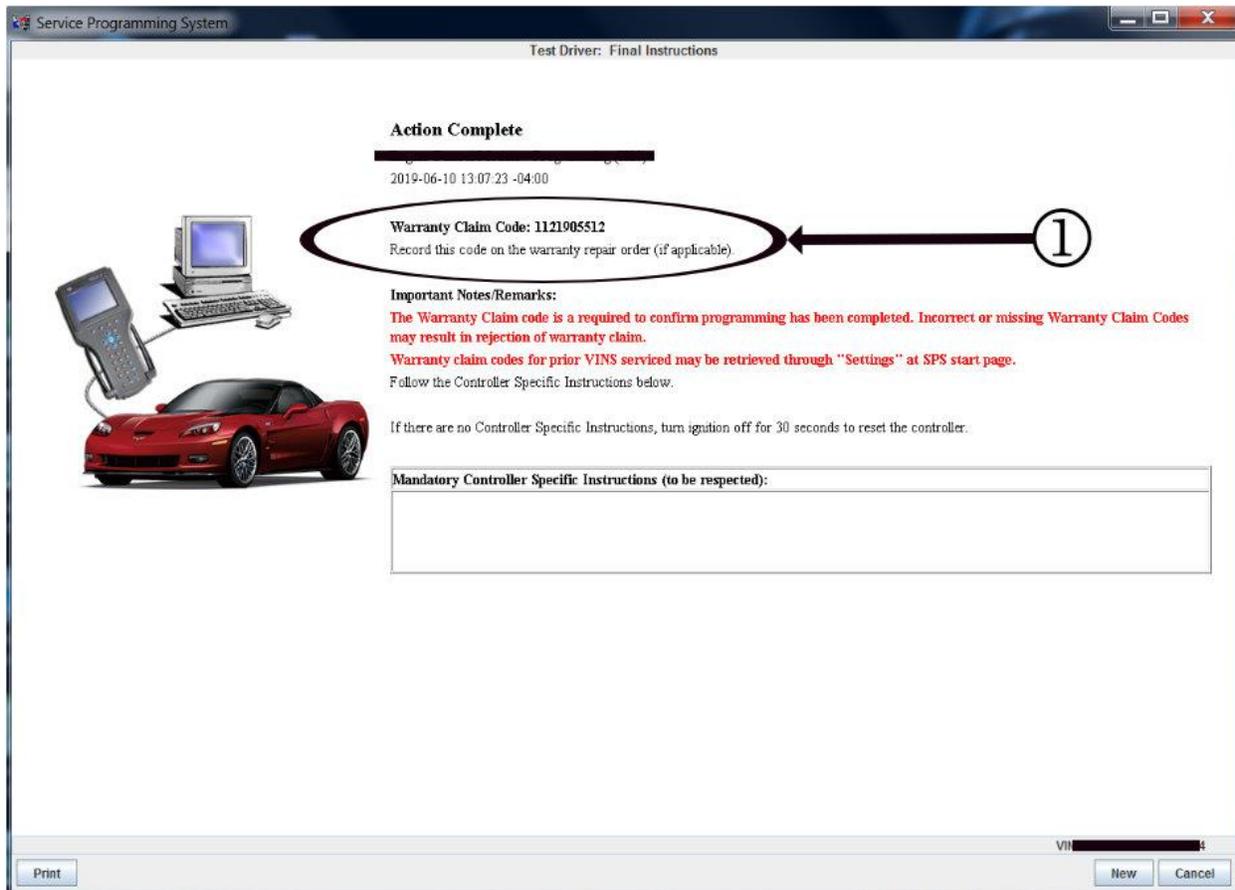
5431209

Note: The screenshots above are an example of module programming and may not be indicative of the specific module that is being programmed. Module selection and VIN information have been blacked out.

Important: To avoid warranty transaction rejections, you **MUST** record the warranty claim code provided on the Warranty Claim Code (WCC) screen shown above on the job card. Refer to callout 1 above for the location of the WCC on the screen.

2. Record SPS Warranty Claim Code on job card for warranty transaction submission.
