Subject: A212336520 - Service Update
Front Left-Hand Strut to Body Not Secured

Models: 2021 Chevrolet Bolt EV

Service Update

A212336520 Front Left-Hand Strut to Body Not Secured

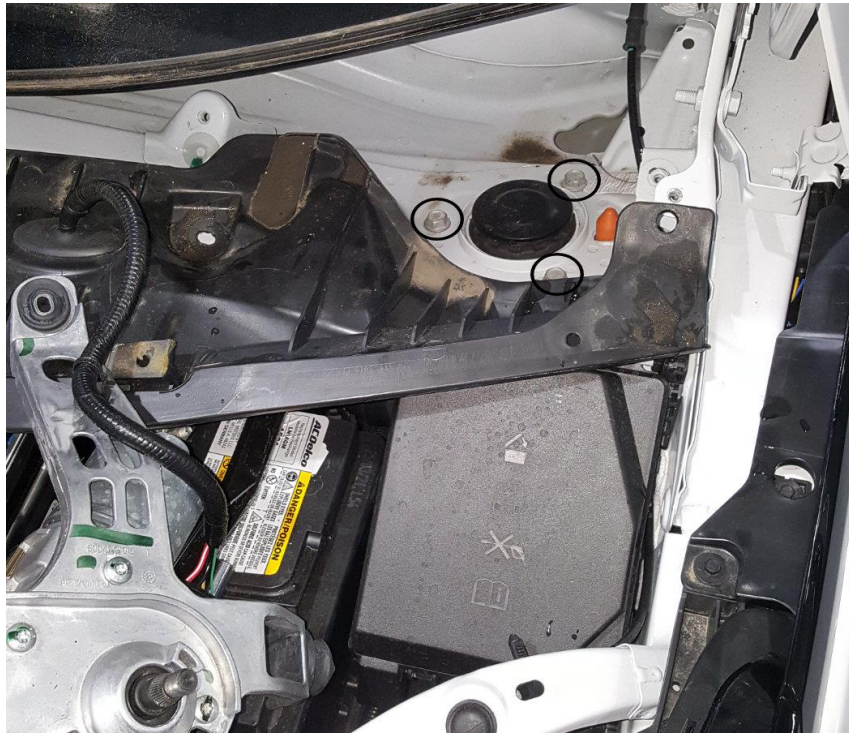
Condition	On certain 2021 model year Chevrolet Bolt EV vehicles, the front left-hand side front suspension strut to the body fasteners may not be torqued properly.
Correction	Dealers are to check the torque and replace the bolt if necessary.

2. Check torque on the left front strut bolts (circled) using a torque wrench. All bolts should be torqued to 16 Lb-ft (22N-m).
 - If any bolts are found to be loose, replace them, and then torque to 16 Lb-ft (22N-m).
3. Reinstall the Front Left Windshield Wiper System Module. Refer to *Windshield Wiper System Module Replacement* in SI.
