SIB 01 21 18

## N63: OIL CONSUMPTION CLASS ACTION SETTLEMENT DIAGNOSIS/REPAIRS (VERSION 13.0)

### MODELS

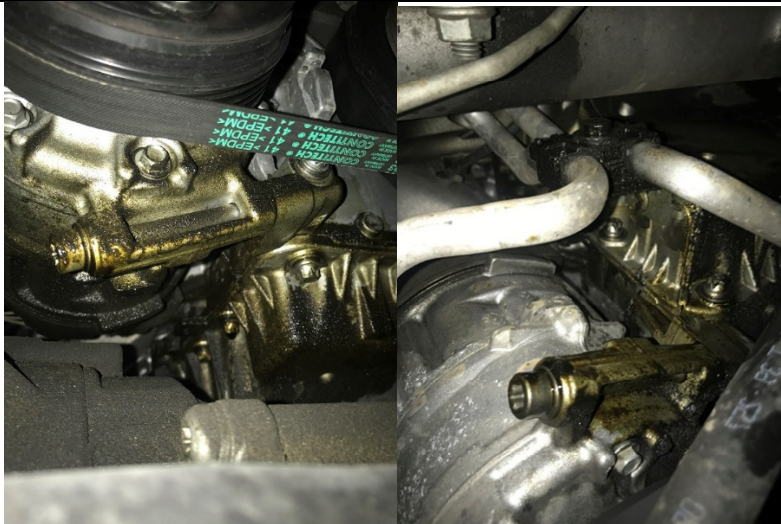
4. Inspect the front engine cover for engine oil leakage.

Front cover is **not** leaking. Go to step 5.

Front cover is leaking. Go to step 7.

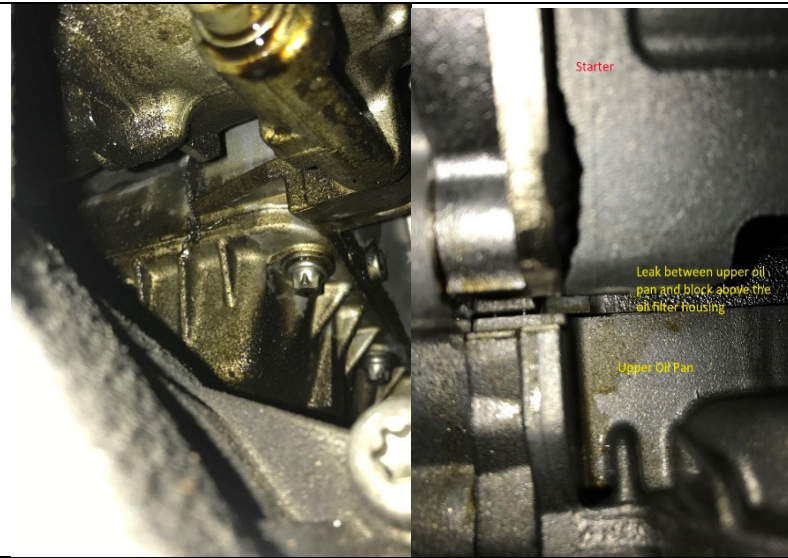
5. Inspect the upper engine oil pan for engine oil leakage.

The upper engine oil pan is **not** leaking.  
Go to step 6.

The upper engine oil pan is leaking.  
Go to step 7.

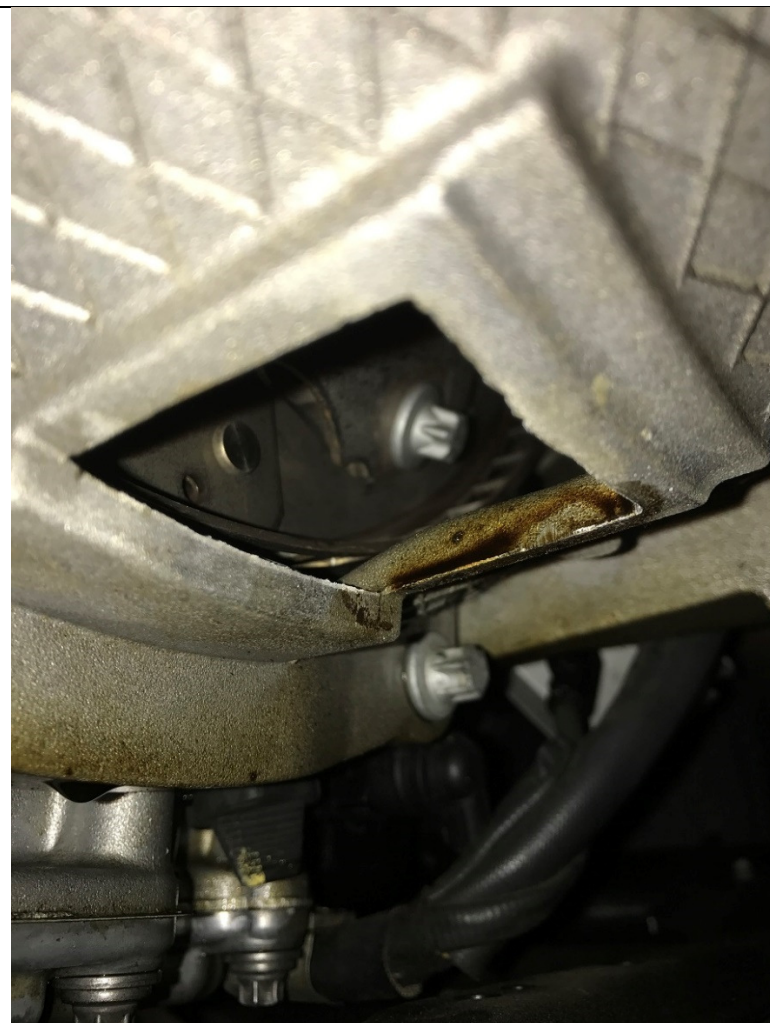
6. Inspect the lower bell housing for engine oil leakage

The lower bell housing is **not** leaking. Go to step 8.

The lower bell housing is leaking. Go to step 7.

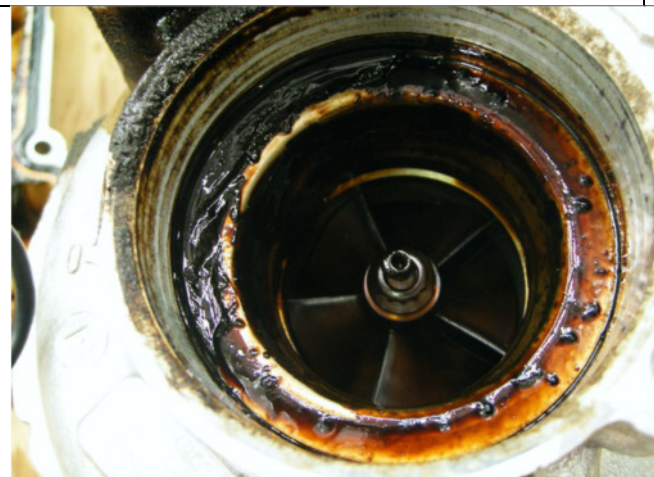
The turbocharger is not OK.  
The turbocharger impeller seals are leaking engine oil.

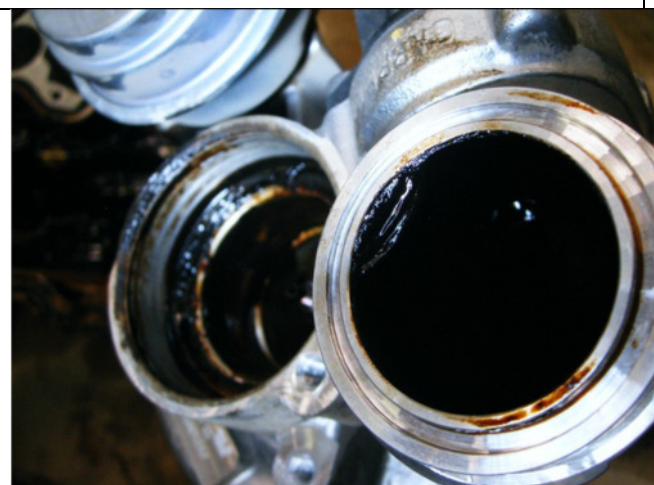
The turbocharger is not OK.  
The turbocharger impeller seals are leaking engine oil.

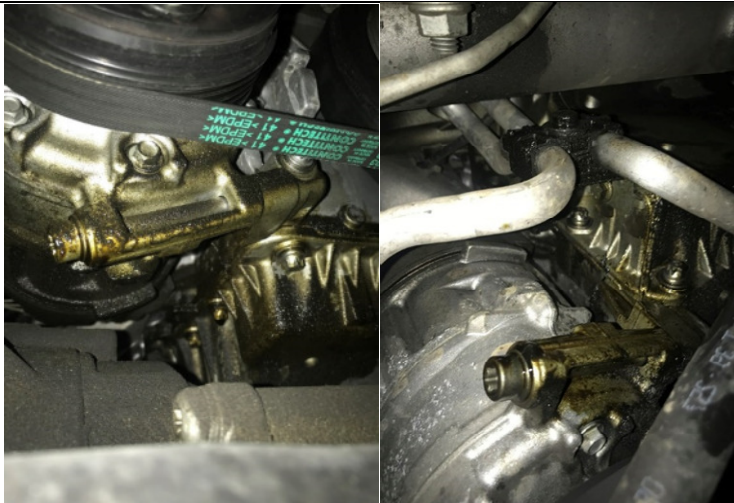
3. Inspect the front engine cover for engine oil leakage.

If the front timing cover is not leaking. Go to step 4.

If the front timing cover is leaking. Go to step 6.

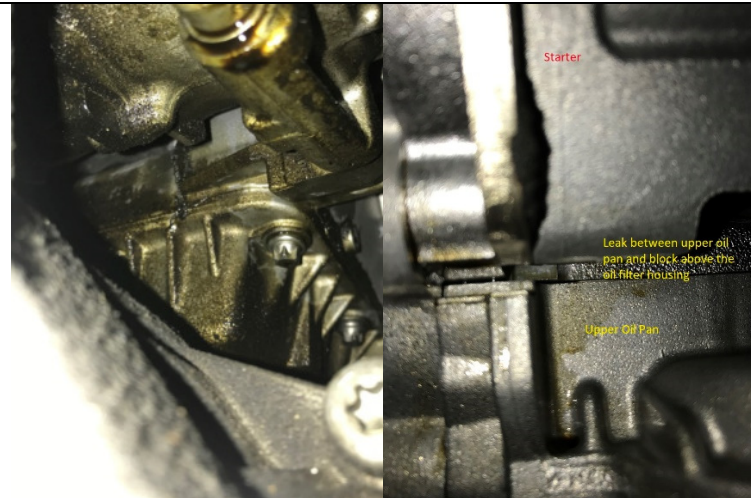
4. Inspect the upper engine oil pan for engine oil leakage.

If the upper engine oil pan is not leaking. Go to step 5.

If the upper engine oil pan is leaking. Go to step 6.

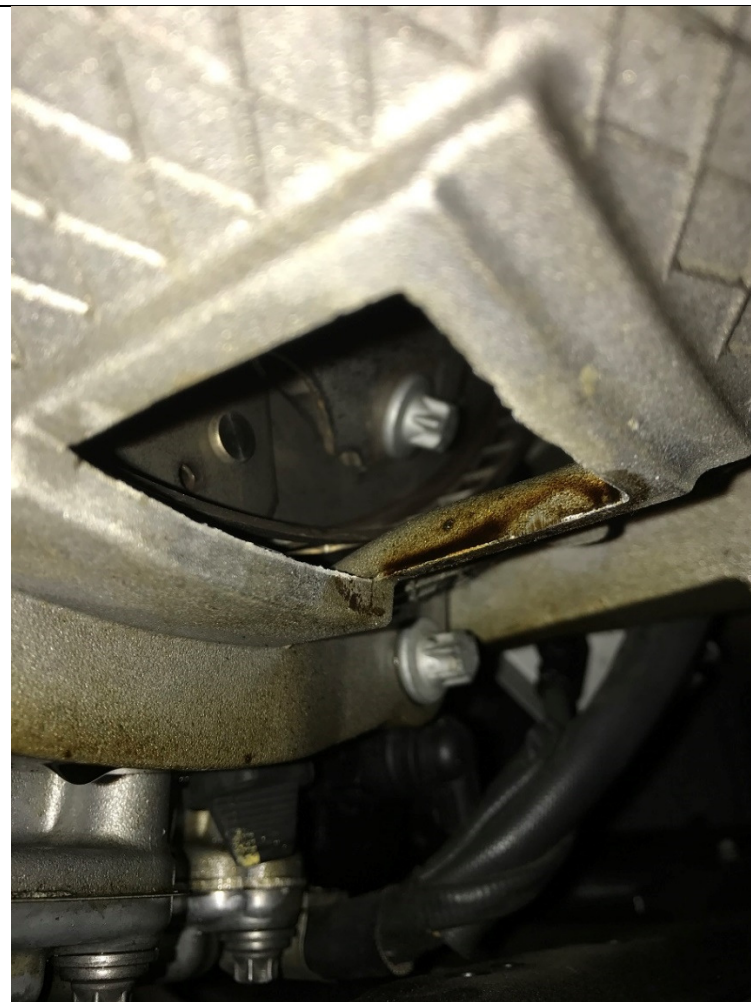
5. Inspect the lower bell housing for engine oil leakage

The lower bell housing is not leaking. Go to step 7.

The lower bell housing is leaking. Go to step 6.

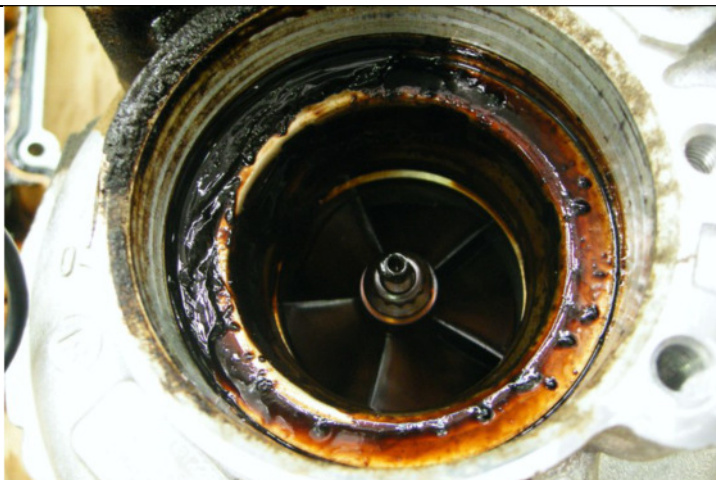
The turbocharger is not OK.  
The turbocharger impeller seals are leaking engine oil.

If the turbocharger inspection is "NOT OK", then replace the turbochargers in conjunction with the recommendations in step 10. Go to step 10.
