SIB 51 33 16

SLOSHING NOISES/WATER IN REAR PASSENGER COMPARTMENT

E-Series	Model Description
F33	4 Series Convertible
F83	M4 Convertible

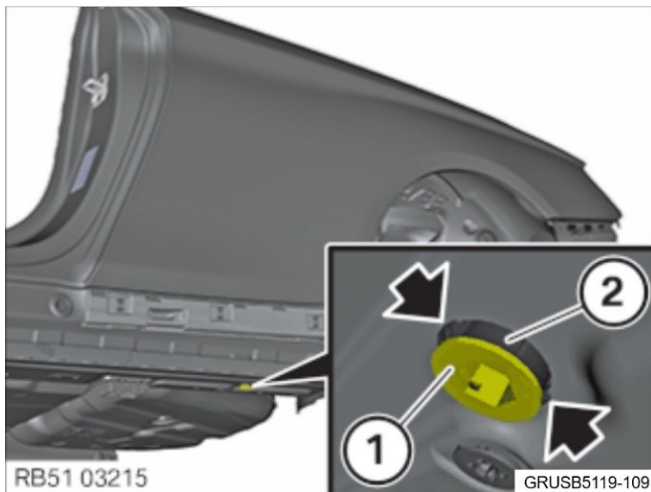
- Water sloshing noises coming from the rear passenger compartment (left or right) while driving
- Water ingress in the luggage compartment, or in the rear passenger compartment-
 - rear seat bench
 - rear passenger compartment foot well
 - rear passenger compartment side panel
- Failure of various control units installed in the area of the water removal channel

Poor water drainage due to installation location of the rocker panel trim.

Remove the underbody paneling to access the water drain outlet shown to the left. Refer to repair instructions **51 71 017 "Removing and installing/replacing (left or right) underbody panelling"**.

Completely remove the drain and do not reinstall. Clean any residual debris from the underbody panelling.
