SIB 52 01 21

SEAT FAILS TO INITIALIZE DUE TO MISSING END STOP

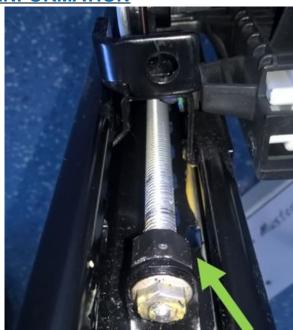
F90 G12 G30 spacer (arrow).

G30 only has a spacer installed on the passenger seat.

- 1. If this occurs after seat rail replacement, and the new rail <u>does NOT include the end stop</u>, then swap the end stop from the original rail.
- 2. If this occurs after seat rail replacement, and the new rail <u>does include the end stop</u>, then confirm the original rail did not have an end stop installed. Remove the end stop from new seat rail.

- 3. If this occurs after a customer has removed the end stop:
 - Request the customer supply the end stops for reinstallation if still available
 - Order end stop if available separately in ETK, see Parts section below.
 - If the end stop is not available separately in ETK then
 - o it may only come with an entire seat rail assembly.
 - o contact Parts Technical Support via a TTS TSARA case for support
