SIB 52 06 21

2021-06-03

NOISE FROM DRIVER OR PASSENGER SEAT UPON LOAD REVERSAL

G12 (7 Series Sedan)	G30 (5 Series Sedan)	G32 (640i xDrive Gran Turismo)	
----------------------	----------------------	--------------------------------	--

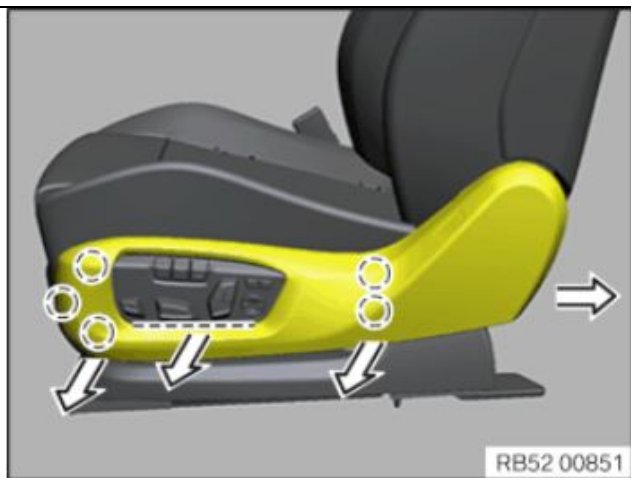
2. Remove cover on the outer front seat base.

Unclip the cover from the front to rear in the direction of the arrow (G12 shown; other models' seats are similar).

Observe repair instructions **52 14 040**.

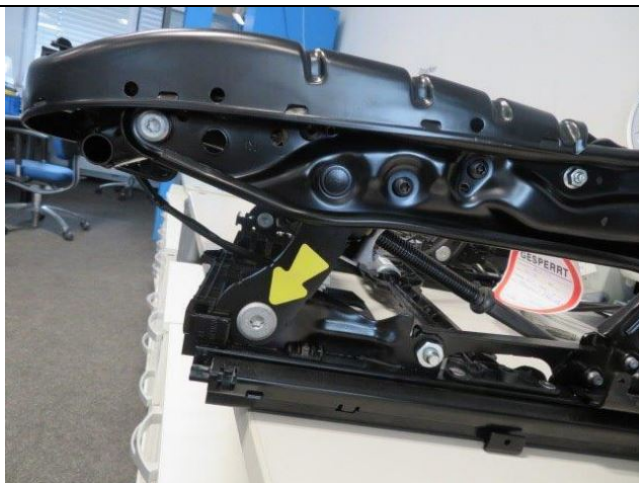
The driver's seat and/or passenger seat rattles ("cracking" noise) during load reversal. There is a slight movement in the seat that is most noticeable when moving forwards and backwards.

Unfavorable tolerance of the connecting elements on the seat.

3. Replace the front outer bolt with part number 52 10 5 A13 770.

This new bolt has a captive washer.

NOTE: Torque bolt to 25 Nm
