SIB 52 09 20

2021-06-08

HEAD RESTRAINT AND/OR BACKREST OF 3RD ROW SEATS CANNOT BE FOLDED DOWN

E-Series	Model Description
G07	X7 Sports Activity Vehicle

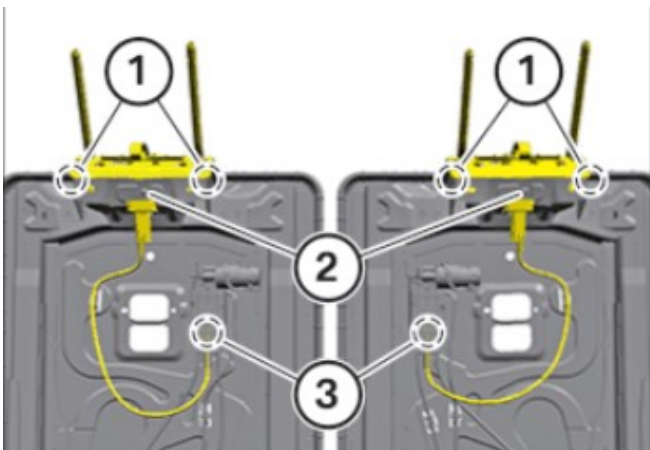
Can the head restraint be manually unlocked using the release loop beneath the headrest (see picture) and thus folded down?

YES = Head restraint mechanism is faulty.
Replace the folding module of the head restraint (#2 in picture).

See REP 52 30 118 Remove and install/replace folding module of left or right head restraint

NOTE: The head restraint cannot be removed without destroying the covering material. **A new cover (leather) will be required to perform this repair.**

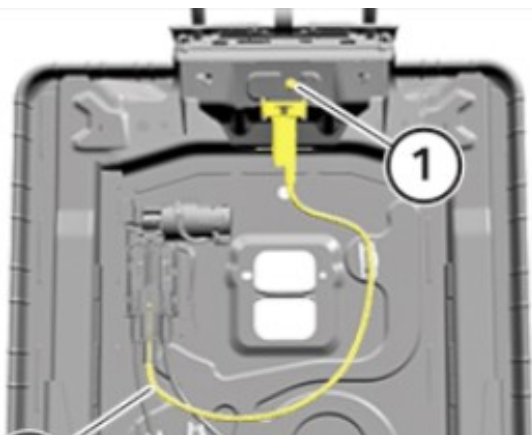
(Bowden cable unlocking device for head restraint).

NO = Check if the Bowden cable is correctly mounted and properly routed.

If the Bowden cable is mounted and correctly routed, replace the Bowden cable for the headrest (shown in yellow in picture).

See REP 52 30 253 Replace Bowden cable for left or right head restraint

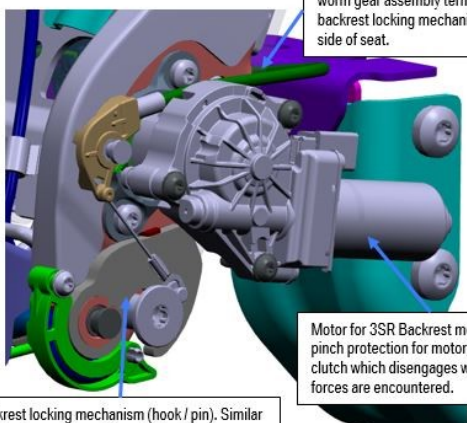
G07 3rd Row Seat – Overview Picture.

Bowden cable which originates at motor / worm gear assembly terminating at backrest locking mechanism on outboard side of seat.

Motor for 3SR Backrest movement. No pinch protection for motor, but has clutch which disengages when high forces are encountered.

Backrest locking mechanism (hook / pin). Similar mechanism exists on inboard side of seat.

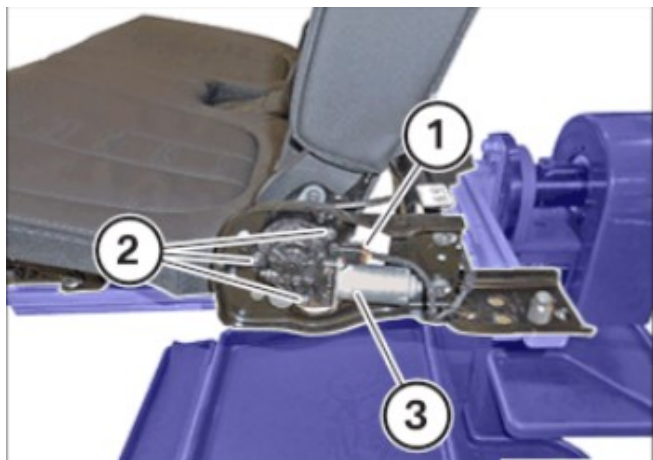
Check if the latch (the fastener on the left or right side) of the third row of seats is open or closed? (this is the hook/pin shown in green in picture)

If the head restraint stays in the seat position, the latch is closed.

If the head restraint falls into the folded position again, the latch is open.

YES (Latch is open) = Replace drivetrain of backrest tilt adjustment.

See REP 67 31 635 Remove and install/replace drivetrain for backrest tilt adjustment of third-row seating (left or right) (according to vehicle diagnosis)

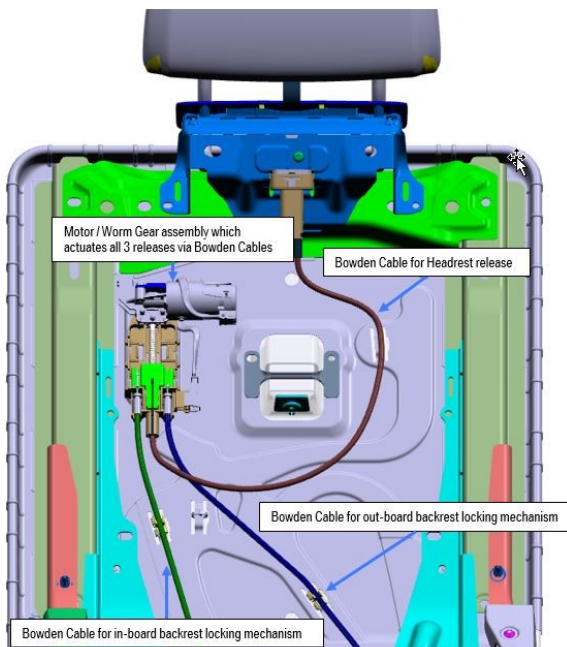
Is the drivetrain for the backrest release (actuator) broken?

YES = Replace only the drivetrain for backrest release (actuator).

See REP 67 31 645 Remove and install/replace drivetrain for backrest release of third-row seating (left or right) (according to vehicle diagnosis)

NO = Replace BOTH the Bowden cable(s) and drivetrain for backrest release (actuator).
