SIB 64 03 21

2021-06-04

AIRFLOW RATE IN THE VEHICLE INTERIOR IS TOO LOW

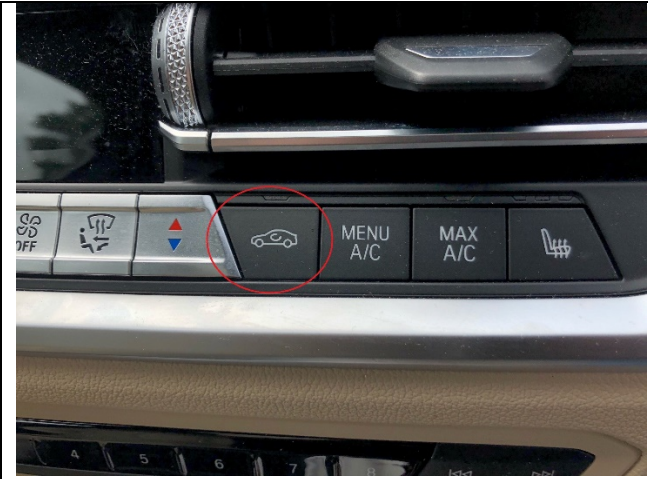
<p>1. Deactivate the air recirculation function by pressing the recirculation button on the climate control panel (Fresh Air mode, circled), LED off.</p>
	<p>2. This can be confirmed in the Central Information Display (CID) in the Climate Control Menu (MENU A/C) under AIR QUALITY.</p>

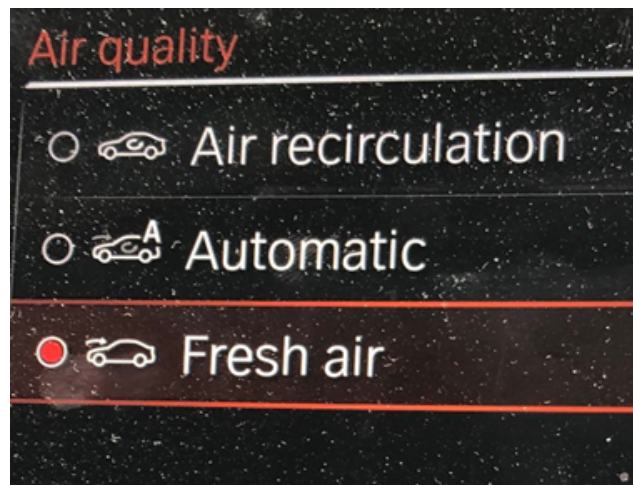
Ensure the flap is set to Fresh air so that it sits flat and does not interfere with microfilter removal.

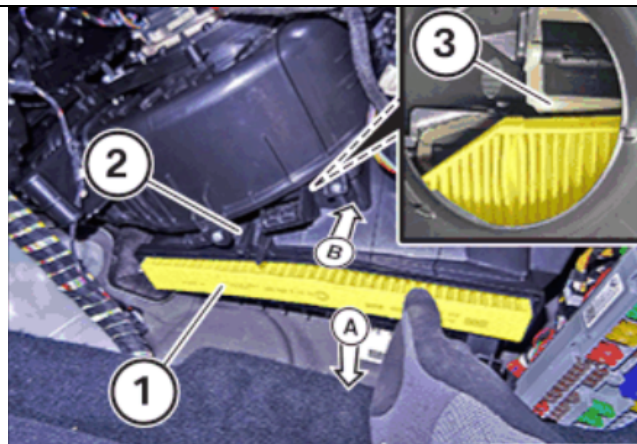
3. Dismantle the microfilter

See **REP 00 00 616** Service microfilter.

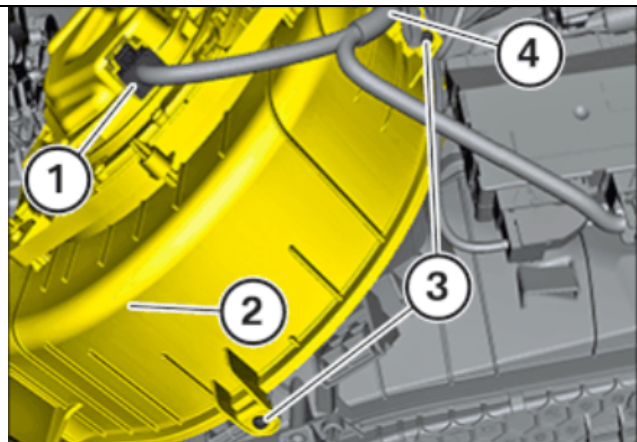
4. Remove the ventilation system blower motor.

See **REP 64 11 213** Removing and installing/replacing heater/air conditioner fan.

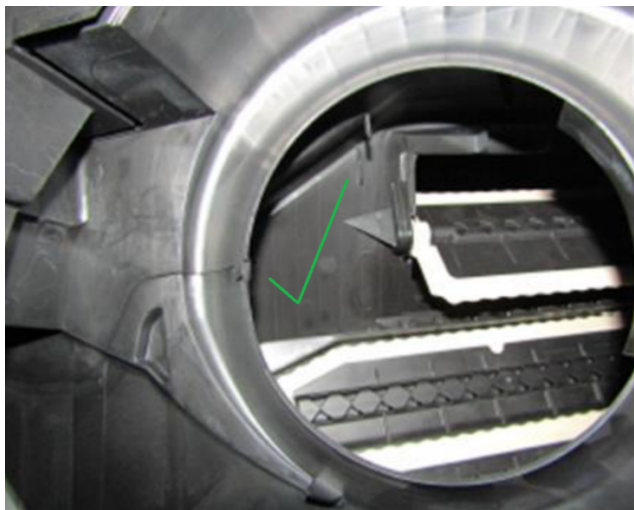
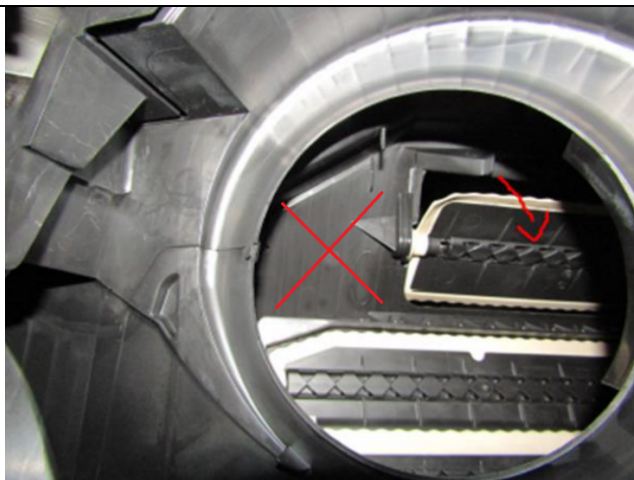
6. If the flap system is not OK, try to correct the flap by hand. See direction of arrow.

7. Once moved back past the end point the flap **may** not function properly. If so, then you may have to remove the stepper motor to check for damage.

- The test plan ABL to re-initialize/address stepper motor position should be run
- Allow vehicle to enter sleep mode after running the test plan prior to testing flap positioning
