SIB 64 04 21

2021-06-10

## MOISTURE IN DRIVER AND/OR PASSENGER FOOTWELL

E-Series	Model Description	Production Date
G05	X5 Sports Activity Vehicle	From Start of Production (SoP)

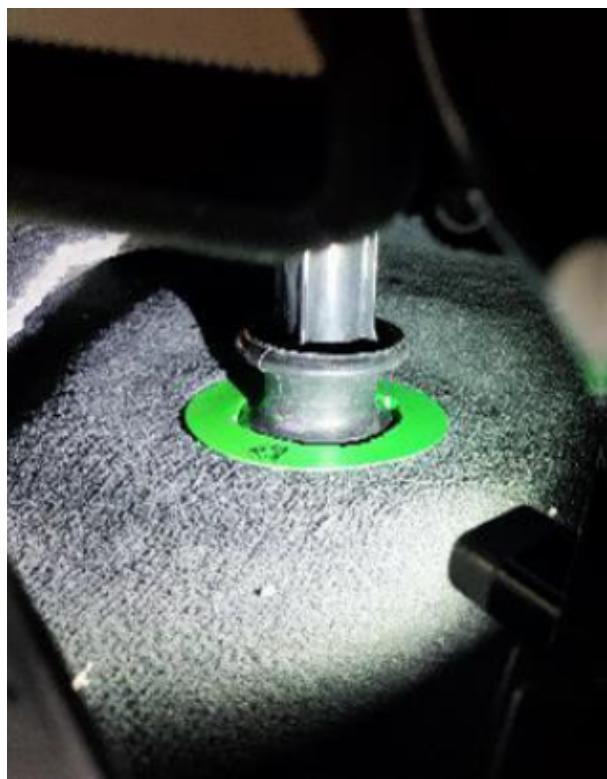
Closely examine the connection point just above the center tunnel (centrally below the instrument panel) and reconnected if necessary.

Pictured is the correct installation of the drain hose.

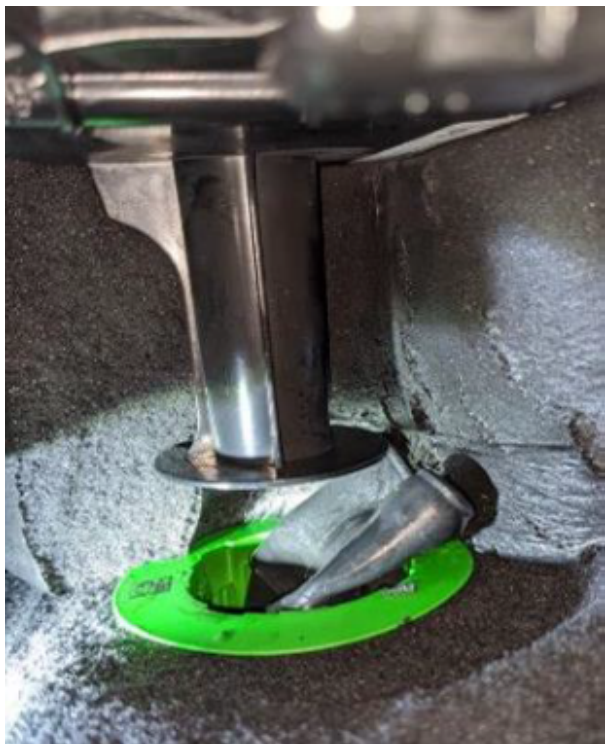
2. Here the drain hose is folded over and will require replacement to seal properly.

If the condensation water drainage hose is damaged, replace it.

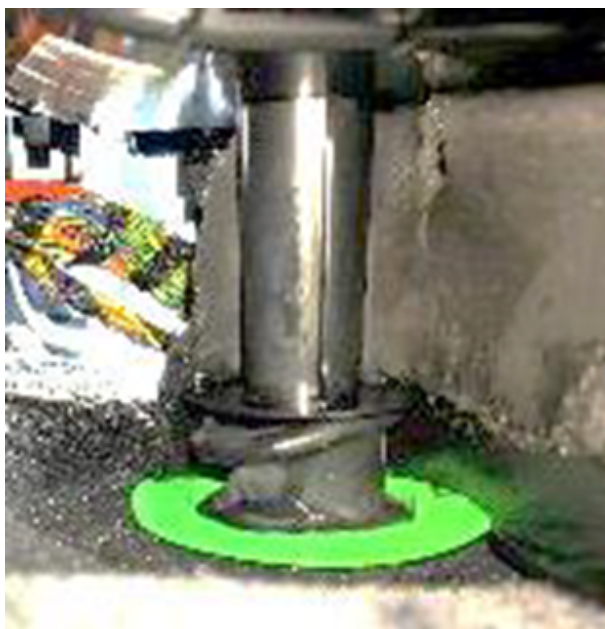
3. Here the drain hose is incorrectly installed and will require replacement to seal properly.
