SIB 64 05 21

2021-06-28

**RATTLING NOISE PERCEPTIBLE IN VEHICLE INTERIOR WITH AC ACTIVATED**

E-Series	Model Description	Production Date
G20	3 Series Sedan	Start of Production up to May 30 2025

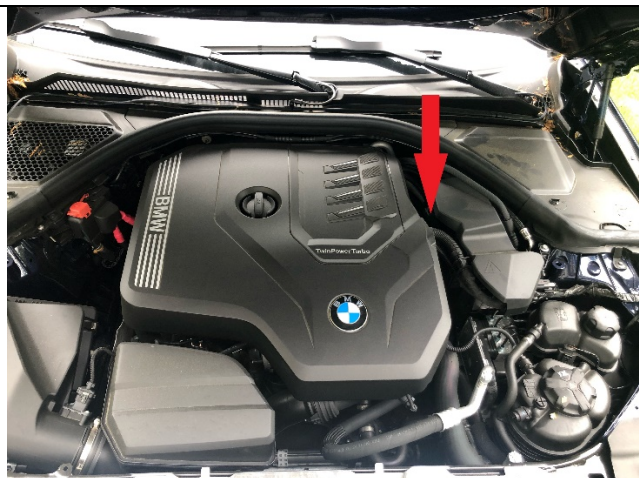
The refrigerant line double pipe and a clamp on the return line of the internal heat exchanger are in line with each other (in the direction of travel, on the left (driver) side of the engine compartment below/behind the DME).and are making contact.

The lines are contacting here.

Insert a strip of felt tape in the area of contact and clamp the two pipes together.

Place a strip of felt tape 10-12cm long around each of the lines at this contact point and then secure the lines together using a worm type hose clamp.
