## SIB 11 08 21 FAILURE OF REAR OXYGEN SENSOR

E-Series	Model Description
K63	S 1000 R
K66	M 1000 RR
K67	S 1000 RR
K69	S 1000 XR

# Service Information Bulletin

11 08 21

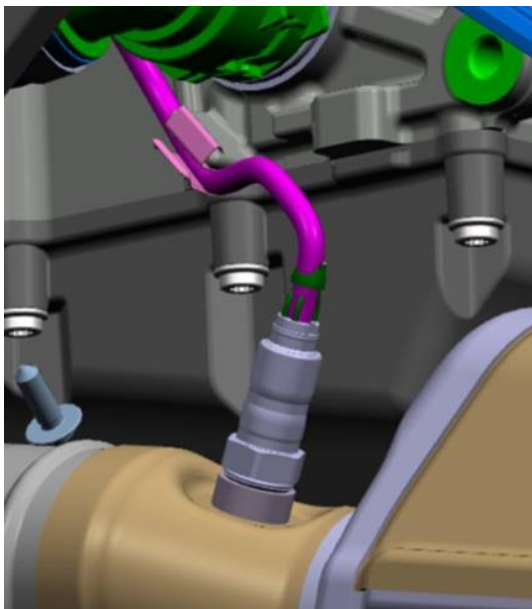
The failure usually occurs shortly after the vehicle handover or the running-in check. Analysis of the defective parts received showed that the oxygen sensor cable is crushed when the engine spoiler is installed.

Cylinder bank 1: At the sheet metal clamp that affixes the oxygen sensor cable, see Figure 1:  
*Figure 1: K69 Oxygen sensor bank 1 - damage of the lines, wiring harness at the clamp*

It is possible to repair the damaged area by insulating the single damaged wire with about 3 cm of black heat-shrink tubing with internal adhesive. The black outer insulation tube must also be appropriately covered to repair the damaged area. If a proper repair is not possible, the oxygen sensor must be replaced.

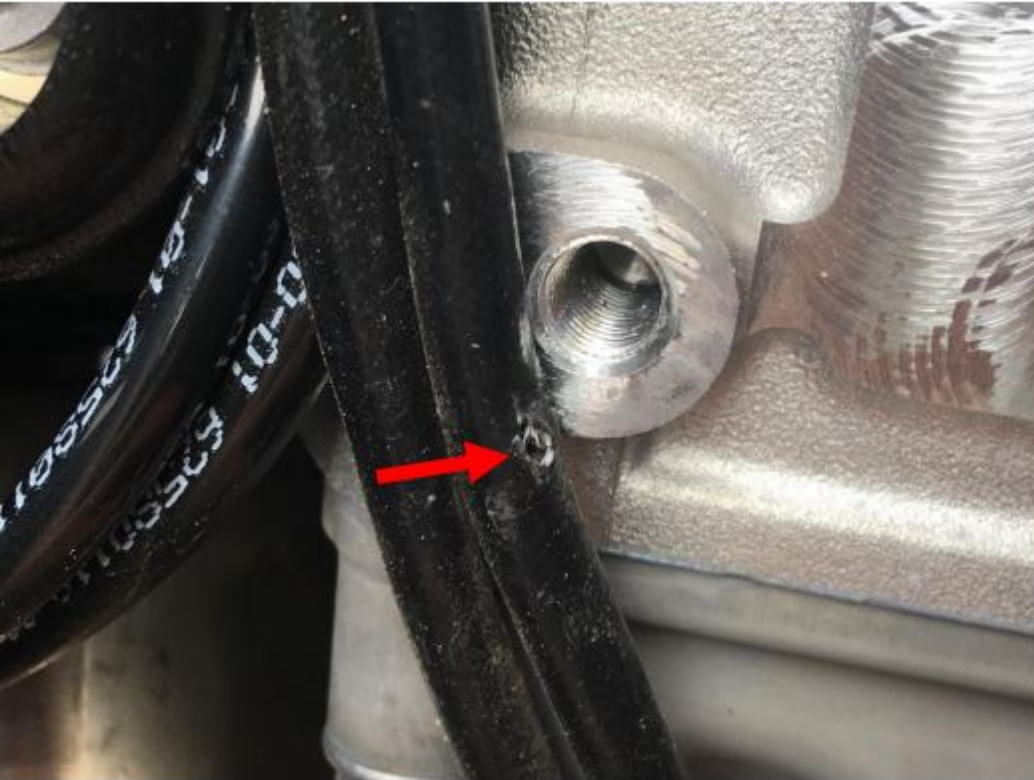
Cylinder bank 2: Incorrectly routed oxygen sensor wiring pinched between the engine and the engine spoiler, see Figure 2:

*Figure 2: K69 Oxygen sensor bank 2 - damage of the lines, wiring harness at the bracket for engine spoiler*

Please ensure that the oxygen sensor cables are not crushed when installing the engine spoilers.

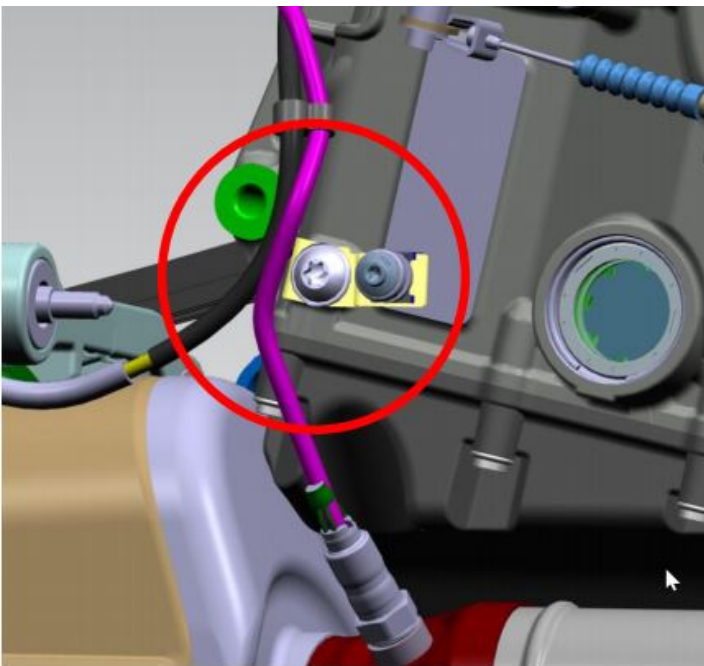
The correct wire routing is pictured in Figure 3:

*Figure 3: K69 Oxygen sensor bank 2 - correct routing of the line, wiring harness to prevent damage*

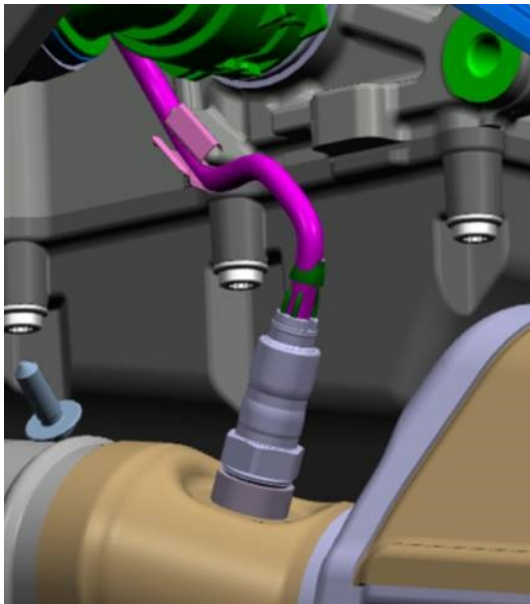
Cylinder bank 1: At the sheet metal clamp that affixes the oxygen sensor cable, see Figure 1:  
*Figure 1: K69 Oxygen sensor bank 1 - damage of the lines, wiring harness at the clamp*

It is possible to repair the damaged area by insulating the single damaged wire with about 3 cm of black heat-shrink tubing with internal adhesive. The black outer insulation tube must also be

appropriately covered to repair the damaged area. If a proper repair is not possible, the oxygen sensor must be replaced.

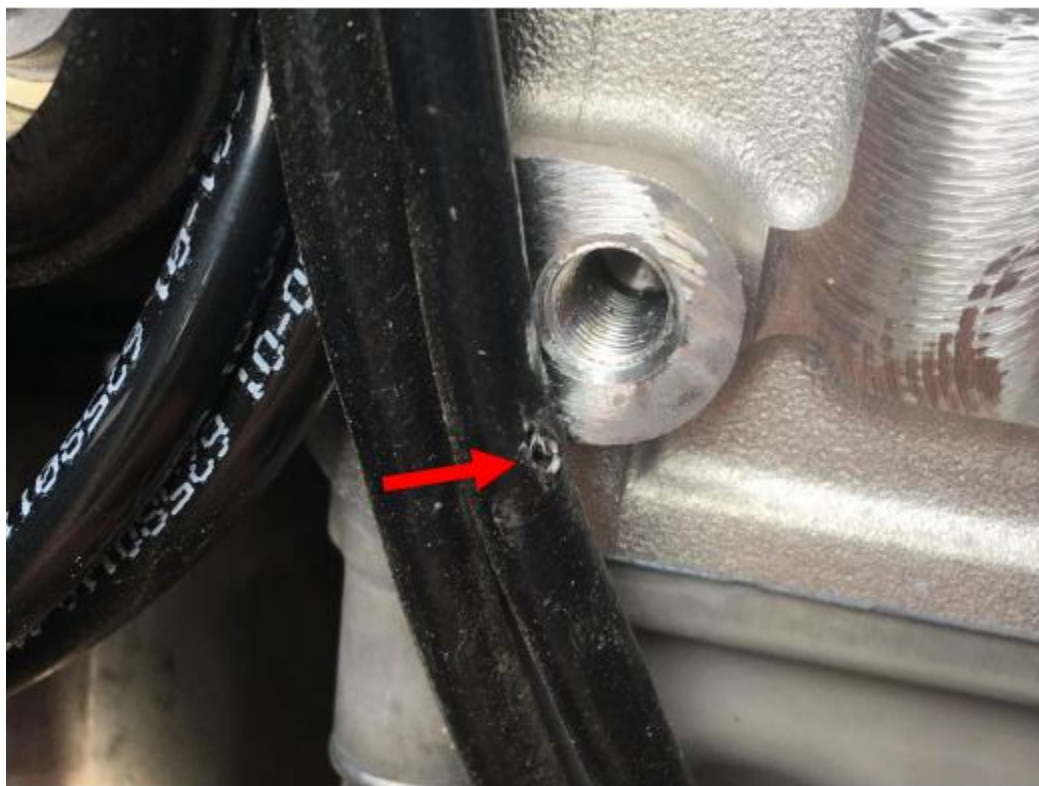
Cylinder bank 2: Incorrectly routed oxygen sensor wiring pinched between the engine and the engine spoiler, see Figure 2:

Figure 2: K69 Oxygen sensor bank 2 - damage of the lines, wiring harness at the bracket for engine spoiler

Please ensure that the oxygen sensor cables are not crushed when installing the engine spoilers.

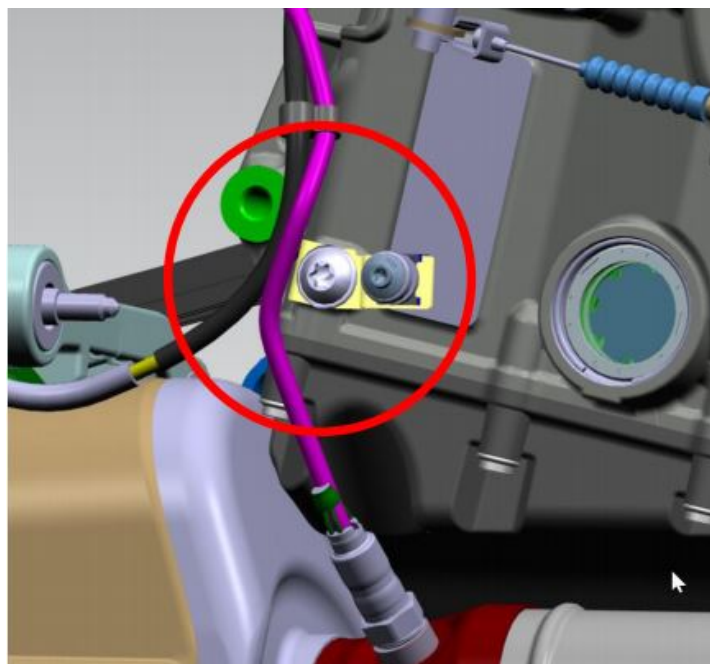
The correct wire routing is pictured in Figure 3:

Figure 3: K69 Oxygen sensor bank 2 - correct routing of the line, wiring harness to prevent damage
