SIB 33 04 21 DRIVE CHAIN CONTACTS SWING ARM

2021-06-08

Model	Model Description	Production Date
K69	S 1000 XR	To May 31, 2021

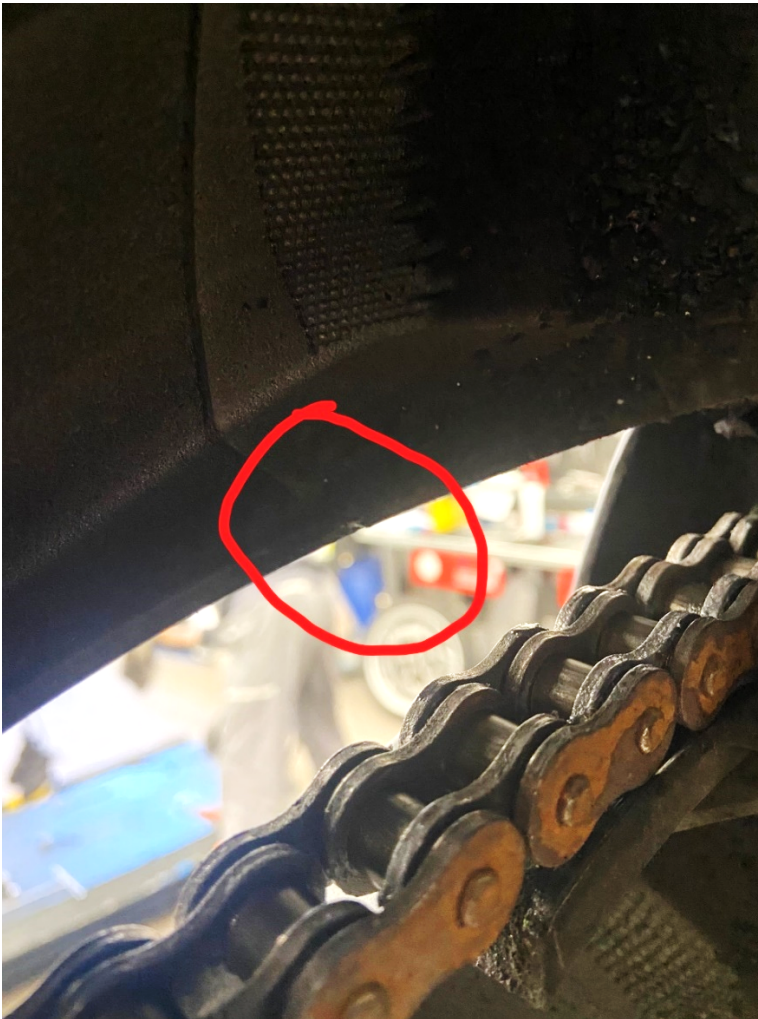
Depending on the chassis and suspension adjustment, as well as vehicle load, the drive chain may make contact with the swing arm under certain conditions.

Figure 1: Location of damage on swing arm

The swing arm should not be replaced due to damage from the chain, as described and pictured. This minimal impact mark does not affect the performance or operation of the swing arm.

For vehicles built before May 31, 2021, the chain impact guard can be retrofitted under warranty in the event of a complaint.

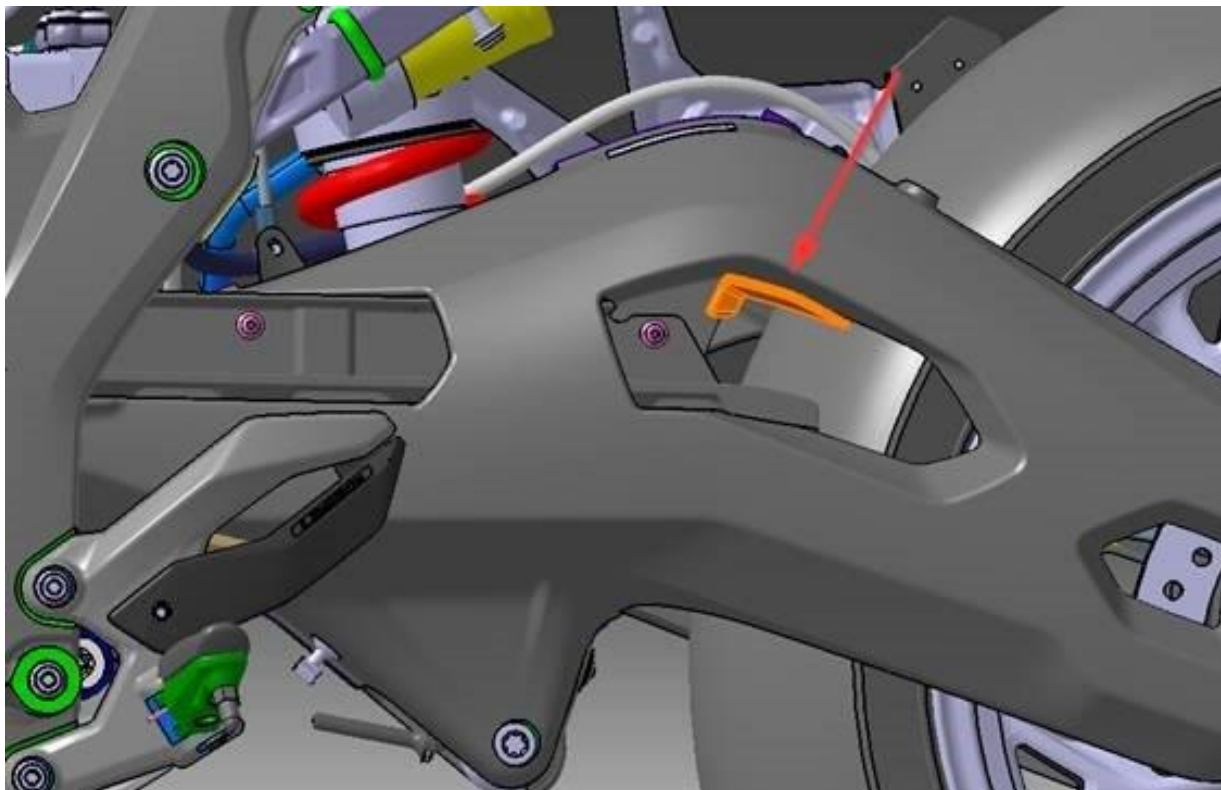
Figure 2: Installation location of chain guard

The area to which the guard is applied must be thoroughly cleaned and free of dirt and chain grease. Please refer to the Figure 2 below for the correct attachment of the guard.

Please note, that a new impact guard must be installed any time the swing arm is replaced.

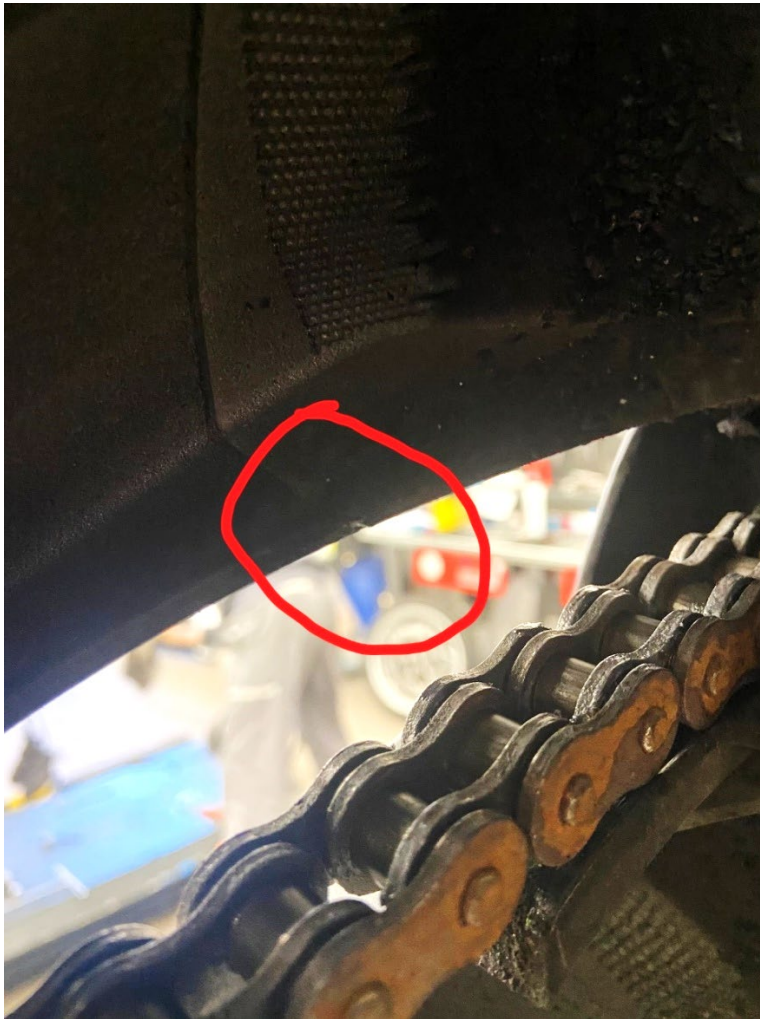
Depending on the chassis and suspension adjustment, as well as vehicle load, the drive chain may make contact with the swing arm under certain conditions.

Figure 1: Location of damage on swing arm

The swing arm should not be replaced due to damage from the chain, as described and pictured. This minimal impact mark does not affect the performance or operation of the swing arm.

For vehicles built before May 31, 2021, the chain impact guard can be retrofitted under warranty in the event of a complaint.

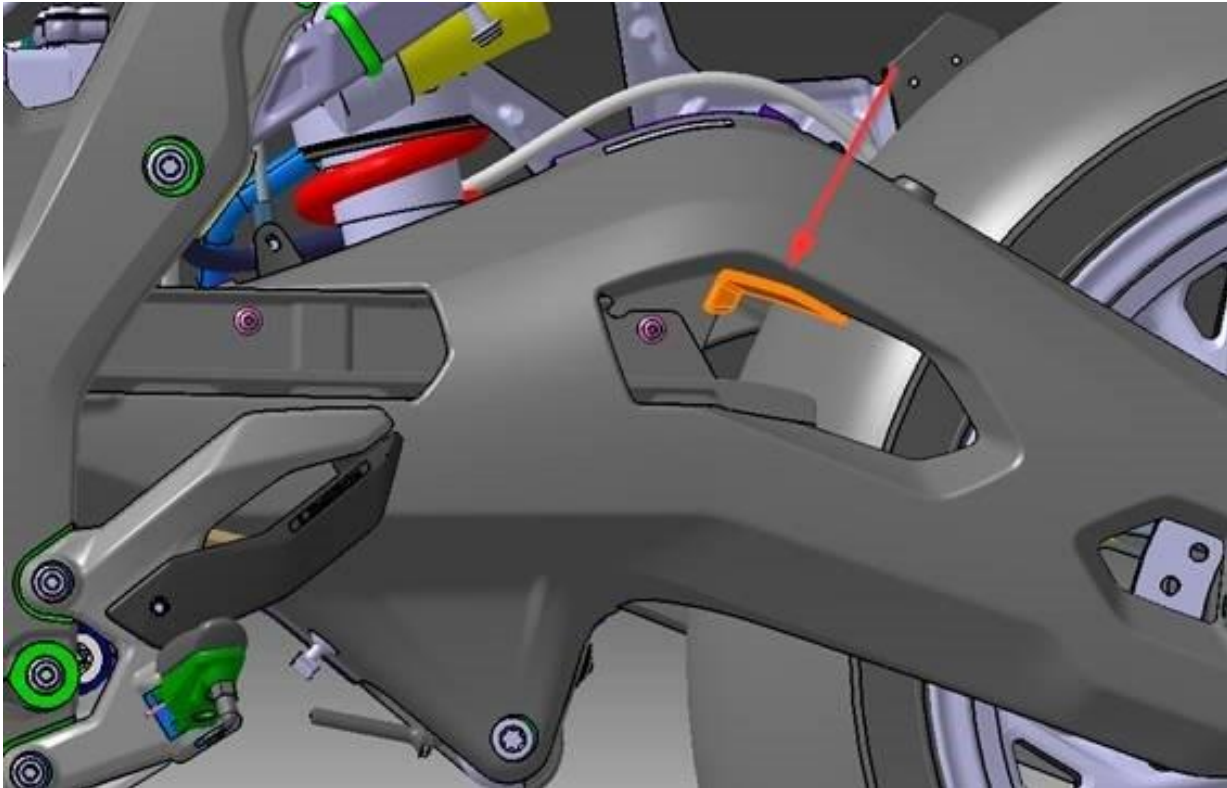
Figure 2: Installation location of chain guard

The area to which the guard is applied must be thoroughly cleaned and free of dirt and chain grease. Please refer to the Figure 2 below for the correct attachment of the guard.

Please note, that a new impact guard must be installed any time the swing arm is replaced.
