SIB 63 02 21

SERVICE ACTION: FRONT TURN INDICATORS BRACKETS

## OL11 - R 18

## 00 60 392 Replacing front turn indicator bracket

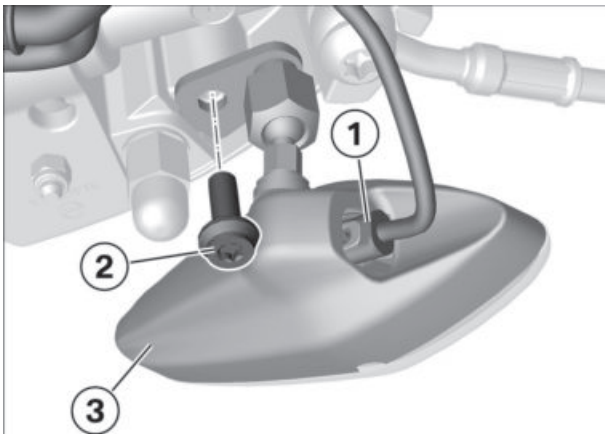
1

► **Removing front turn indicators, left and right**

- Disconnect connector (1).
- Remove bolt (2) and take off turn indicator (3).
- Remove front right turn indicator in the same way.

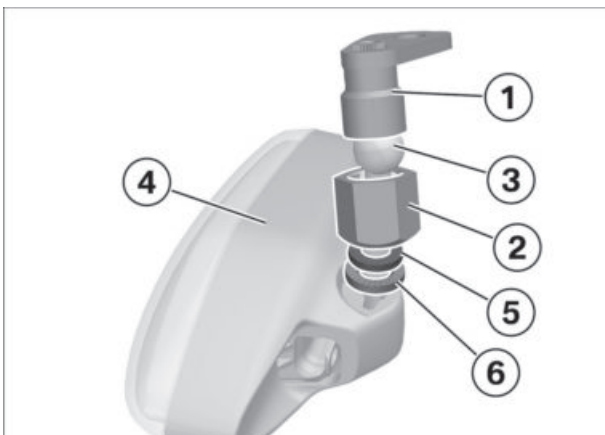
2

► **Replacing ball head to front turn indicator**

The tabs for the turn indicator on the left and right are different. Make sure installation is correct!

Bore hole for screw is positioned eccentrically offset to the rear (in direction of travel).

- Carefully clamp tab (1) into vice.
  - Use vice jaw protectors.
- Loosen union nut (2), **Caution: left-hand thread!**
- Remove ball stud (3) and union nut (2) from turn indicator (4).
  - Turn only on ball head (Torx 25), **not on hexagon!**
- Remove washer (5) and lock washer (6).
- Secure new ball stud (3) according to removal to turn indicator (4).

**Tightening torques**

**Ball stud in turn indicator**

M6  
Thread-locking compound (micro-encapsulated)

8 Nm

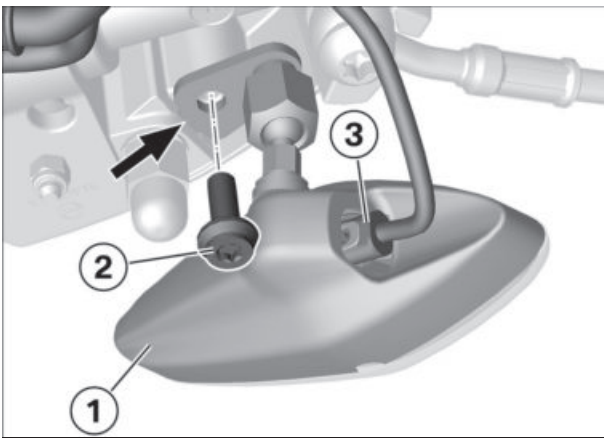
**3**

► **Installing front turn indicators, left and right**

- Clean thread.
- Position turn indicator **(1)** noting locator **(arrow)**.
- Install bolt **(2)**.

<b>Tightening torques</b>		
<b>Turn indicator with turn indicator bracket to multi-function switch</b>		
M6 x 16 Thread-locking compound (micro-encapsulated)	8 Nm

- Connect connector **(3)**.
- Align turn indicator vertically toward the front.
- Install right turn indicator in the same way.
