GROUP	MODEL
BOD	2022MY Stinger (CK)
NUMBER	DATE
302	August 2021

## TECHNICAL SERVICE BULLETIN

### SERVICE ACTION: FRONT DOOR TRIM GRIP HANDLE INSPECTION AND REPAIR (SA483)

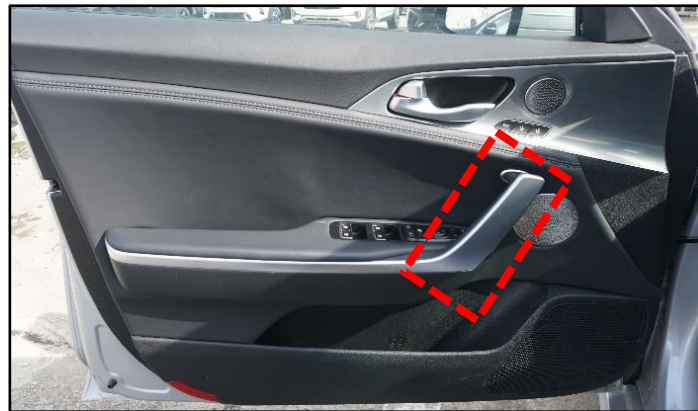
Door Trim Grip Handle (Left)

This bulletin provides information to inspect the two (2) (LHS & RHS) front door trim grip handles on some 2022MY Stinger (CK) vehicles produced from February 25, 2021 through June 17, 2021, which may have the grip handle detached from the inside door trim. Follow the procedure outlined in this publication to inspect the front door trim grip handles and replace the door inside handle bracket screws or replace the front door trim as outlined in the inspection. Before conducting the procedure, verify that the vehicle is included in the list of affected VINs.

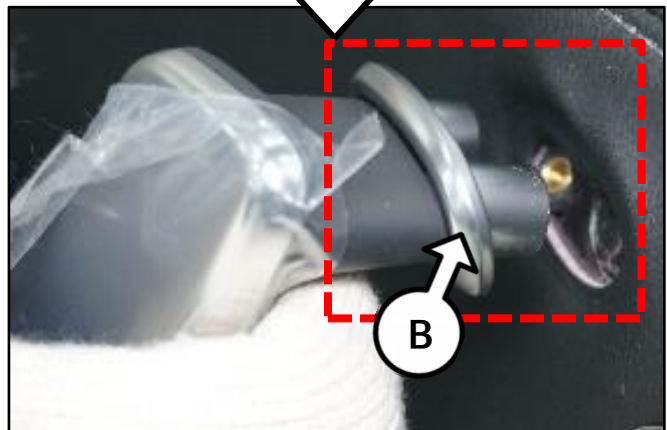
- A. If the grip handle (B) is detached from the door trim panel (as shown to the right), then replace the front door trim panel assembly by referring to the "Body (Interior and Exterior) → Front Door → Front Door Trim → Repair procedures" in the applicable Shop Manual on KGIS.

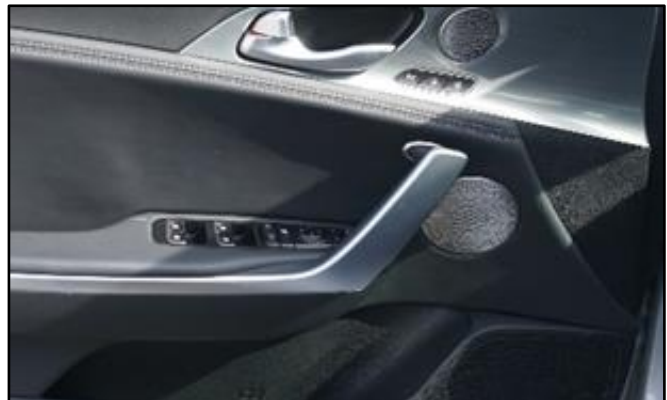
- B. If the grip handle is not detached, replace the front door inside handle bracket screws by following the 'Replacement Procedure' outlined on page 3.
