## Notice of Defect

This notice is sent to you in accordance with the requirements of the Motor Vehicle Safety Act. This is to inform you that your vehicle may contain a defect that could affect the safety of a person. The VIN numbers of your affected Polar trailers are listed above. We are referring to this action as the "Dexter Recall" and it has been assigned file number 2021-320 by the Department of Transport.

**Subject: SMART-STEER 2.0 Bolt-On Steer Arm Reinforcement Welds**

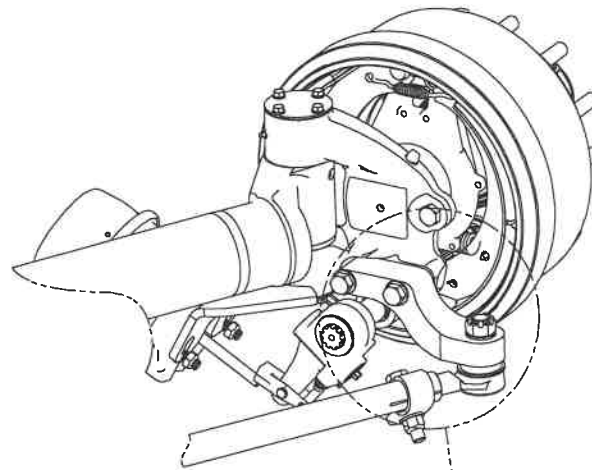
Based on feedback from our customers, Dexter Heavy Duty has become aware that under certain loading conditions, the 8-7/8" steer arm setup on the SMART-STEER 2.0 axle is prone to shearing the attaching steer arm bolts. This will lead to a failure in the steer arm assembly.

1. Visually inspect steer arm bolts and washers for mechanical tightness and replace if necessary.
2. Ensure the steer arm bolts are torqued to 400 Ft. Lbs.
3. Place welds as shown on page three of this bulletin. If you would like a copy of engineering drawing 750049, please contact one of the service technicians listed below.

NOTE:  
TURN KNUCKLE AT FULL TURN TO  
GAIN ACCESS TO STEER ARM  
AND WELD
