# Service Information Letter

August 16, 2021

Units Affected: AT200A aerial devices built on Ford F450/F550 chassis from 2011 to 2016 with steel utility bodies (Verify that your unit serial number is affected by reviewing the attached list in this SIL or by accessing your fleet on [connect.altec.com/login](http://connect.altec.com/login))

## Mounting Frame Inspection, Units with Steel Bodies

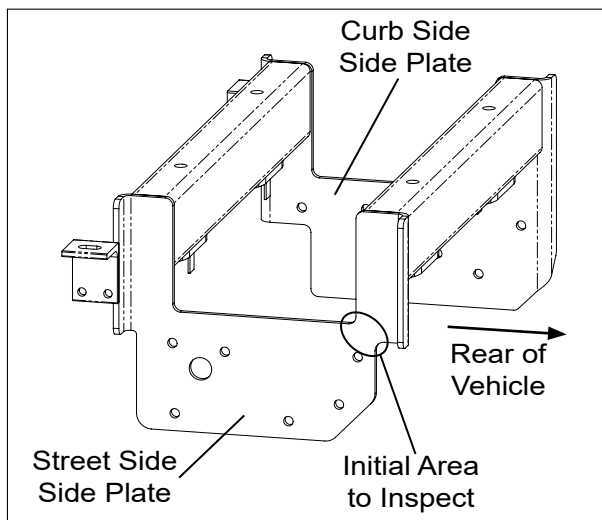
**Figure 1 – Mounting Frame Initial Inspection**

3. The initial area to inspect is the narrow section at the rear portion of the side plate on the street side of the mounting frame (refer to Figure 1). Use a wire brush to remove any paint and rust from this area.
4. Using a flashlight, inspect the outer surface and the upper and lower rounded corners of the narrow section of the side plate for the extent of any cracking in the steel plate, as defined below.
  - No cracking means no visible cracking at all in the plate.
  - Partial cracking means a visible crack anywhere in the narrow section that extends only part way across the width or part way through the thickness of the plate (refer to Figure 3).
  - Full cracking means a visible crack across the full width of the narrow section extending through the full thickness of the plate and causing the complete separation of the material (refer to Figure 4).

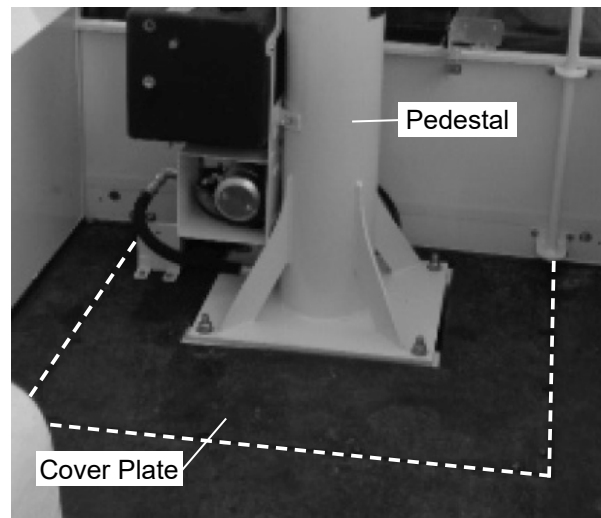
**Figure 2 – Removing Cover Plate**

1. Position the unit on a level surface. Apply the parking brake and turn off the engine. Remove the key from the ignition and secure it. Chock the wheels. Follow your employer's vehicle lockout/tagout procedure.
2. Determine if both side plates of the mounting frame can be inspected from under the vehicle (refer to Figure 1).
  - If both side plates can be inspected from under the vehicle, proceed to step 3.
  - If both side plates cannot be inspected from under the vehicle, remove the cover plate at the base of the pedestal (refer to Figure 2).

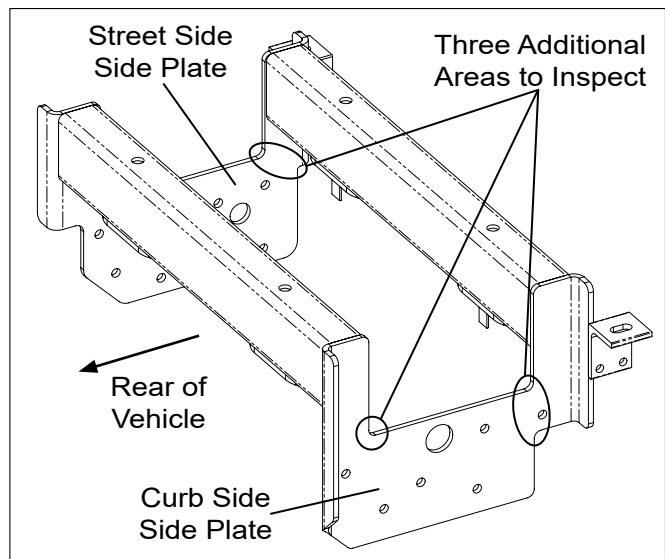
**Figure 5 – Mounting Frame Additional Inspection**

2. Use a wire brush to remove any paint and rust from the other three corners of the mounting frame (refer to Figure 5).

3. Using a flashlight, inspect the outer surface and the rounded corners of the three corners of the mounting frame as shown in Figure 5 for the extent of any cracking in the steel plate.

- If there is no cracking in any of these three areas, order the kit as specified on page 1 and install it before putting the unit back into service.
- If there is cracking in any of these three areas, call 1-877-GO ALTEC (1-877-462-5832) option 1 and speak to Technical Support for further direction.
