Technical Service Bulletin

40 Rumbling/creaking noises from front of the vehicle when driving - Q7, Q8, A8, and Audi e-tron quattro

40 21 27 2058489/3 August 17, 2021. Supersedes Technical Service Bulletin Group 40 number 20-03 dated March 12, 2020 for reasons listed below.

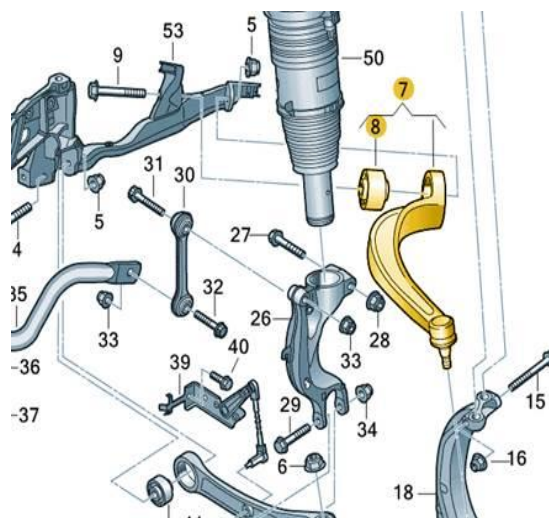
Figure 1. Hydro-bush.

The noises can be generated on the lower-left guide in the area of the hydro-bush. (Figure 1, Position 7 and 8).

The noises from the guide link can be transmitted into the vehicle interior by the connection of the subframe on the body and are noticeable in the footwell.

1. Replace the hydro-bush on the guide link in pairs (Figure 1, Position 8) according to the instructions in Elsa at Repair Manual, *Chassis >> Suspension, Wheels, Steering >> 40 Front Axle >> Lower Control Arm and Ball Joint >> Guide link bonded rubber bushing, Removing and Installing*.
2. Before installation, ensure that the new parts of the hydro-bush have a parts version of **03S** or higher (Figure 3).

3. If repeat repairs are necessary and the hydro-bush has already been replaced (pressed out/in), the complete guide link has to be replaced (Figure 1, Position 7) in Elsa at Repair Manual, *Chassis >> Suspension, Wheels, Steering >> 40 Front Axle >> Lower Control Arm and Ball Joint >> Guide Link, Removing and Installing*.

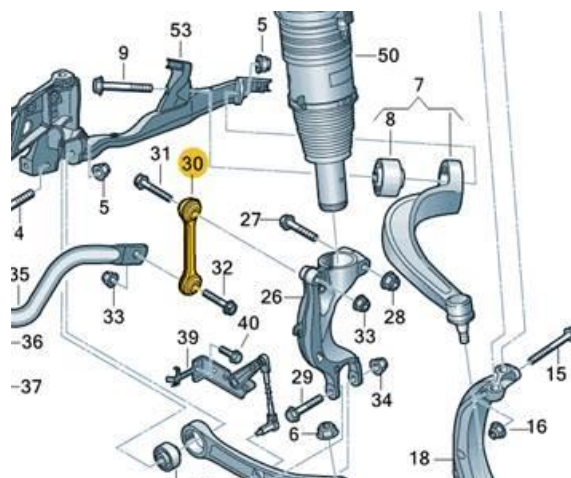
Figure 2. Coupling rod.

Parts such as the coupling rod (Figure 2, Position 30) are usually replaced by mistake, presenting no problems.
