SERVICE BULLETIN

Reference number:	SB-55-1465V2	Issued: 16 July, 2021
Subject:	Windscreen Demist Improvement	
Model(s):	DBX	
VIN Range:	Part A: All DBX Part B: VINs to V00832 only	
Applicable to:	All Dealers	
Distribute to:	Head of Business After Sales Manager Service Manager Sales Manager	Warranty Staff Technician(s) Parts Staff

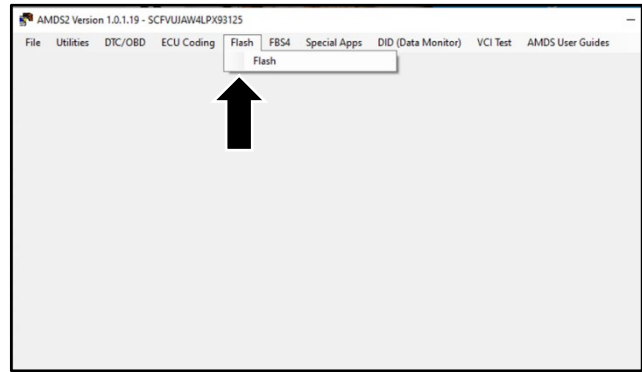
Figure 1

- 4. Select "Flash" (refer to Figure 1).

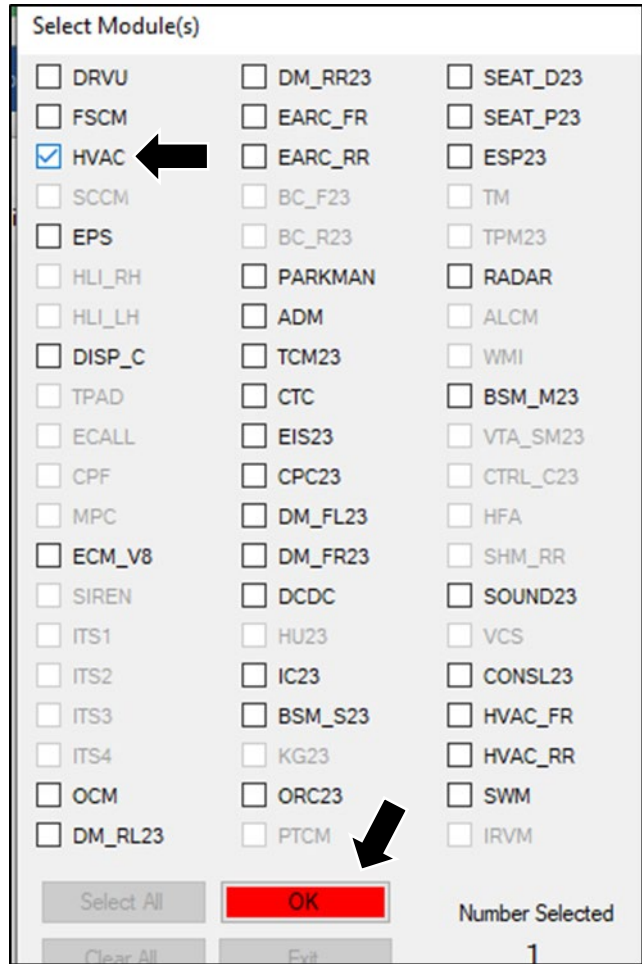
Figure 2

- 5. Select the "HVAC" module then click "OK" (refer to Figure 2).

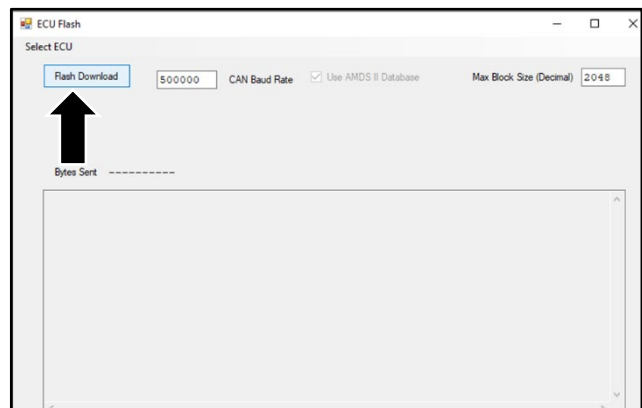
Figure 3

- 6. Select "Flash Download" (refer to Figure 3).
