GROUP	MODEL
TRA	2015MY K900 (KH) w/8AT
NUMBER	DATE
096	August 2021

TECHNICAL SERVICE BULLETIN

SUBJECT: 8AT (A8LR1-SBW) SOLENOID VALVE REPLACEMENT AND TCU LOGIC IMPROVEMENT

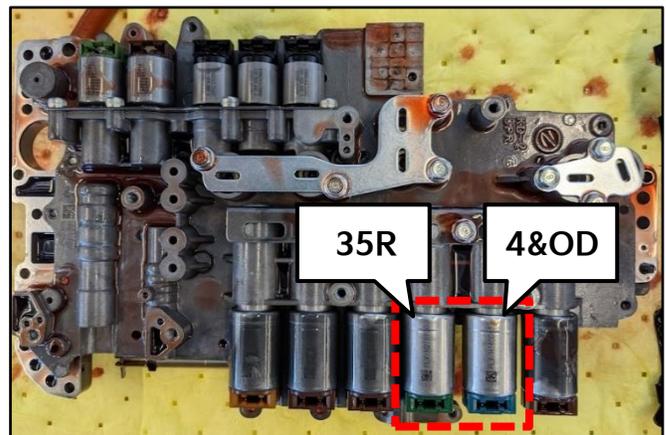
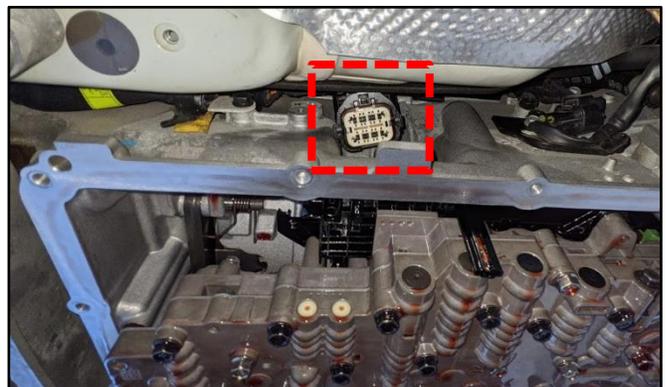
Be sure that the wire harness connector is unlocked (located on the passenger/right side) prior to removing/lowering the valve body.

Damage to wire harness may occur if it is still attached/locked secure.

1. Replace the two (2) solenoid valves (35R and 4&O/D) by referring to the "Automatic Transmission System → Automatic Transmission Control System → 35R and 4&OD Clutch Control Solenoid Valve → Repair Procedures" chapter in the applicable Shop Manual on KGIS.

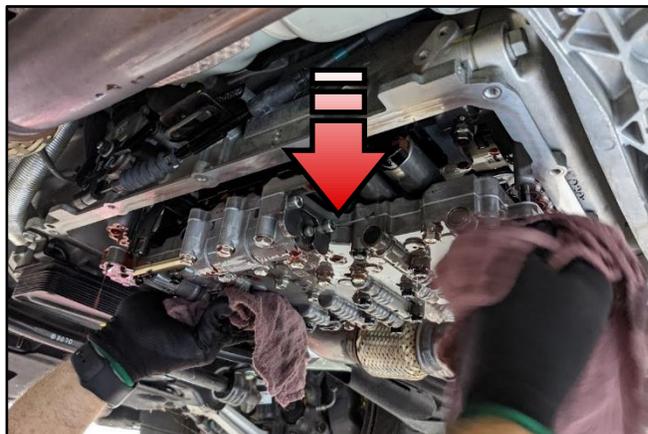
The valve body is heavy, carefully lower it when removing. DO NOT drop it or damage will occur.

Follow bolt removal sequence on KGIS.
