Technical Service Bulletin

63 Paint peeling on the front bumper cover near the center lower air intake grille

63 21 06 2064362/1 August 24, 2021.

Model(s)	Year	VIN Range	Vehicle-Specific Equipment
A6, S6	2019	000001 - 12150	Not Applicable

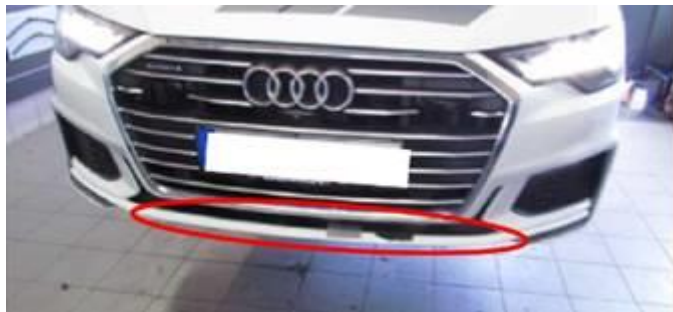
The loss of adhesion of the paint in this specific area is confirmed. No outside influence is found after careful inspection. The following images depict the paint adhesion loss at the location at issue:

1. Figure 1 shows the area of the front bumper where the paint peeling is located. For this TSB to apply the peeling condition is confined only to this area of the front bumper cover.

Figure 1. Lower lip section of the bumper cover.

If the paint adhesion loss is as described in this TSB and solely confined to the lower lip section of the bumper cover where it meets the center lower air intake grille the front bumper cover must be replaced.

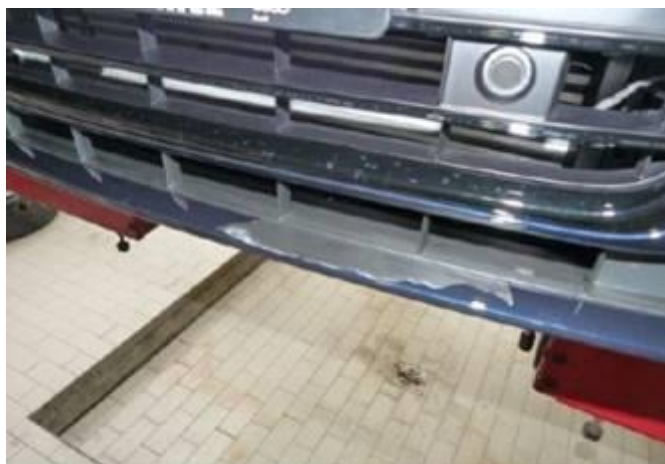
2. Figure 2 shows a closer view of the peeling.

Figure 2. Loss of adhesion of the bumper paint.

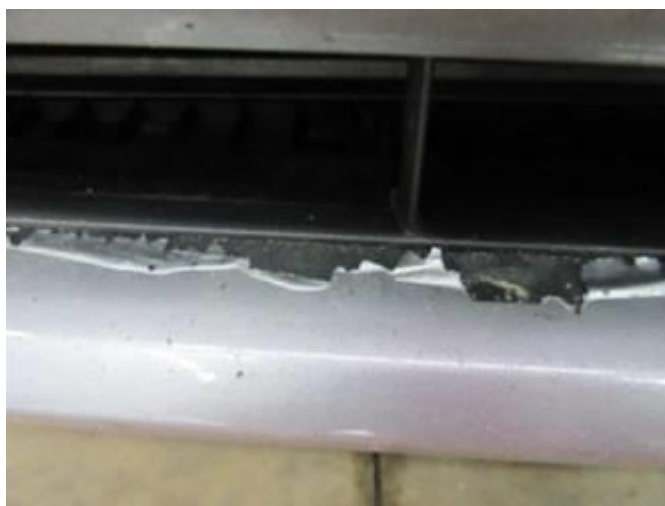
3. Figure 3 shows a close-up view of the peeling paint in this area.

Figure 3. Moderate paint adhesion loss.

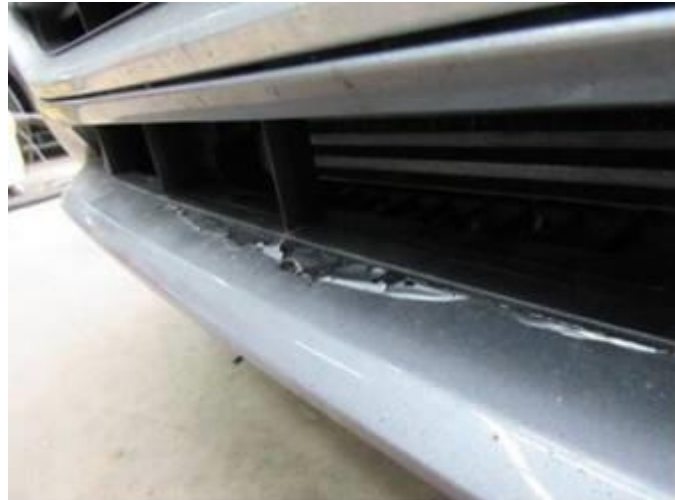
4. Figure 4 shows a side view depicting the length of the paint peel.

Figure 4. Side view of the bumper with the paint peeling.

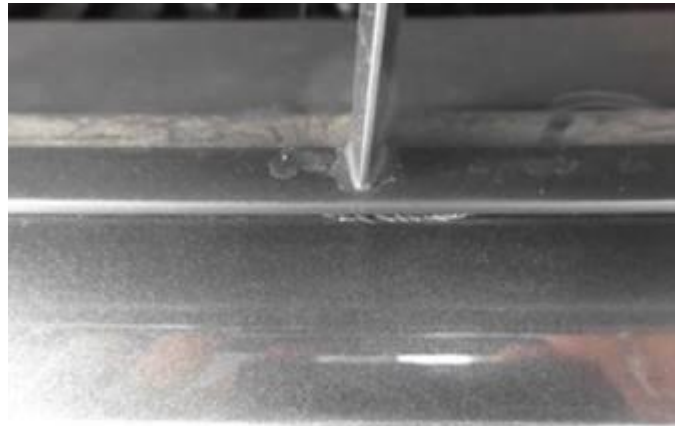
5. Figure 5 shows the beginning stages of the paint adhesion loss.

Figure 5. Early-stage of paint peel.
