Technical Service Bulletin

90 Instrument cluster: trip odometer and/or clock sporadically resets to zero - MY21

90 21 12 2064301/1 August 19, 2021.

Model(s)	Year	VIN Range	Vehicle-Specific Equipment
Q3	2021	All	FPK

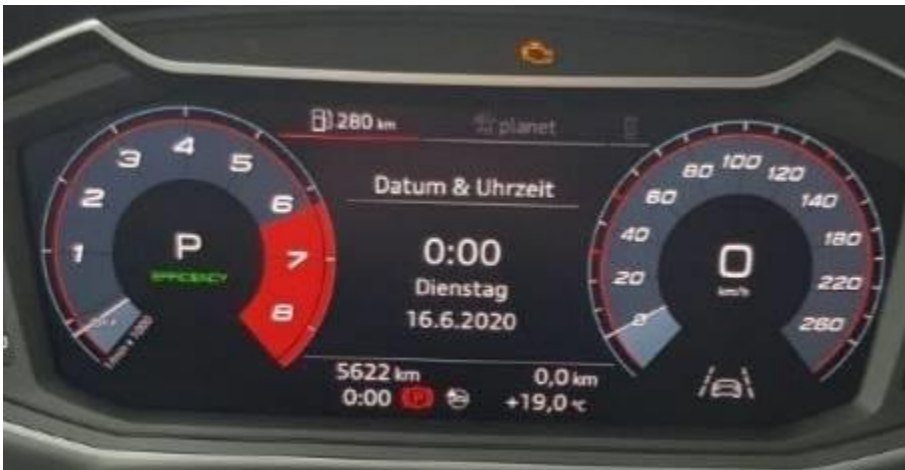
- The trip odometer and/or the clock in the instrument cluster will sporadically reset to zero (Figure 1).

Figure 1. Clock and trip odometer reset to zero.

A software issue in the instrument cluster can cause it to reset on start-up clearing the clock and trip odometer.

- Follow all instructions in TSB 2011732: *00 Software Version Management (SVM), operating instructions.*
- Update the instrument cluster, J285 (address word 0017) using the SVM action code as listed in the table below, if necessary:
