**Freightliner
Service Bulletin**

Rain Light Sensor Calibration Procedure

Checking Windshield Transmittance

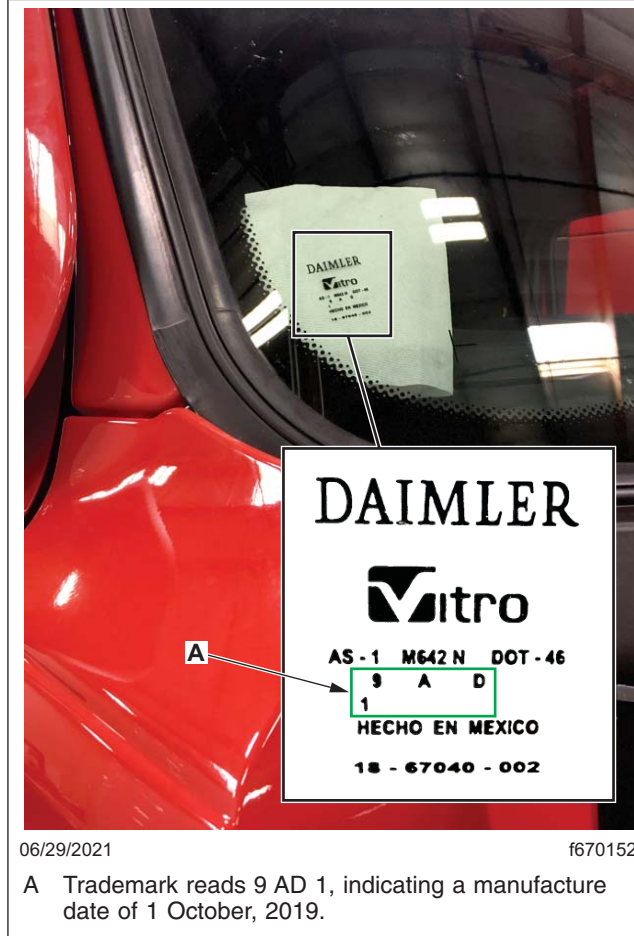
Fig. 1, Locating the Windshield Trademark Code

If the RLS fails to calibrate, then a possible cause is a slight variance in windshield transmittance from the target value in a limited group of windshields. To see if your windshield is in this group, locate the trademark code in the bottom-right of the windshield, shown in [Fig. 1](#). Compare the trademark code with the codes in [Table 1](#) to determine if windshield transmittance is the cause.

If the three-part trademark code on the windshield matches any of the codes in [Table 1](#), the windshield must be replaced.
