**Freightliner
Service Bulletin**

General Information

Heater Hose Modification

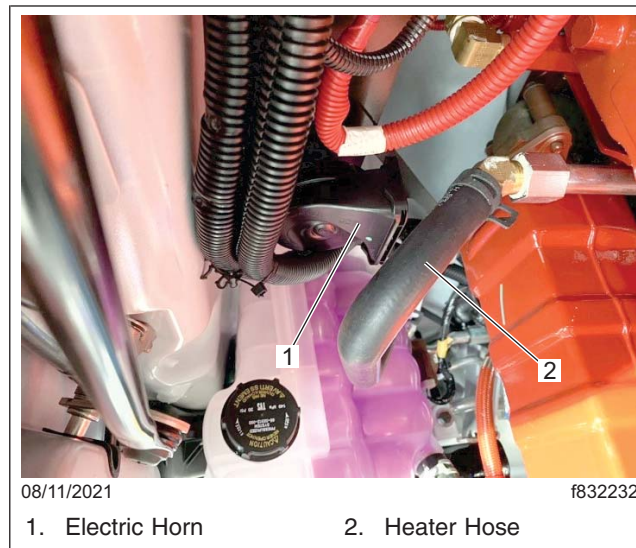
Some Business Class M2 106 vehicles built from January 2017 through June 2021 may have a heater hose installed too close to the electric horn. This applies to Business Class M2 106 vehicles with a 160 mm cab equipped with Cummins ISB engines and either single or dual horns. It also applies to heater systems with or without automatic shut-off valves. Horn failures have been reported due to high heat produced by the heater hose. In some cases, the horn comes in direct contact with the heater hose. See **Fig. 1**.

Fig. 1, Heater Installation with Close Proximity to Electric Horn

1. Park the vehicle on a level surface, shut down the engine, and apply the parking brake. Chock the tires.
2. With the ignition switch ON, check for proper operation of the horn(s). If the horn does not sound, or sound is weak, dull or abnormal, replace the horn(s) following the Horn Replacement procedure below.
3. Disconnect the batteries.
4. Open the hood to access the heater hose installation.
5. Drain the coolant.
6. Remove the coolant hose as follows.
 - 6.1 Remove the clamp opposite the 45 degree fitting, as shown in **Fig. 2**.

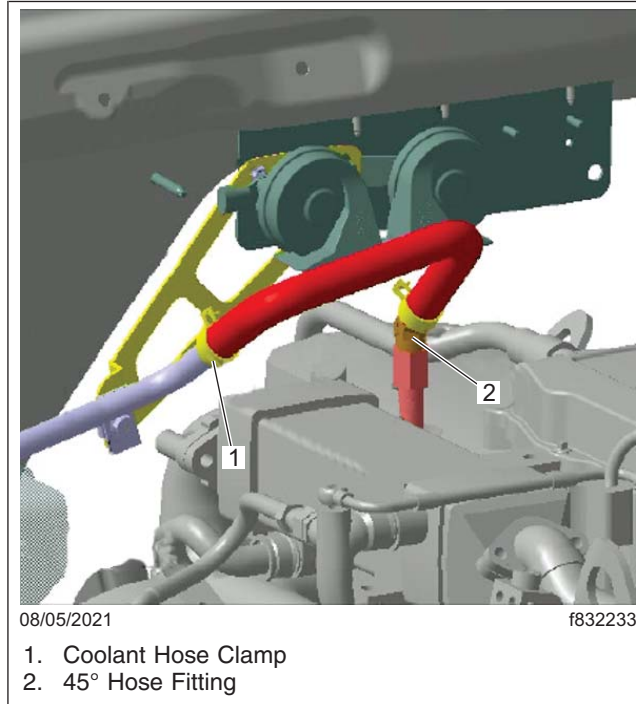
Fig. 2, Original Heater Hose Installation

- 6.2 Remove the 45 degree fitting, shown in **Fig. 2**. Use a wrench to hold the end of the heater coolant supply tube as you remove the fitting.
7. Install the tube reflecting sleeve (part number BEN 476445028) on the heater hose and secure it with tie straps. See **Fig. 3**.

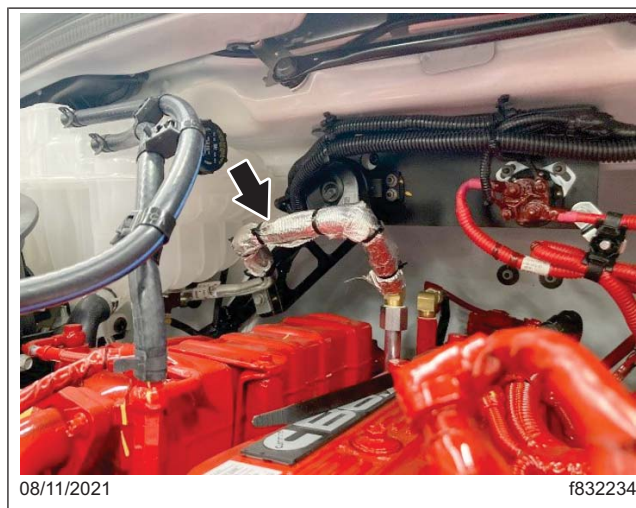
Fig. 3, Tube Reflecting Sleeve

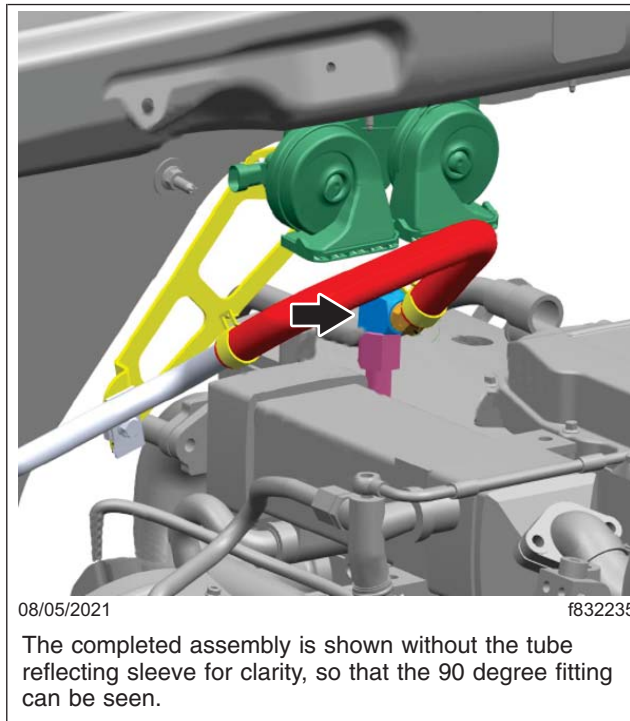
Fig. 4, Updated Heater Hose Installation

NOTE: The additional 90 degree fitting is not required if the heater coolant system is equipped with an optional supply shut-off valve. In this case, only install the tube reflecting sleeve.

8. Attach the 90 degree fitting (part number 210503 000027) under the 45 degree fitting. See [Fig. 4](#).

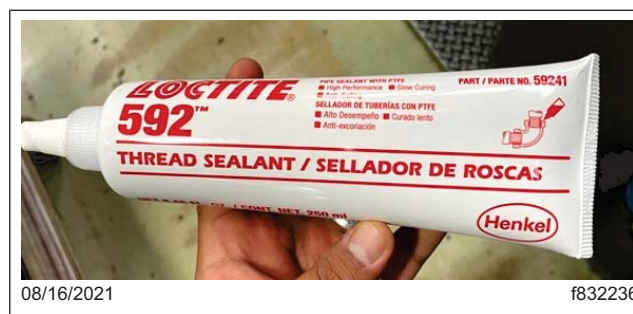
Fig. 5, Loctite 592 Thread Sealant

8.1 To prevent coolant leaks, apply Loctite® 592 thread sealant to both the 90 degree fitting and the 45 degree fitting before assembly. See [Fig. 5](#).

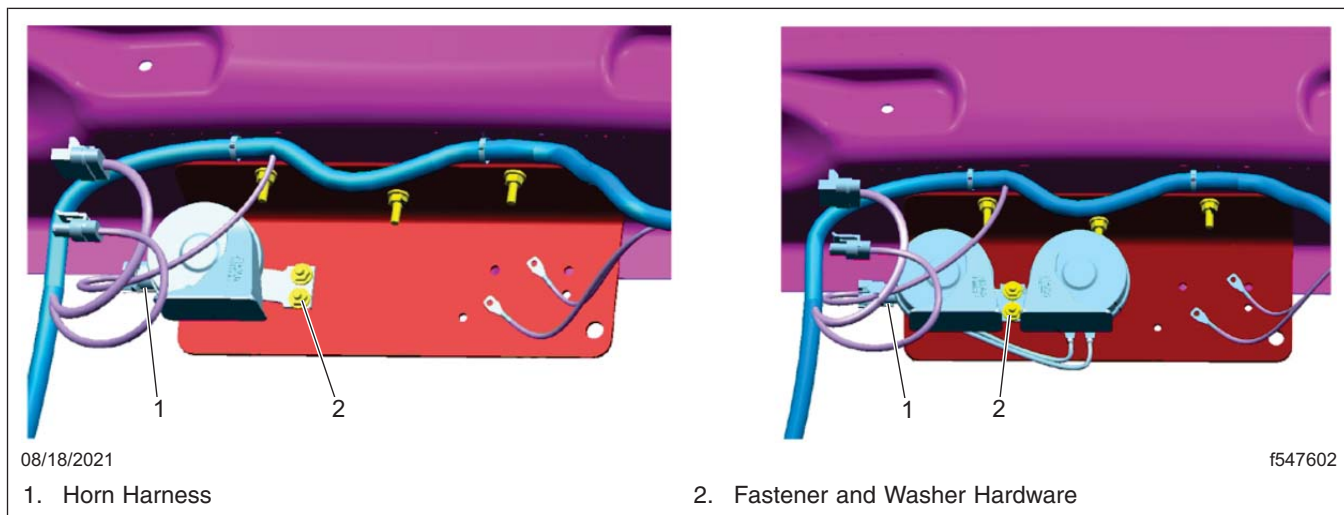
Fig. 6, Single- and Dual-Horn Installation

1. Unplug the horn harness.
2. Remove the two fastener and washer hardware sets. See [Fig. 6](#).

3. Replace the single or dual horn part numbers with same part number, or replacement part, per available Paragon information. Use removed hardware to install. Tighten the fasteners 48 to 60 lbf-in (542 to 678 N-cm).
