SS 717-WST 2021 49X Door Drain Plug & Water Pooling

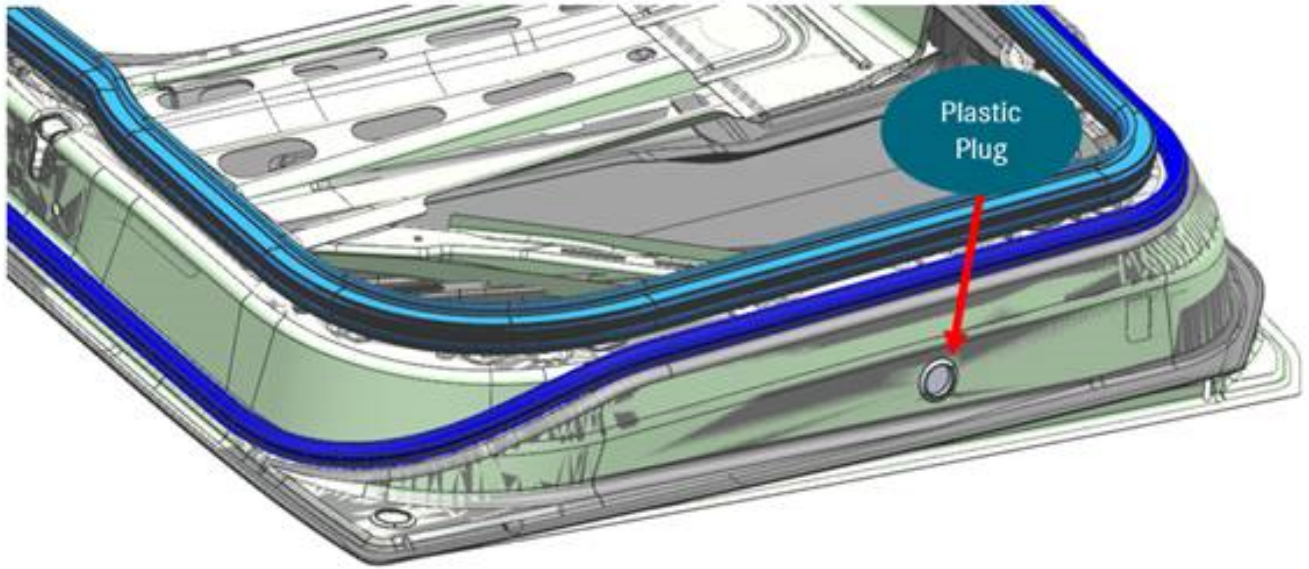
Water pooling inside of driver or passenger doors.

Drain hole location not allowing enough water to drain timely.

- Remove drain plug located at the bottom of the door shown below
- Drill 1/4" hole through center of drain plug
