# SS 3090 FTL2021 M2-106 DD8 Engine Harness Chafing Air Compressor Suction Line

FTL M2 106 with DD8 Engines.

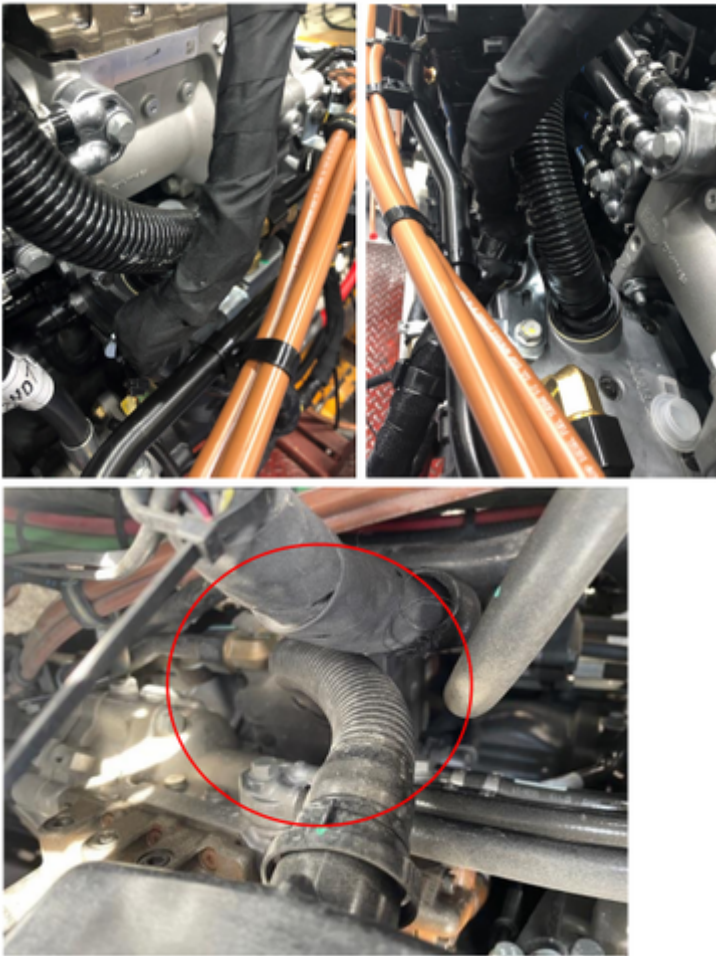
Engine Harness routing may cause chaffing/rubbing with Air Compressor suction line creating air leaks that in some cases may not allow the system to build air pressure. A hole in the suction line allows dirty air /debris to be sucked by air compressor with potential to damage internal components of the air compressor.

Figure 1: Interference between Engine Harness and Air Compressor Suction Line.

Engine Harness routing needs to be revised adding a Mounting-Tie, Cable, Dual Swivel and two Clamp Cable Ties to bundle Harness and suction line together as shown in the Figure 2.

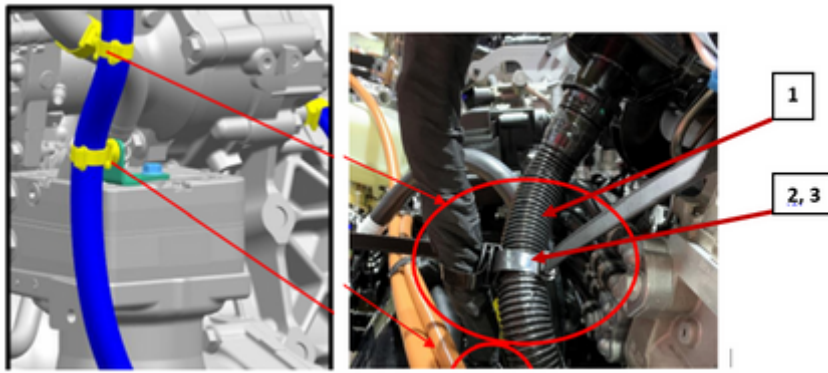
Figure 2: Revised Engine Harness routing adding additional clipping point.

1. Park the vehicle, shut down the engine, and apply the parking brakes. Chock the tires.
2. Disconnect the batteries.
3. Open the hood to get access to the Air Compressor Suction Line and Engine Harness.
4. Remove and replace Air Compressor Suction Line with new Suction Line Item 1.
5. Install Items 2 and 3 to bundle together Harness and Suction Line. Care must be taken to avoid crushing the Suction Line and causing air intake restrictions.
