Technical Service Bulletin

39 Oil leak at sealing cap on rear final drive, sport differential

39 21 44 2064024/1 August 26, 2021.

Model(s)	Year	VIN Range	Vehicle-Specific Equipment
RS6 Avant, RS7, SQ7, SQ8, RSQ8, and S8	2020 - 2021	All	V8 & Sport differentials

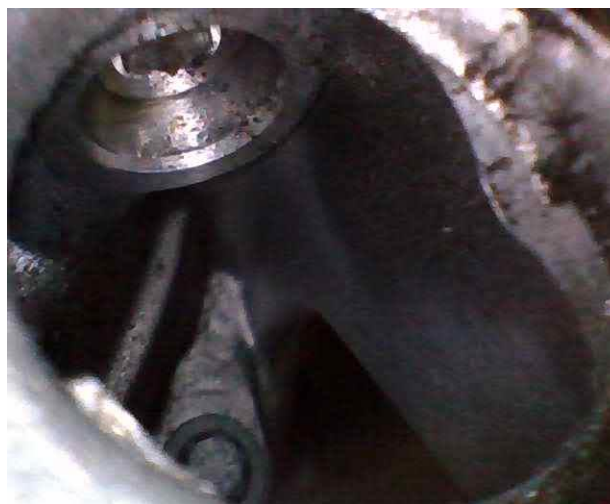
- An oil leak is confirmed from the top of the differential near the output flanges.
- One or both of the sealing caps are missing from the pressure limiting valves (Figures 1 - 3).

Figure 1. Missing sealing cap viewed with a pocket mirror.

If the leak can be confirmed to be from a missing sealing cap, then perform the following repair.

1. Following the Elsa Repair Manual instructions remove the differential from the vehicle and place it on a suitable working surface.

3. Place the new sealing cap on a drift and coat it lightly with locking fluid around the outside edge (red arrow Figure 4).

4. Knock sealing cap onto pressure limiting valve using a drift and soft-faced hammer at a right angle to machined surface of housing until it reaches its stop. When it reaches its stop, a dull sound can be heard and a spring-back effect can be felt at the hammer (Figure 5).

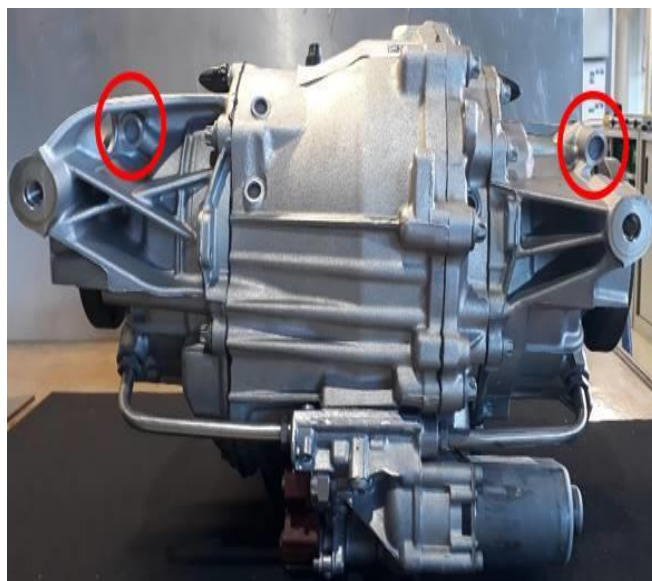
Figure 2. Location of sealing caps on the OD3 differential.

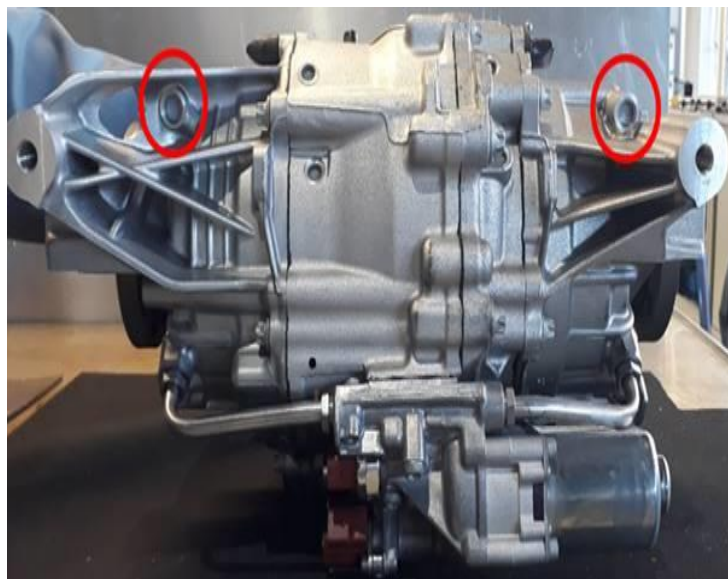
Figure 3. Location of sealing caps on the OBX differential.

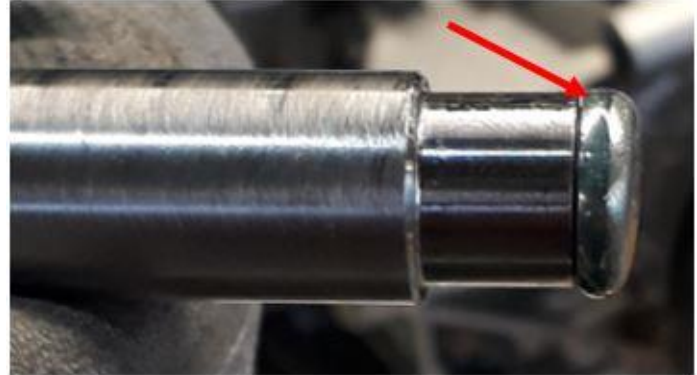
Figure 4. Sealing cap on a drift.

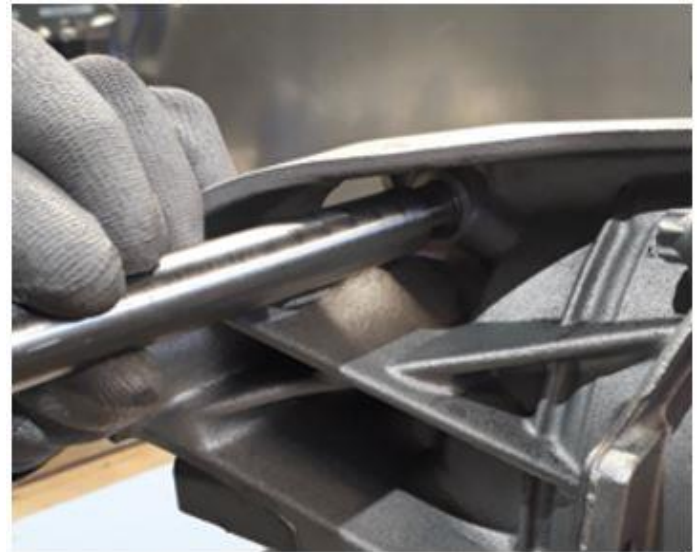
Figure 5. Installing sealing cap

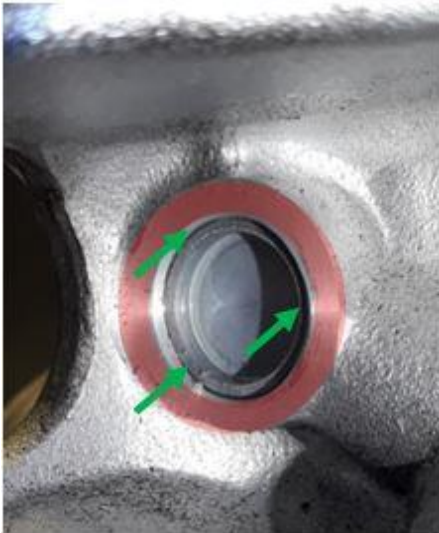
Figure 6. Measurement locations.

5. Remove excess locking fluid with a clean cloth.
6. Perform a visual check to see whether the sealing cap has been installed evenly around the entire circumference.
7. Perform a check measurement with a caliper gauge. The measurement from the machined surface of the housing (the red area in Figure 6) to the upper collar of the sealing cap (green arrows in Figure 6).

This measurement must be performed in three locations at intervals of 120° and a minimum dimension of 1.00 mm and a deviation of no more than 0.3 mm must be ensured.

In the event of deviations from the minimum dimension or the maximum deviation being exceeded, the sealing cap can be knocked carefully in with the drift and soft-faced hammer if necessary.

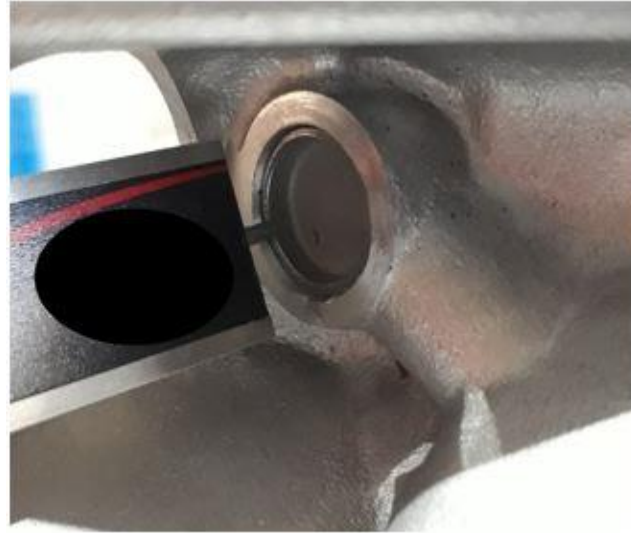
Figure 7. Performing measurement.

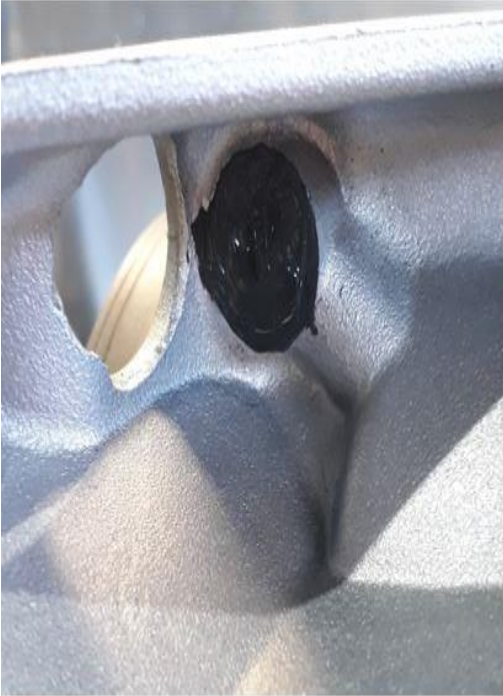
Figure 8. Silicone adhesive sealant example 1.

9. After a drying time of at least 30 minutes, clean the area around the sealing caps of the pressure limiting valves (both sides) using a clean cloth (lightly coated with brake cleaner if necessary).
10. Both sealing caps must be bonded over the entire surface using the silicone adhesive sealant. A layer of skin forms and then hardens (Figures 8 - 9). A drying time of at least 30 minutes must be ensured before reinstallation into the vehicle.

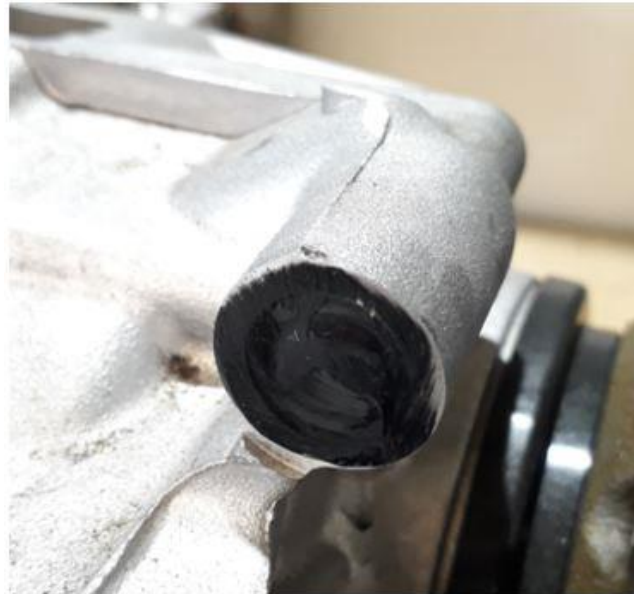
Figure 9. Silicone adhesive sealant example 2.
