**TECHNICAL SERVICE BULLETIN****Illuminated ABS Indicator, Engine Will Not Turn Off And/Or Various Electrical Symptoms - BJB Cover Not Fully Seated****21-2176**13 August
2021

This bulletin supersedes 20-2298. Reason for update: Concern Carryover to New Model

Ford 2020-2021 Super Duty

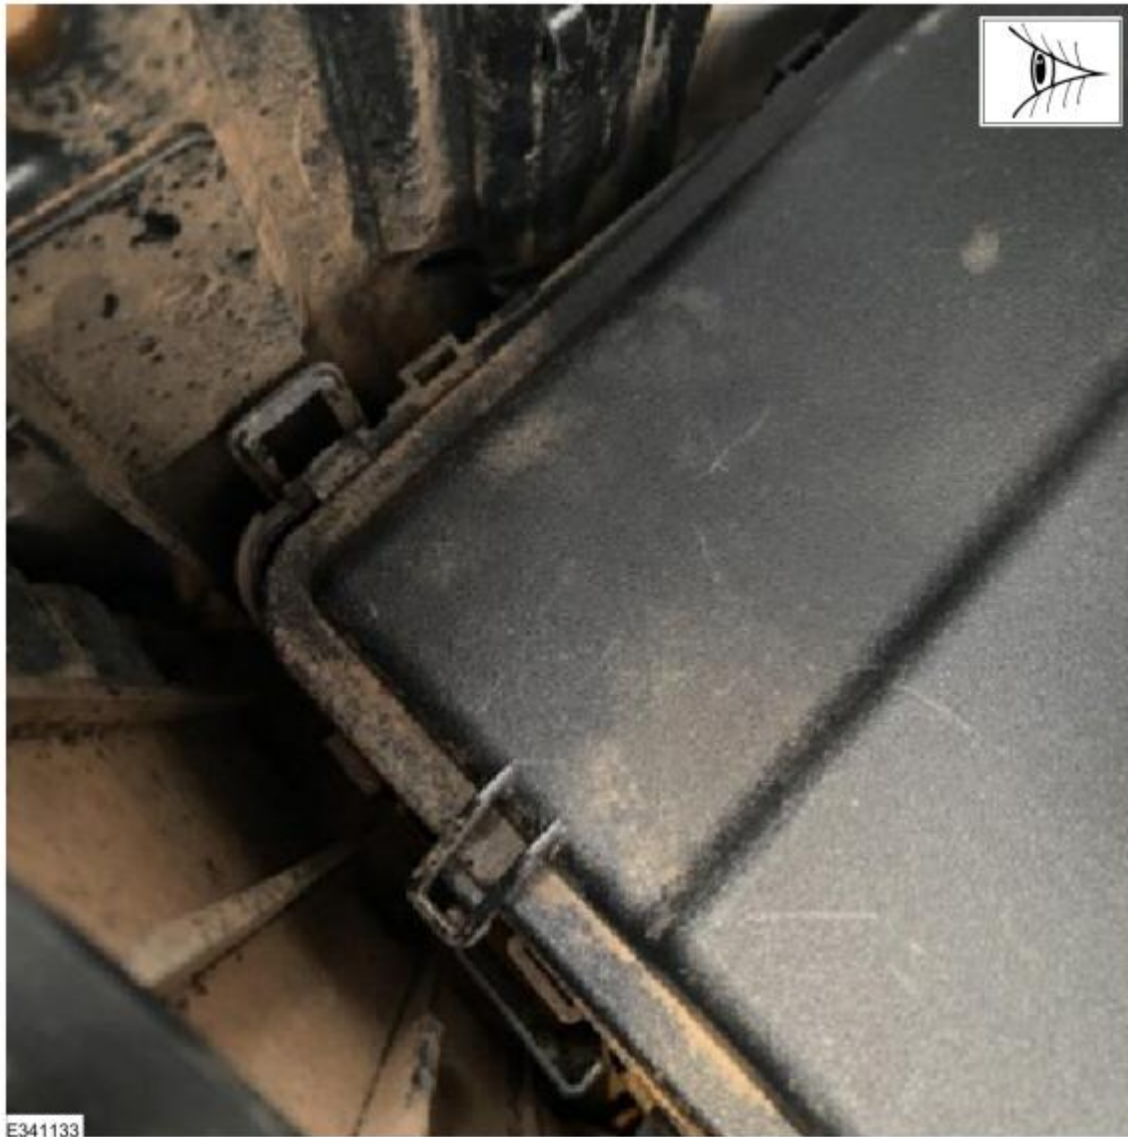
Figure 1 - Example of moisture intrusion with BJB cover on

2. Replace the BJB assembly.

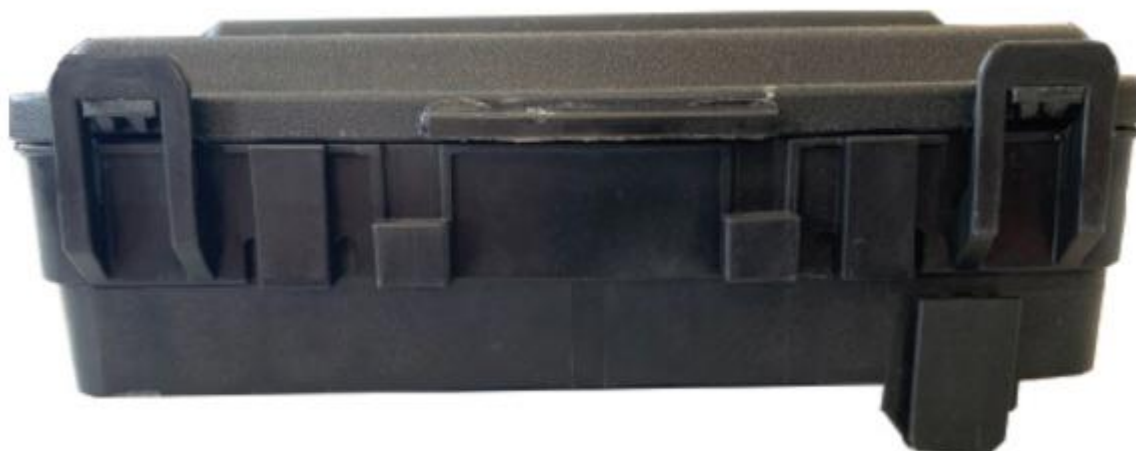
E341135

Figure 3 - Correct cover installation

- (9). Install the new BJB cover making sure the cover tabs/locking fingers are installed correctly.
- (10). Install the battery tray and battery back into the vehicle. Refer to WSM, Section 414-01.

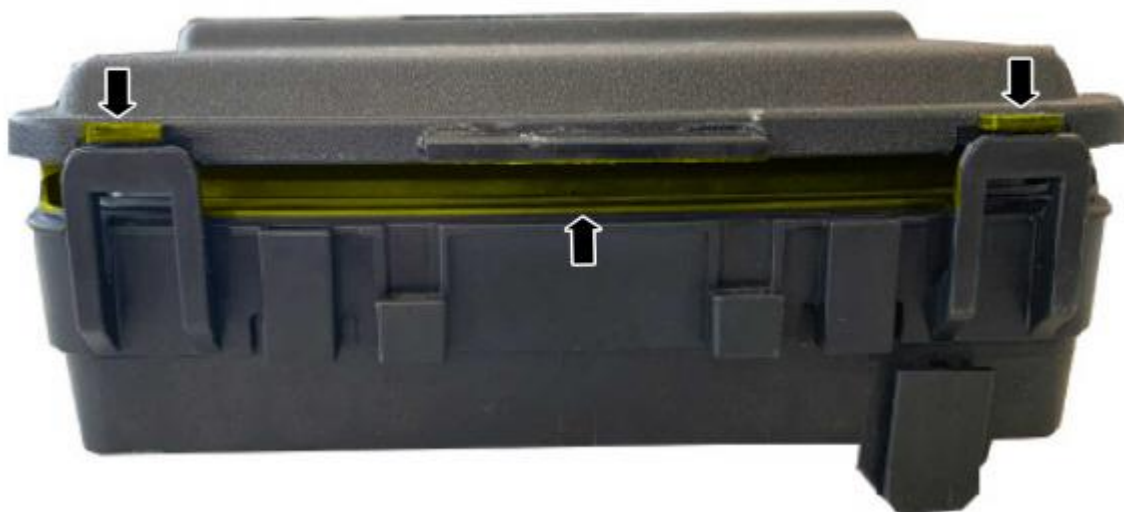
E341136

Figure 4 - Incorrect cover installation
