TECHNICAL SERVICE BULLETIN

Vibration/Pulsation From Brakes - Brake Pad Material Stuck To Rotor

21-220624 August
2021**Model:**

Ford 2021 Mustang Mach-E

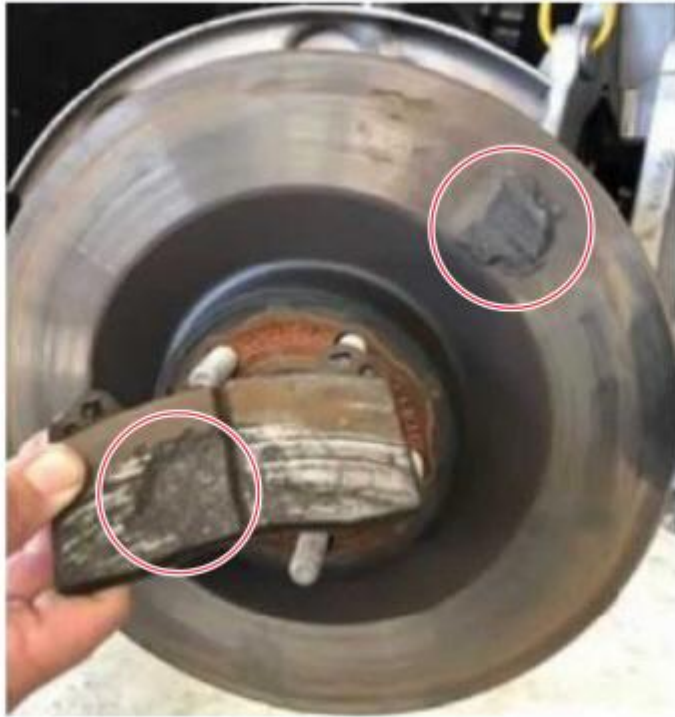
Figure 1

Issue: Some 2021 Mustang Mach-E vehicles may exhibit a vibration or pulsation from the brakes. This may be due to brake pad material bonded to the rotor. To correct the condition, follow the Service Procedure steps to replace the brake pads and resurface the rotors.

1. Replace the front brake pads with the revised brake pads that do not contain the center V channel. Refer to Workshop Manual (WSM), Section 206-03.
2. Resurface the front brake rotors to remove the brake pad material. Refer to WSM, Section 206-00.
