# TECHNICAL SERVICE BULLETIN

## Hybrid - Rattle/Buzz Originating In The Right Rear Quarter Area - Built On Or Before 19-Jul-2021

21-2271

Ford 2020-2021 Escape
--------------------------

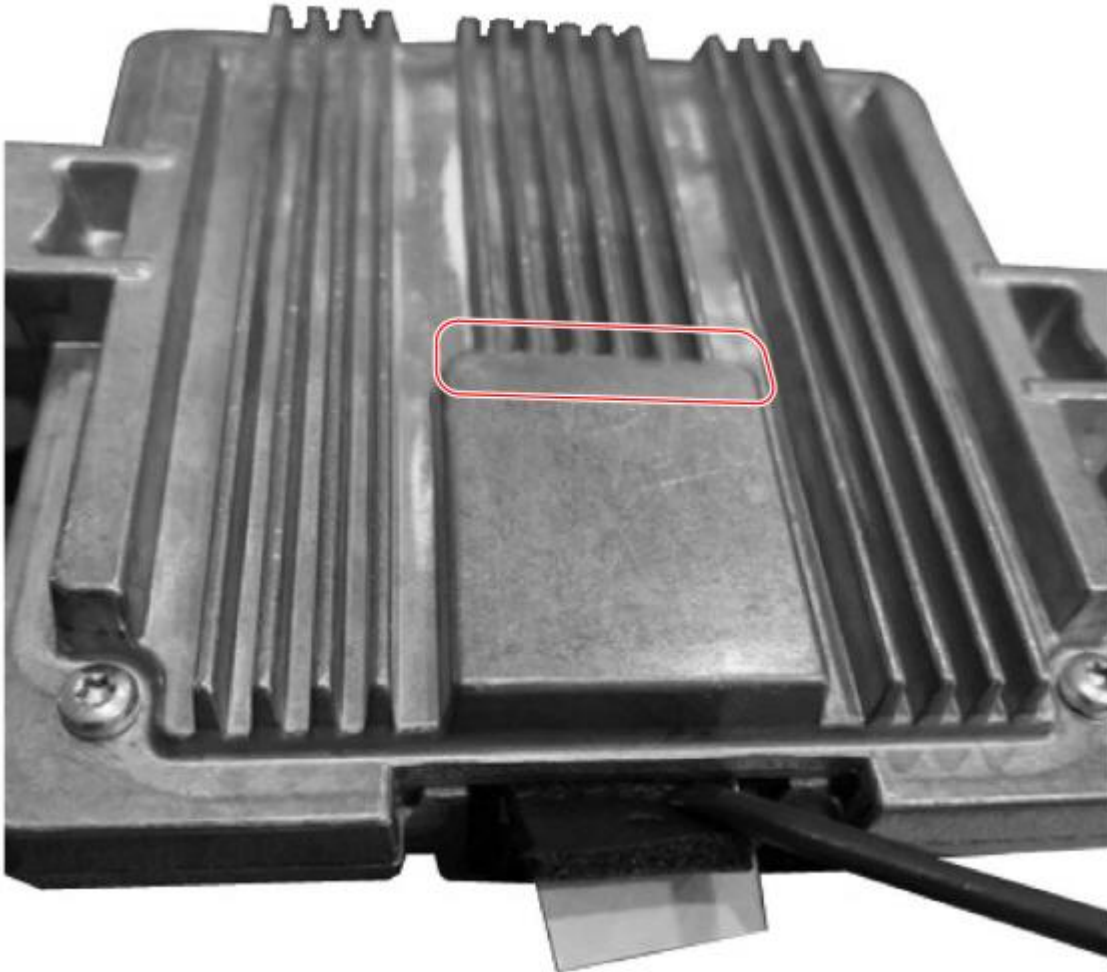
Figure 1

**NOTE: The connector's inboard side is attached to the printed circuit board of the module at the location indicated in Figure 1. This attachment provides some flexibility while working at the other end of the connector.**

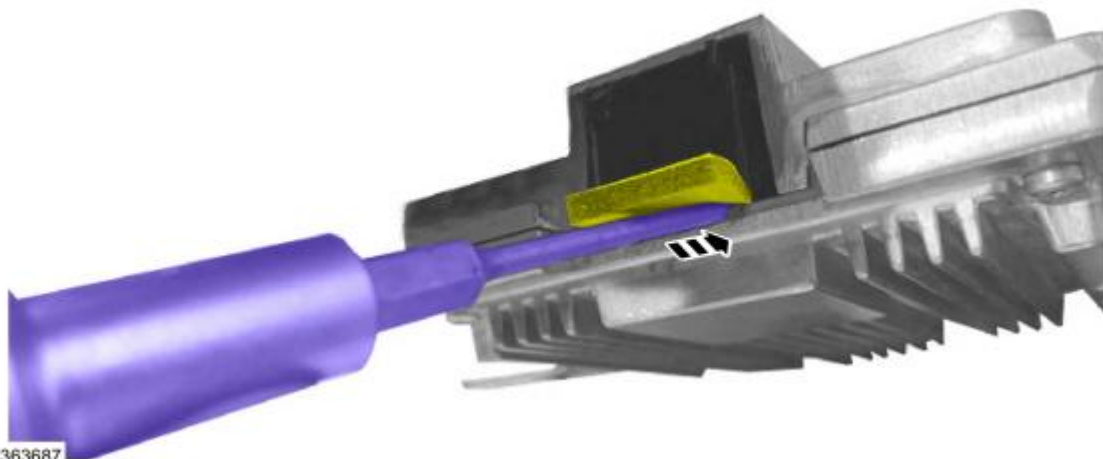
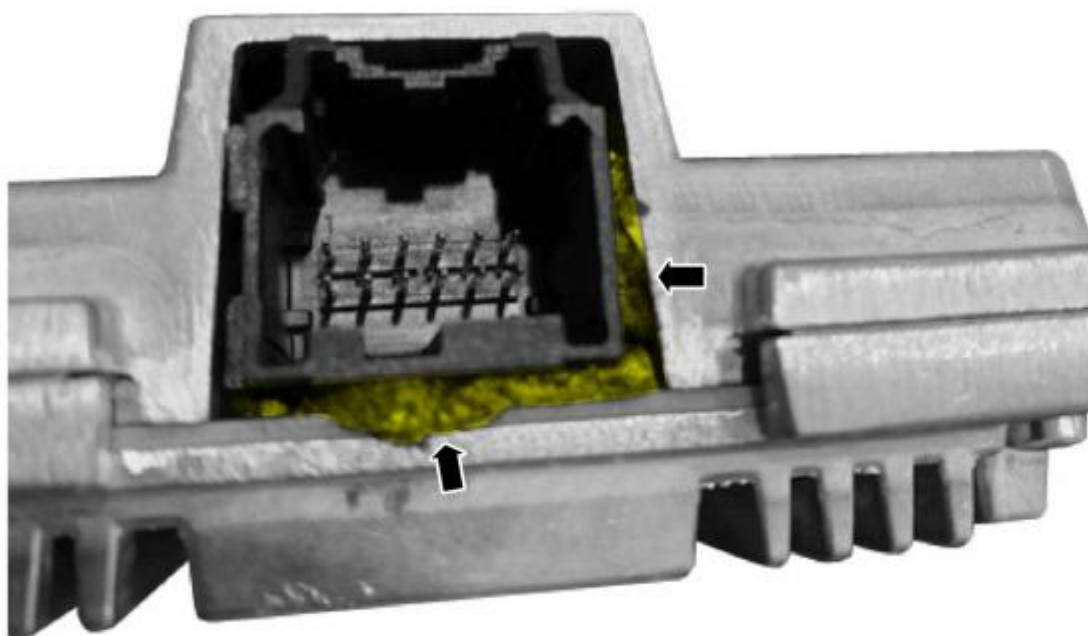
**Issue:** Some 2020-2021 Escape hybrid vehicles built on or before 19-Jul-2021 may exhibit a rattle/buzz originating in the right rear quarter area. This may be due to the pedestrian alert control module (PACM) internal connector vibrating against the metal housing when subjected to audio frequencies between 50 and 60 Hz. To correct the condition, follow the Service Procedure to insulate the connector.

4. Fold the 1 inch (2.5 cm) squares over so that they are doubled in thickness.
5. Using a trim tool or small flat head screwdriver, insert the PVC foam in between the metal housing and the external facing internal connector. Insert the foam pieces between two sides of the connector to module case (Figures 2-3).
