JLRTB02058NAS1

TECHNICAL BULLETIN

SUBJECT/CONCERN:Tapping Noise From A-Pillar Area

MODEL:	MODEL YEAR:	VIN:	ASSEMBLY PLANT:
Defender (LE)	2020-2022	000584-072849	Nitra (Slovakia)

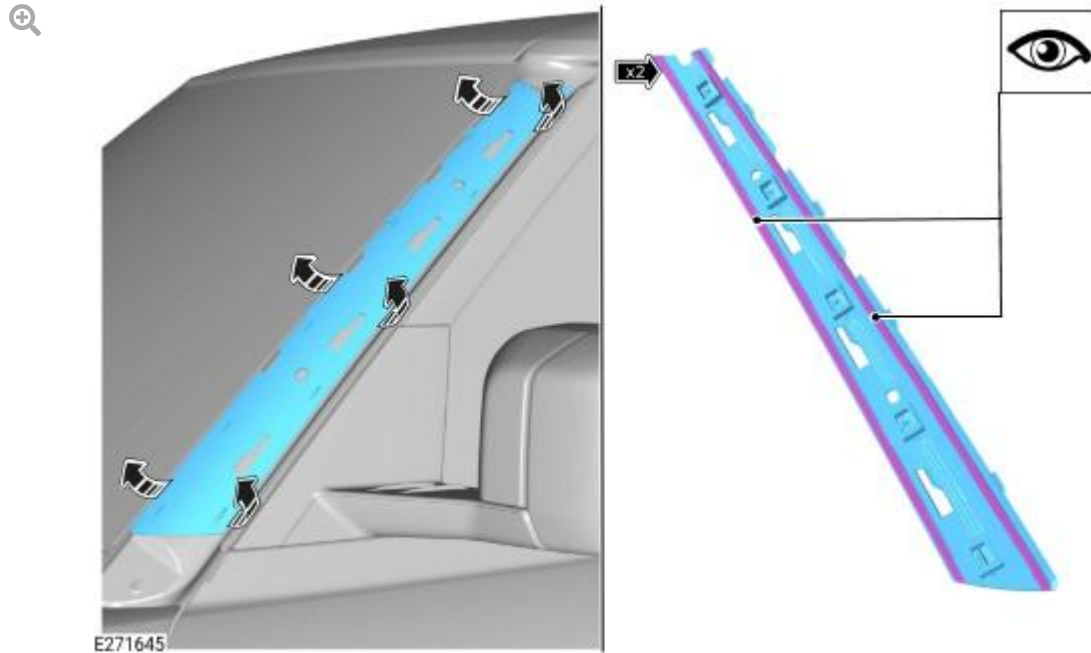
Check that the 2 strips of double sided tape are fully adhered to the body.

- By hand, pull along both edges of the windshield molding carrier while visually inspecting the tape for adhesion.
 - If both strips of double sided tape **are** fully adhered to the body, **continue to step 14.**
 - If any of the strips of double sided tape **are not** fully adhered to the body, **renew the windshield molding carrier as part of a separate warranty claim (see TOPIx Workshop Manual section 501-11: Glass, Frames and Mechanisms - Removal and Installation - Windshield Molding Carrier).**

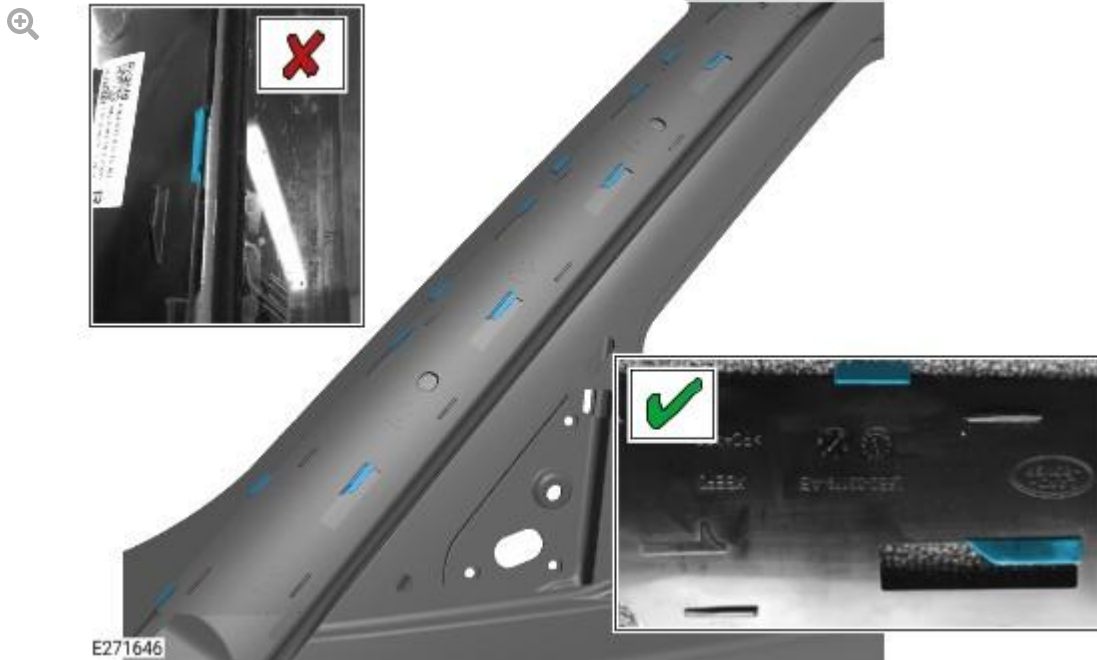
Visually inspect the windshield molding carrier for damage to the clipping features shown in the illustration.

- If the clipping features **are not** damaged, as shown in the image with a **GREEN '✓'**, **continue to step 15.**
- If any of the clipping features **are** damaged, as shown in the image with a **RED 'X'**, **renew the windshield molding carrier as part of a separate warranty claim (see TOPIx Workshop Manual section 501-11: Glass, Frames and Mechanisms - Removal and Installation - Windshield Molding Carrier).**

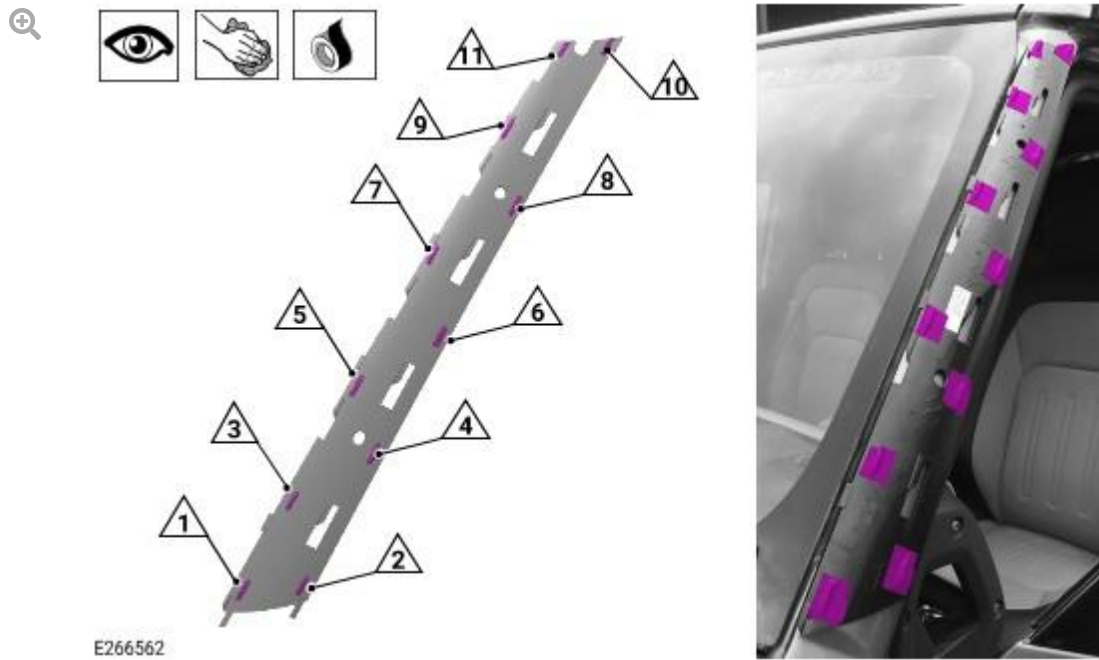
Locate the 11 windshield molding retaining ribs, as shown highlighted in the illustration.

- Clean the area around each windshield molding retaining rib.
 - Apply felt tape to cover each of the 11 windshield molding retaining ribs, as shown in the illustration.
-

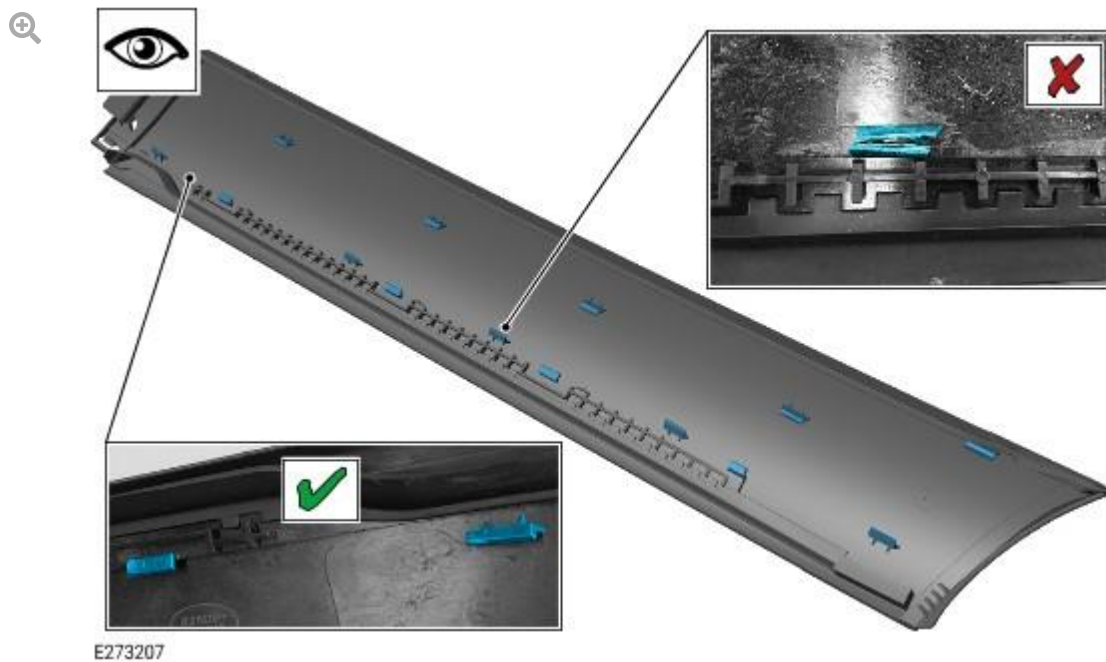
Inspect the windshield molding for damaged clipping features.

- If the clipping features **are not** damaged, as shown in the image with a **GREEN '✓'**, **continue to step 24.**
 - If any of the clipping features **are** damaged, as shown in the image with a **RED 'X'**, **a new windshield molding must be ordered and claimed as part of a separate warranty claim before continuing to step 24.**
-

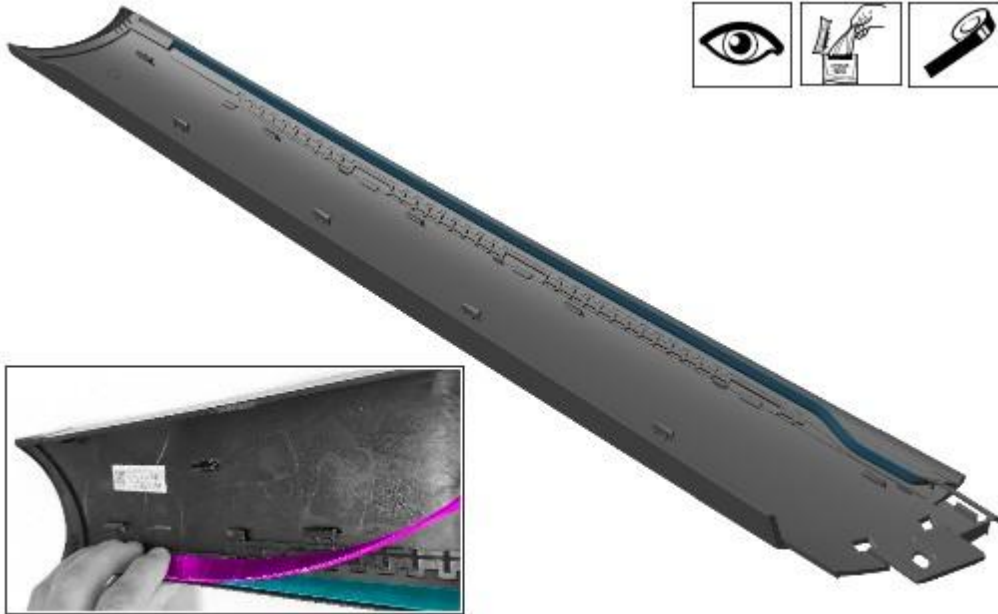
E271647

Inspect the rubber seal on the windshield molding for damage. If the seal is damaged a new windshield molding is required before continuing with this step, this must be claimed as a separate warranty claim.

Using 3M™ surface cleaner, clean the inside edge of the rubber seal, as shown highlighted in the illustration.

Following the manufacturer's specifications, apply the 3M™ adhesion promoter to the inside edge rubber seal, as shown highlighted in the illustration.

Gradually remove the adhesive backing and install the 3M adhesive tape - ST 1200 (or equivalent) in small sections at a time. Apply firm pressure along the entire length of the rubber seal to make sure the adhesive is bonded.

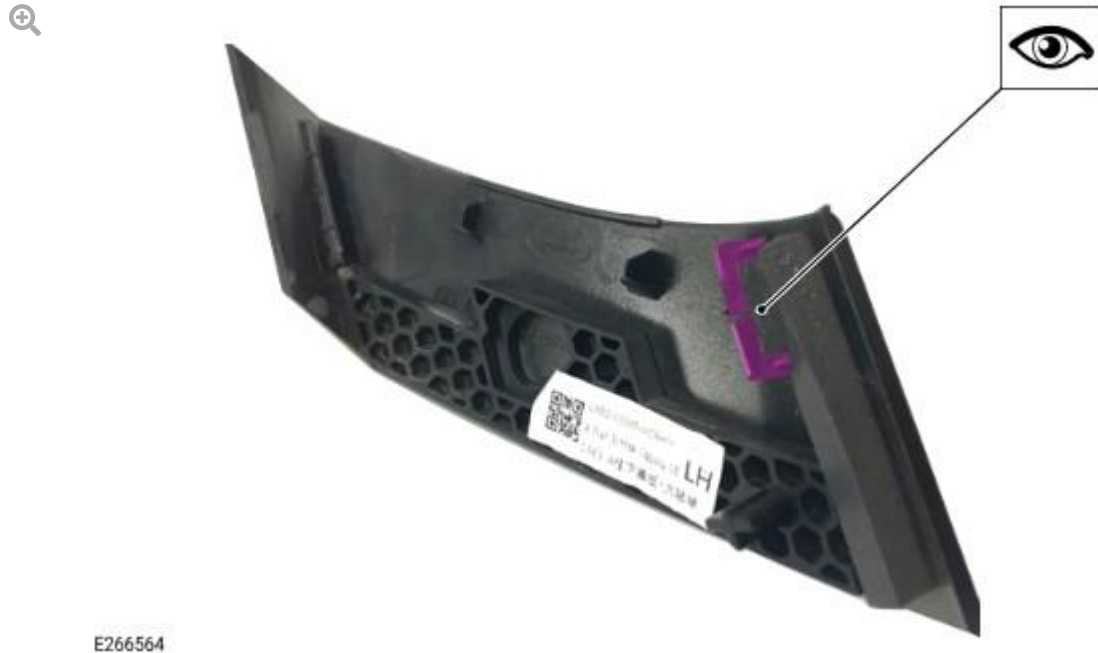
E266564

Inspect the retaining clip on the windshield molding bolt cover.

- If the retaining clip is broken, as shown highlighted in the illustration, **install a new windshield molding bolt cover during the next step and claim it as part of a separate warranty claim.**
 - If the retaining clip is **not** broken, **install the original windshield molding bolt cover during the next step.**
-
