N564NAS1

TECHNICAL BULLETIN

Service Action - Windshield Water Ingress

MODEL:	MODEL YEAR:	VIN:
Discovery (LR)	2018-2019	032671-414716

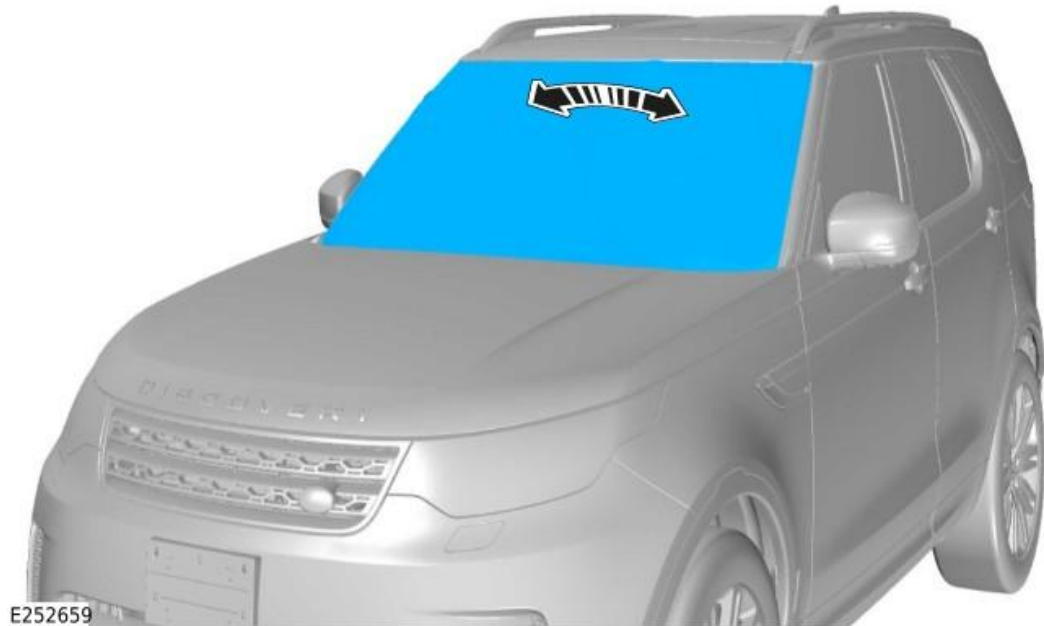
Complete a water test on the outside of the windshield, with a second technician inside the vehicle.

- Start in the lower section and spray the whole area, working left to right in stages.
- From inside the vehicle, apply gentle pressure by hand around the edge of the windshield.

-
2. From inside the vehicle, inspect around the edge of the windshield for water ingress.
- If water ingress is evident, **continue to the Service Instruction.**
 - If water ingress is not evident, **continue to Service Inspection 3.**

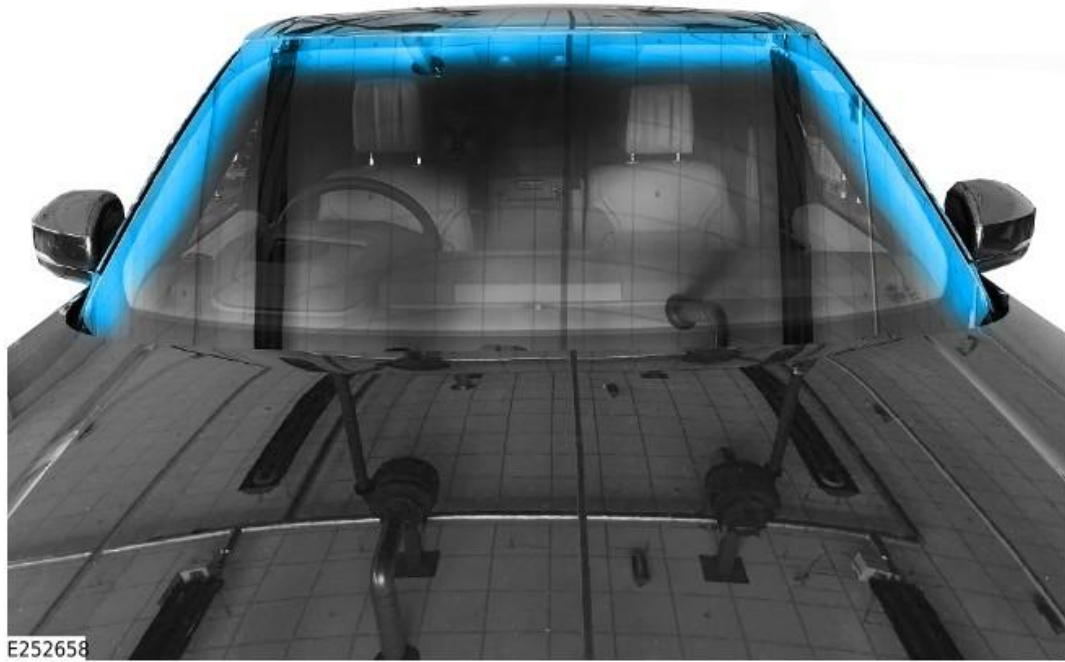
Apply soapy water around the edge of the windshield, as shown in the illustration.

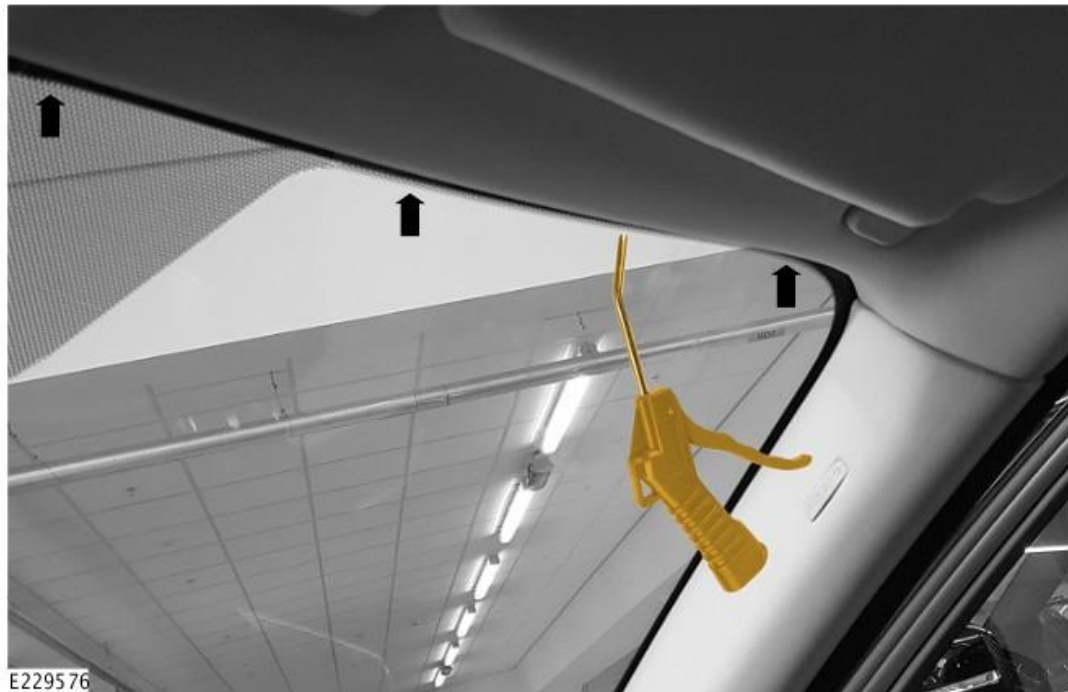
Using an air blower, blow compressed air around the inside edge of the windshield, as shown in the illustration.

- While continuing to blow air around the inside edge of the windshield, apply gentle pressure by hand around the inside edge of the windshield.

- If bubbles **can** be seen forming in the soapy water, **continue to the Service Instruction.**
- If bubbles **cannot** be seen forming in the soapy water, **continue to step 4.**

1. Renew the windshield (see TOPIx Workshop Manual section 501-11: Glass, Frame and Mechanisms - Removal and Installation - Windshield).
