**Document ID:** IK0900143  
**Revision:** 0  
**Created:** 6/1/2021  
**Last Modified:** 8/13/2021  
**Author:** Allan Hertko

**Title:** CV Heater Core Outlet Tube

**Applies To:** CV

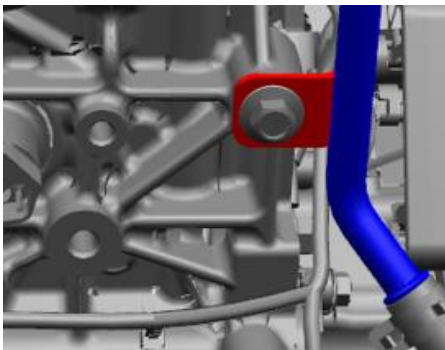
### **Current Welded Design**

A coolant leak can develop from a cracked heater core outlet tube along the lower engine bracket weld. A redesigned tube, bracket and clamp has been released to resolve this concern.

Step 1: Open hood assembly.

Step 2: Drain cooling system.

Step 3: Remove right front inner fender.

Step 4: Remove intake air box top and lower box.

Step 5: Unlatch the heater hose from the outlet tube.

Step 6: Remove the lower hose and clamp.

Step 7: Remove both bolts and tube from engine compartment. Do not discard bolts save for reuse.
