Document ID: IK1600131

Title: Cab Water Leak Troubleshooting Tips

Applies To: LT, RH, ProStar, HX Steel Cab, and Lonestar sleeper cabs. However some aspects may also apply to all cabs in the High Performance Vehicle family - MV, HV, LT, RH, ProStar, LoneStar, TransStar, WorkStar(HV), DuraStar(MV), and TerraStar. 9000i, PayStar(HX) Aluminum Cab, CityStar, CV, or LoadStar are not covered in this document.

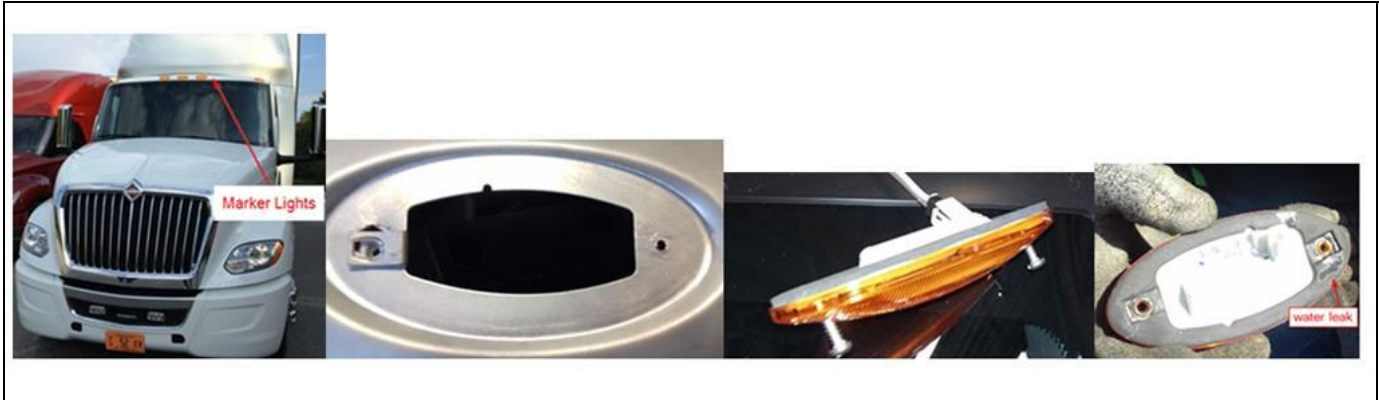
- Water leaks from the sunshade mounting can originate where the bracket mounts to the cab or where the sunshade mounts to the mounting bracket. One or both areas may not be properly sealed.
3. Roof marker lights
- Each marker light is held in place with two #8 SS sheet metal screws. One goes directly into the cab roof and the other goes into a U-nut clip. Sometimes the U-nut tears the foam gasket. Sometimes the screw that goes directly into the cab roof strips the hole and causes the gasket not to compress and seal. Add a new U-nut to the stripped hole location.
 - Remove each marker light to inspect and verify seal integrity. (See attached photos for example of defective seal.)
 - Check all five marker lights as more than one could be leaking.

Be sure to remove and inspect all five marker light seals and be careful to not over torque the fasteners upon reinstallation.

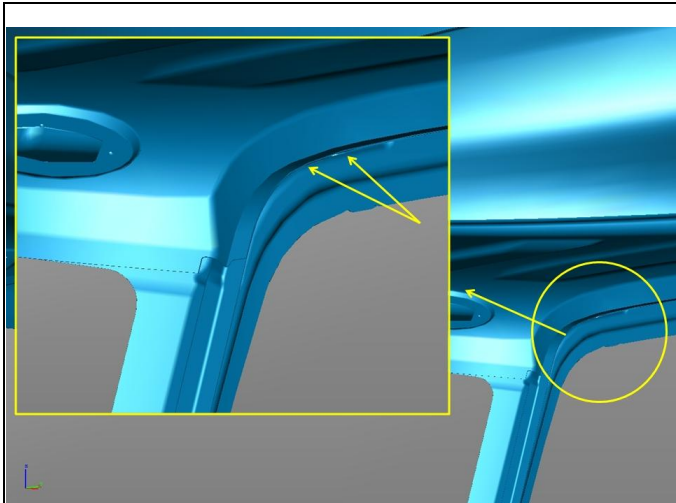
Although this seam is covered by the door seal, water can work its way under the seal and through this seam if this seam is not sealed properly at the factory.

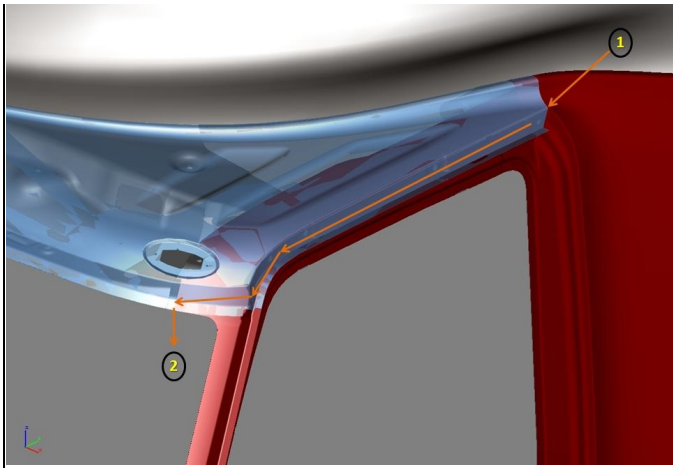
1. Water enters here.
2. Water exits here and drips down the inside of the windshield.

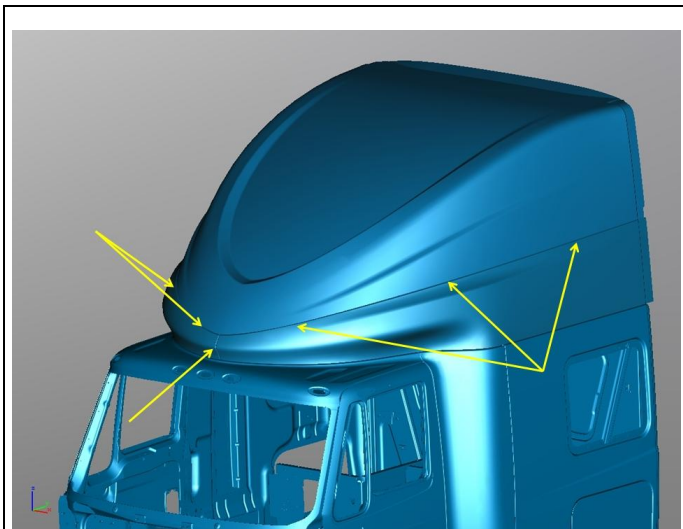
All roof seams should be checked for cracks or voids in the sealer.

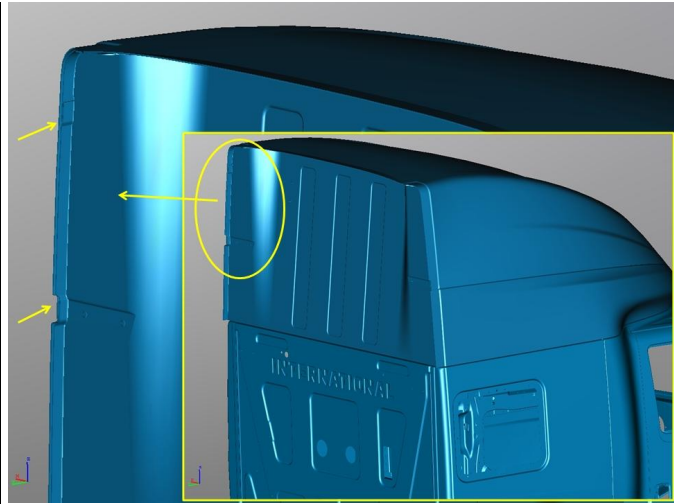
Seams at the rear corners of the Skyrise cab should be checked for voids.

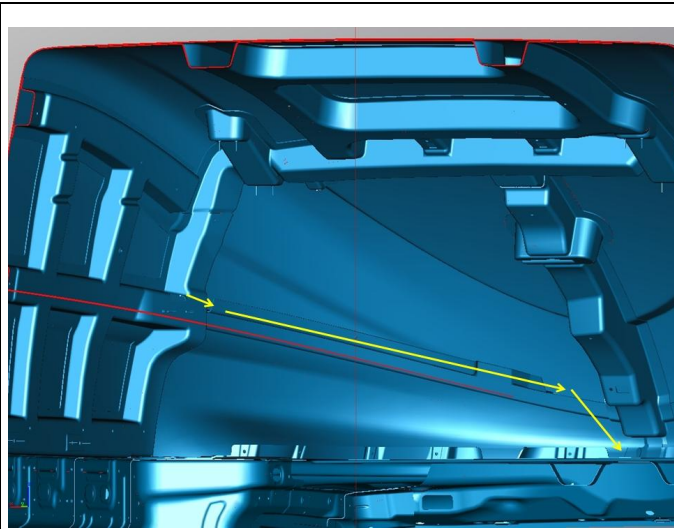
After penetrating the outer seams, water can travel along internal reinforcement bond lines, ultimately draining into the trough formed by the lower roof panel and dumping near the front center of the driver compartment.

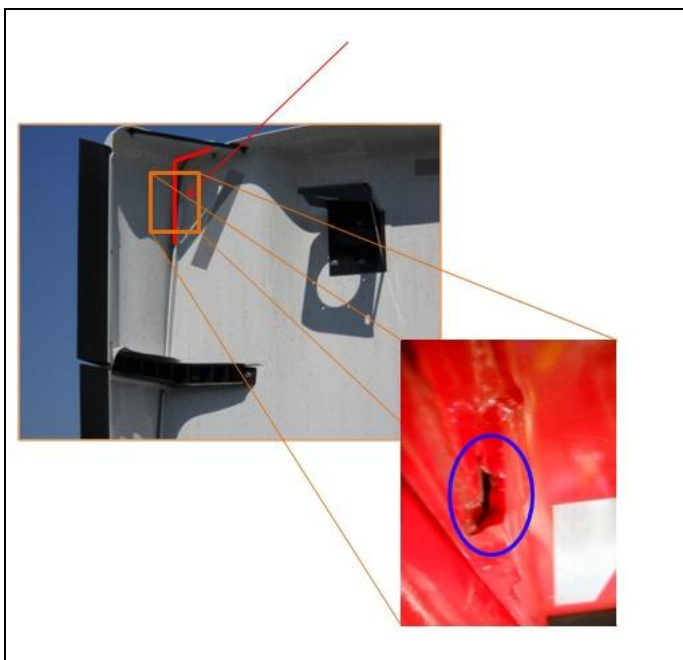
Top Photo - Driver side shown, passenger side symmetrically opposite.

This area is illustrated due to its obscurity as a water entry point. These instructions can be used on any roof seam that exhibits a void or inconsistency in sealer.

2. Allow the surfaces to dry.
3. Apply Dow® BETASEAL™ (2611723C1) to the same areas cleaned in Step 1.
4. Immediately wipe off the surfaces (prolonged exposure to the Dow® primer could damage the paint). These surfaces are now prepped for good adhesion to the sealer.
5. Apply 3M® SMP Adhesive Sealant 760UV™ to the prepped surfaces. Force material into the joint where possible. For best results, apply sealer into the seam wiping in both directions.
6. Allow material to dry.

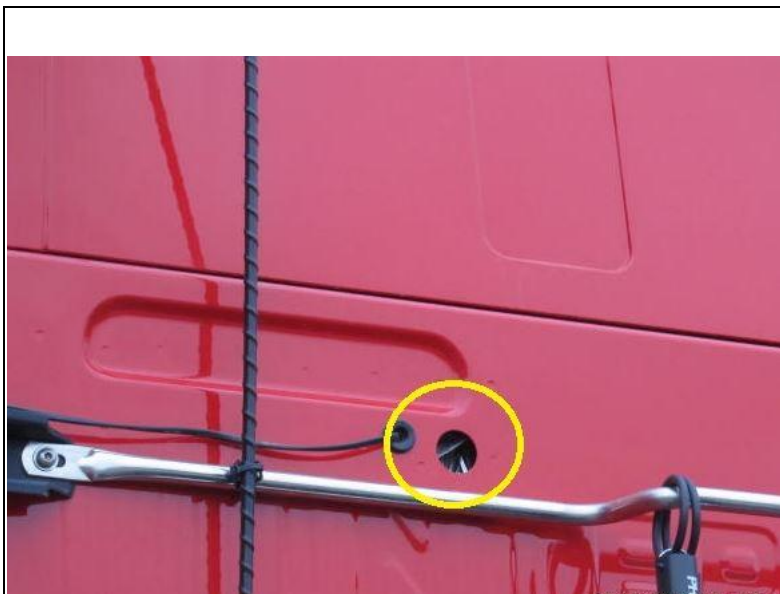
Example of missing plastic plug on BOC of most sleeper configurations. If this plug is missing; replace it with new one from service parts (p/n: 498376C1)

Note: When inspecting BOC on Sleepers - Look to be sure the black plastic plug is not missing. If plug is missing replace with service part plug. (P/N: 498376C1)
