WMBO - Reworking Screws for Side Cushions on the Rear Seats (Workshop Campaign)

Model Line: **Taycan (Y1A)**

Model Year: **2020**

Concerns: **Side cushions on the rear seats**

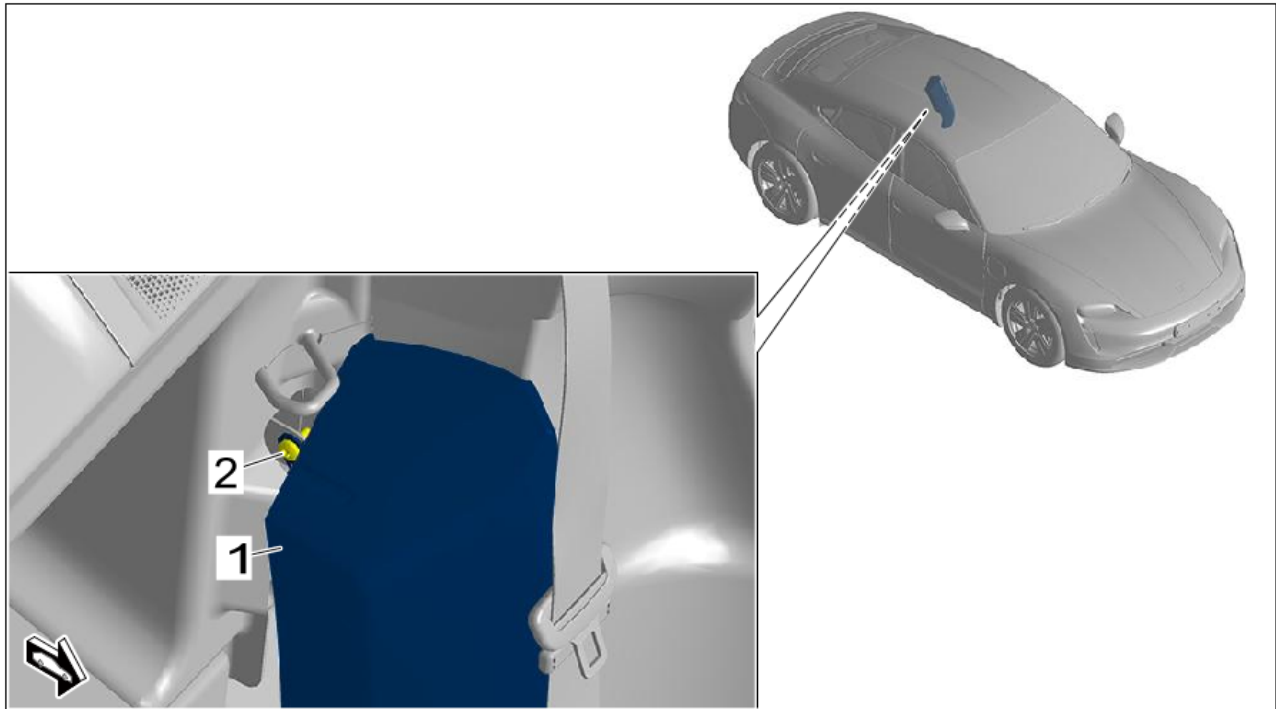
Installation position overview (Example: left)

- 1 – Side cushion on the rear seats
- 2 – Screws (**rework**)

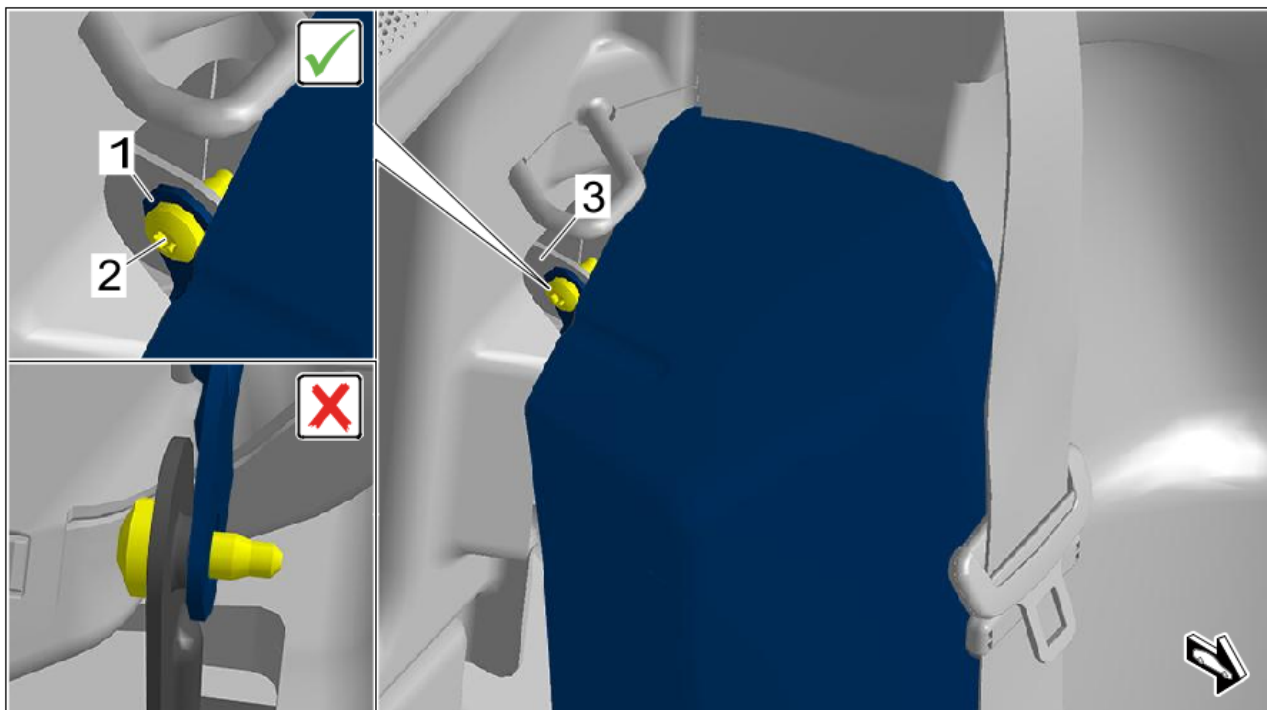
Tab of side cushion

- Work Procedure:
- 1 Fold left rear backrest over.
 - 2 Check whether the tab of the side cushion ⇒ *Tab of side cushion-1-* is installed between the screw head ⇒ *Tab of side cushion-2-* and holder on the body ⇒ *Tab of side cushion-3-*.
