Complaint – Creaking Noise from Driver or Passenger Footwell: Reworking Floorpan (98/21)

Model Line: **Taycan (Y1A/Y1B)**

Model Year: **As of 2020 up to 2021**

Concerns: **Floorpan**

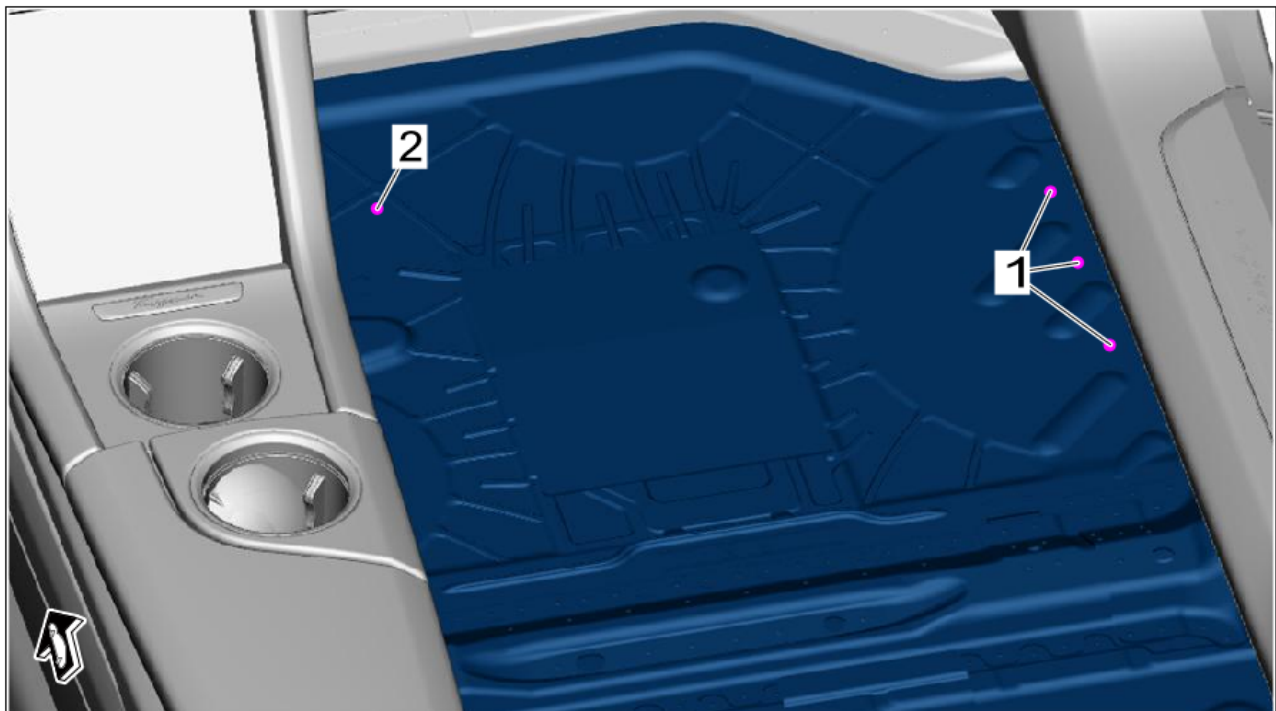
Overview of floorpan (in right footwell as example)

Information: When load is placed on the floorpan of the vehicle and release (e.g. when getting in and out of the vehicle), a creaking noise can be heard from the driver or passenger footwell. This is caused by the floorpan bending downwards and then popping back to its original position.

- 1 – Re-pressing position 1 (a total of 3 positions)
- 2 – Re-pressing position 2 (one position, only if required)
